PLAT OF SURVEY
-OF-

LOT 6 OF HILLVIEW PARK SUBDIVISION, BEING A SUBDIVISION LOCATED IN THE SOUTHEAST 1/4 OF THE NORTHWEST 1/4 OF SECTION 35, TOWNSHIP 4 NORTH, RANGE 16 EAST OF THE FOURTH PRINCIPAL MERIDIAN, IN THE TOWN OF LAGRANGE, COUNTY OF WALWORTH AND STATE OF WISCONSIN.

SURVEY FOR: JOHN AND DEBRA CARROLL
SURVEY ADDRESS: W5540 LOST NATION ROAD, ELKHORN, WI 53121

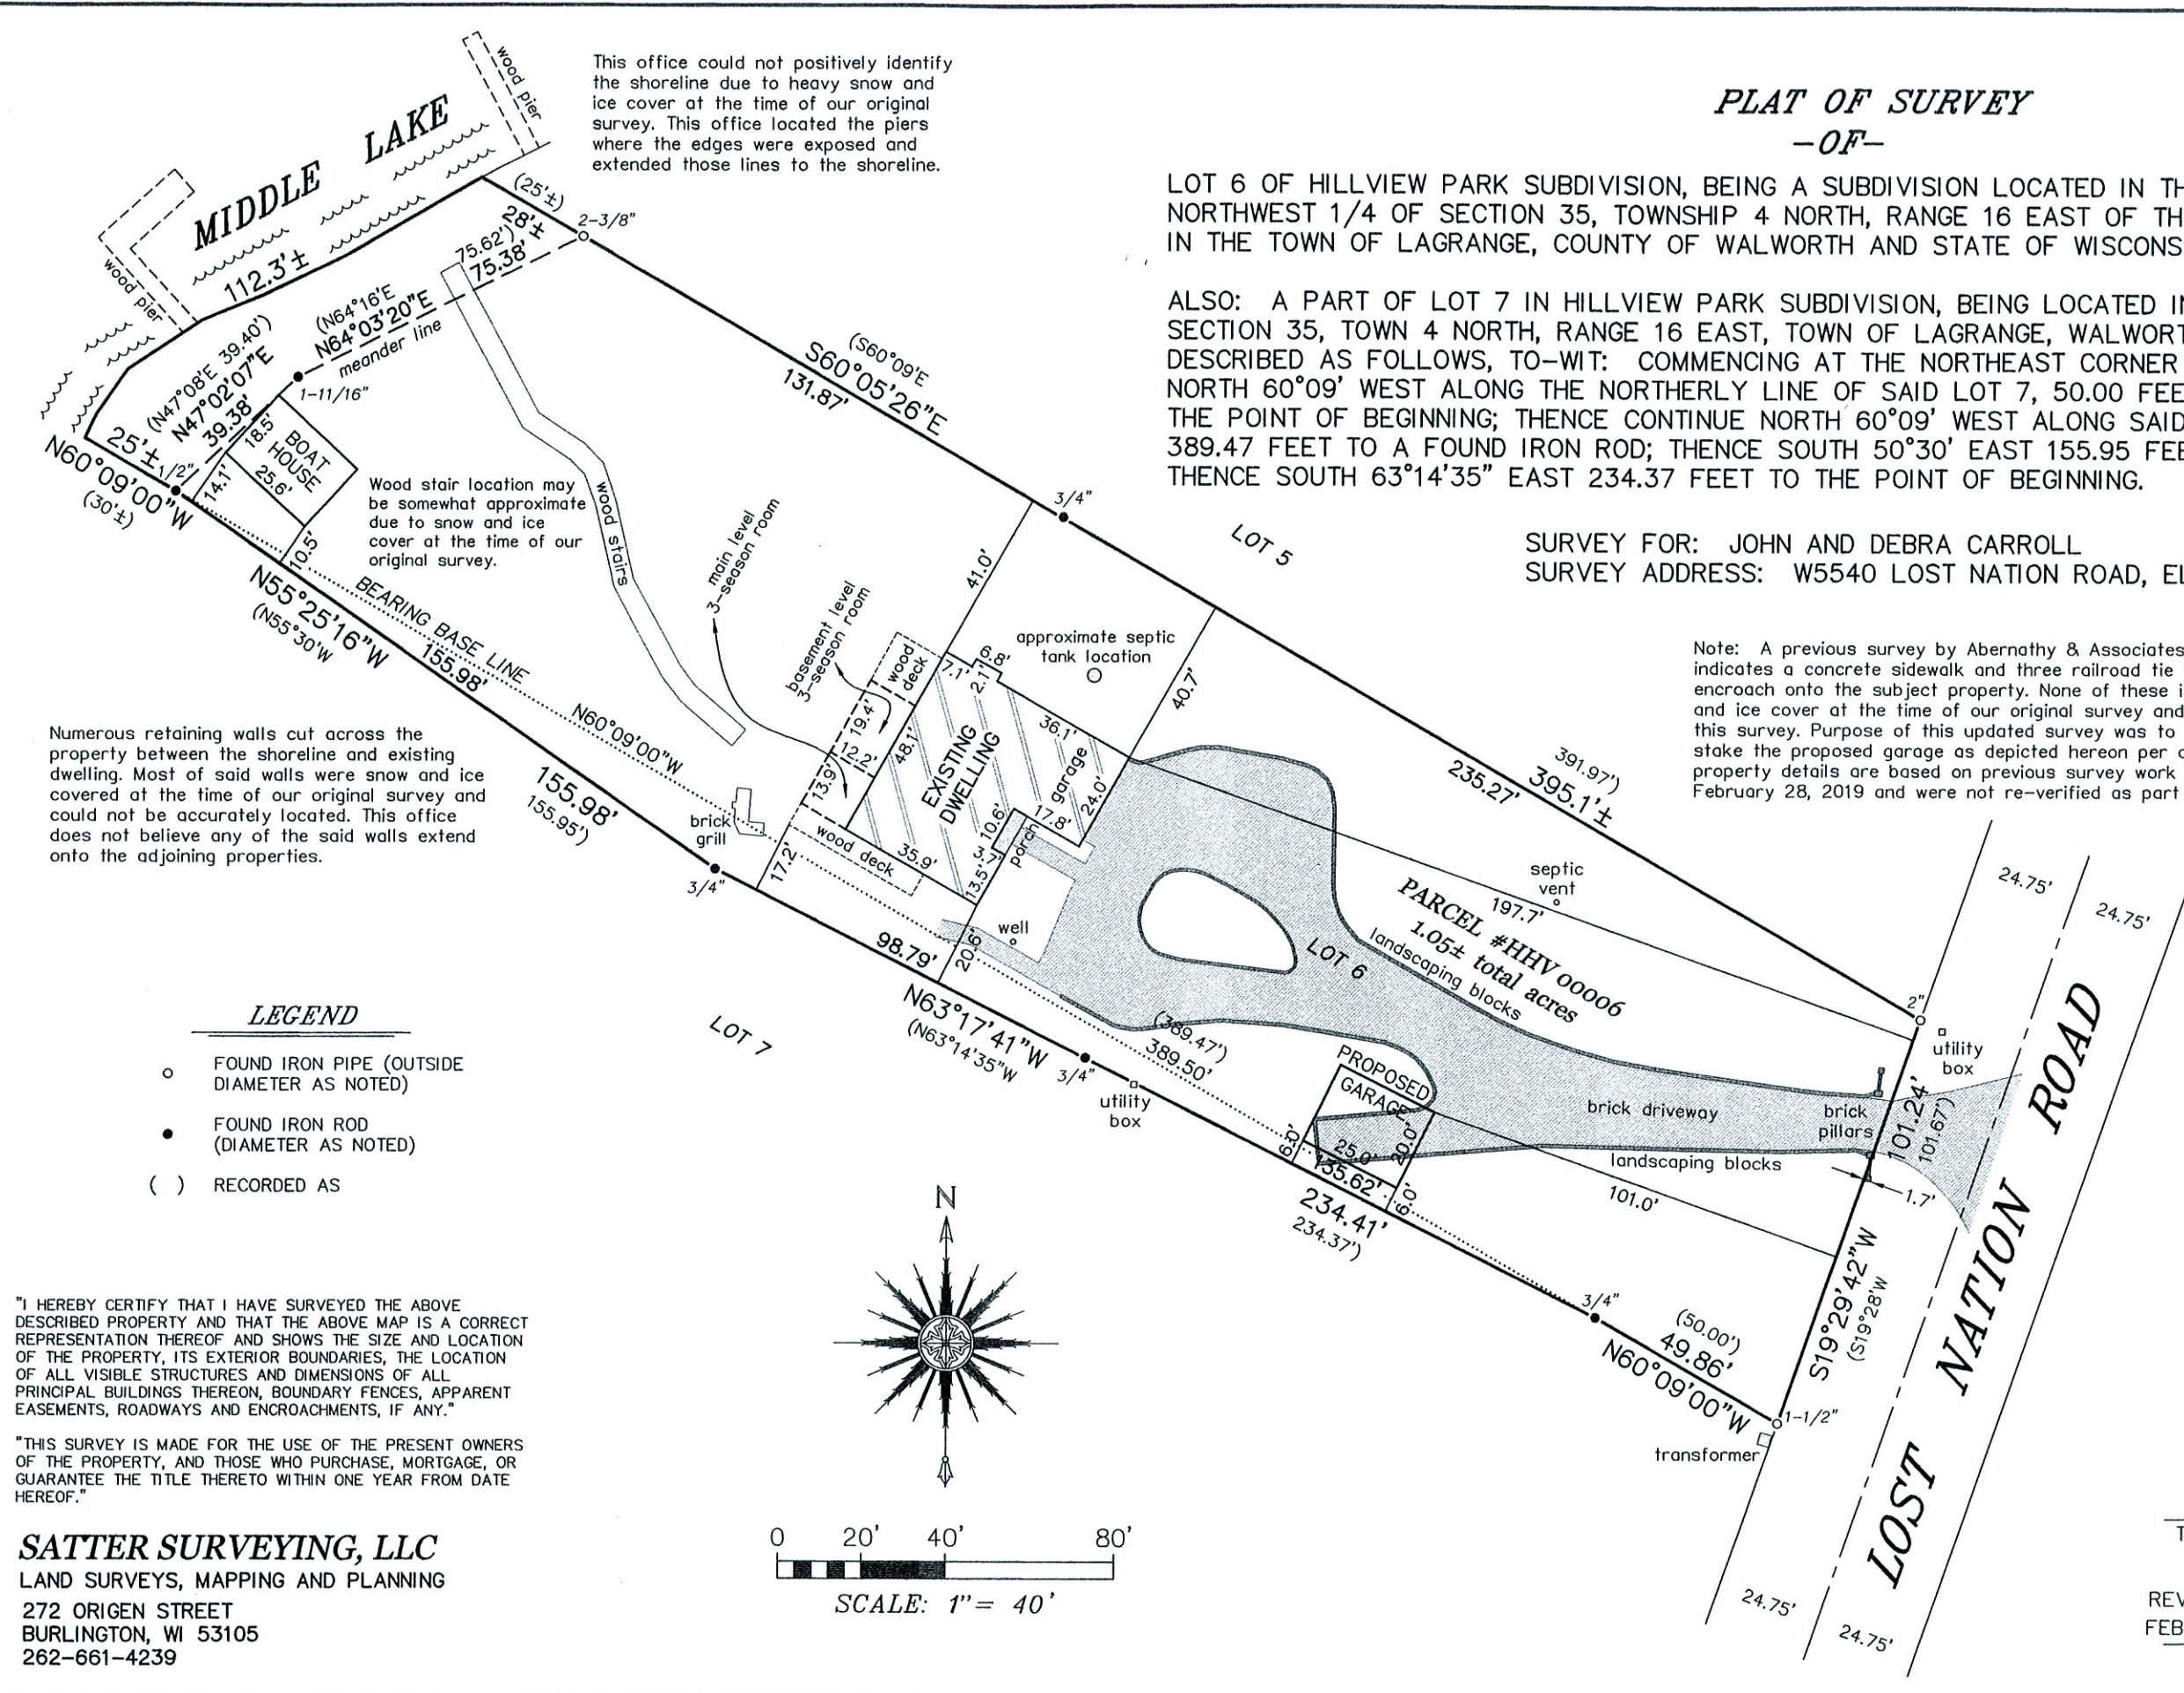
Note: A previous survey by Abernathy & Associates dated January 4, 1991 indicates a concrete sidewalk and three railroad tie retaining walls on Lot 5 that encroach onto the subject property. None of these items were visible due to snow and ice cover at the time of our original survey and were not verified as part of this survey. Purpose of this updated survey was to locate the existing driveway and stake the proposed garage as depicted hereon per owners' request. All other property details are based on previous survey work performed by this office dated February 28, 2019 and were not re-verified as part of this updated survey.

This office could not positively identify the shoreline due to heavy snow and ice cover at the time of our original survey. This office located the piers where the edges were exposed and extended those lines to the shoreline.

Wood stair location may be somewhat approximate due to snow and ice cover at the time of our original survey.

Numerous retaining walls cut across the property between the shoreline and existing dwelling. Most of said walls were snow and ice covered at the time of our original survey and could not be accurately located. This office does not believe any of the said walls extend onto the adjoining properties.
