# Plat of Survey

## Lot 11 in Block 39 of Davis Addition to the Village of Elkhorn,

a subdivision located in the Northeast 1/4 of Section 36, Town 3 North,  
Range 16 East, City of Elkhorn, Walworth County, Wisconsin.

Surveyed for: **Norman Papcke**  
W7691 Wisconsin Parkway  
Delavan, Wisconsin. 53115

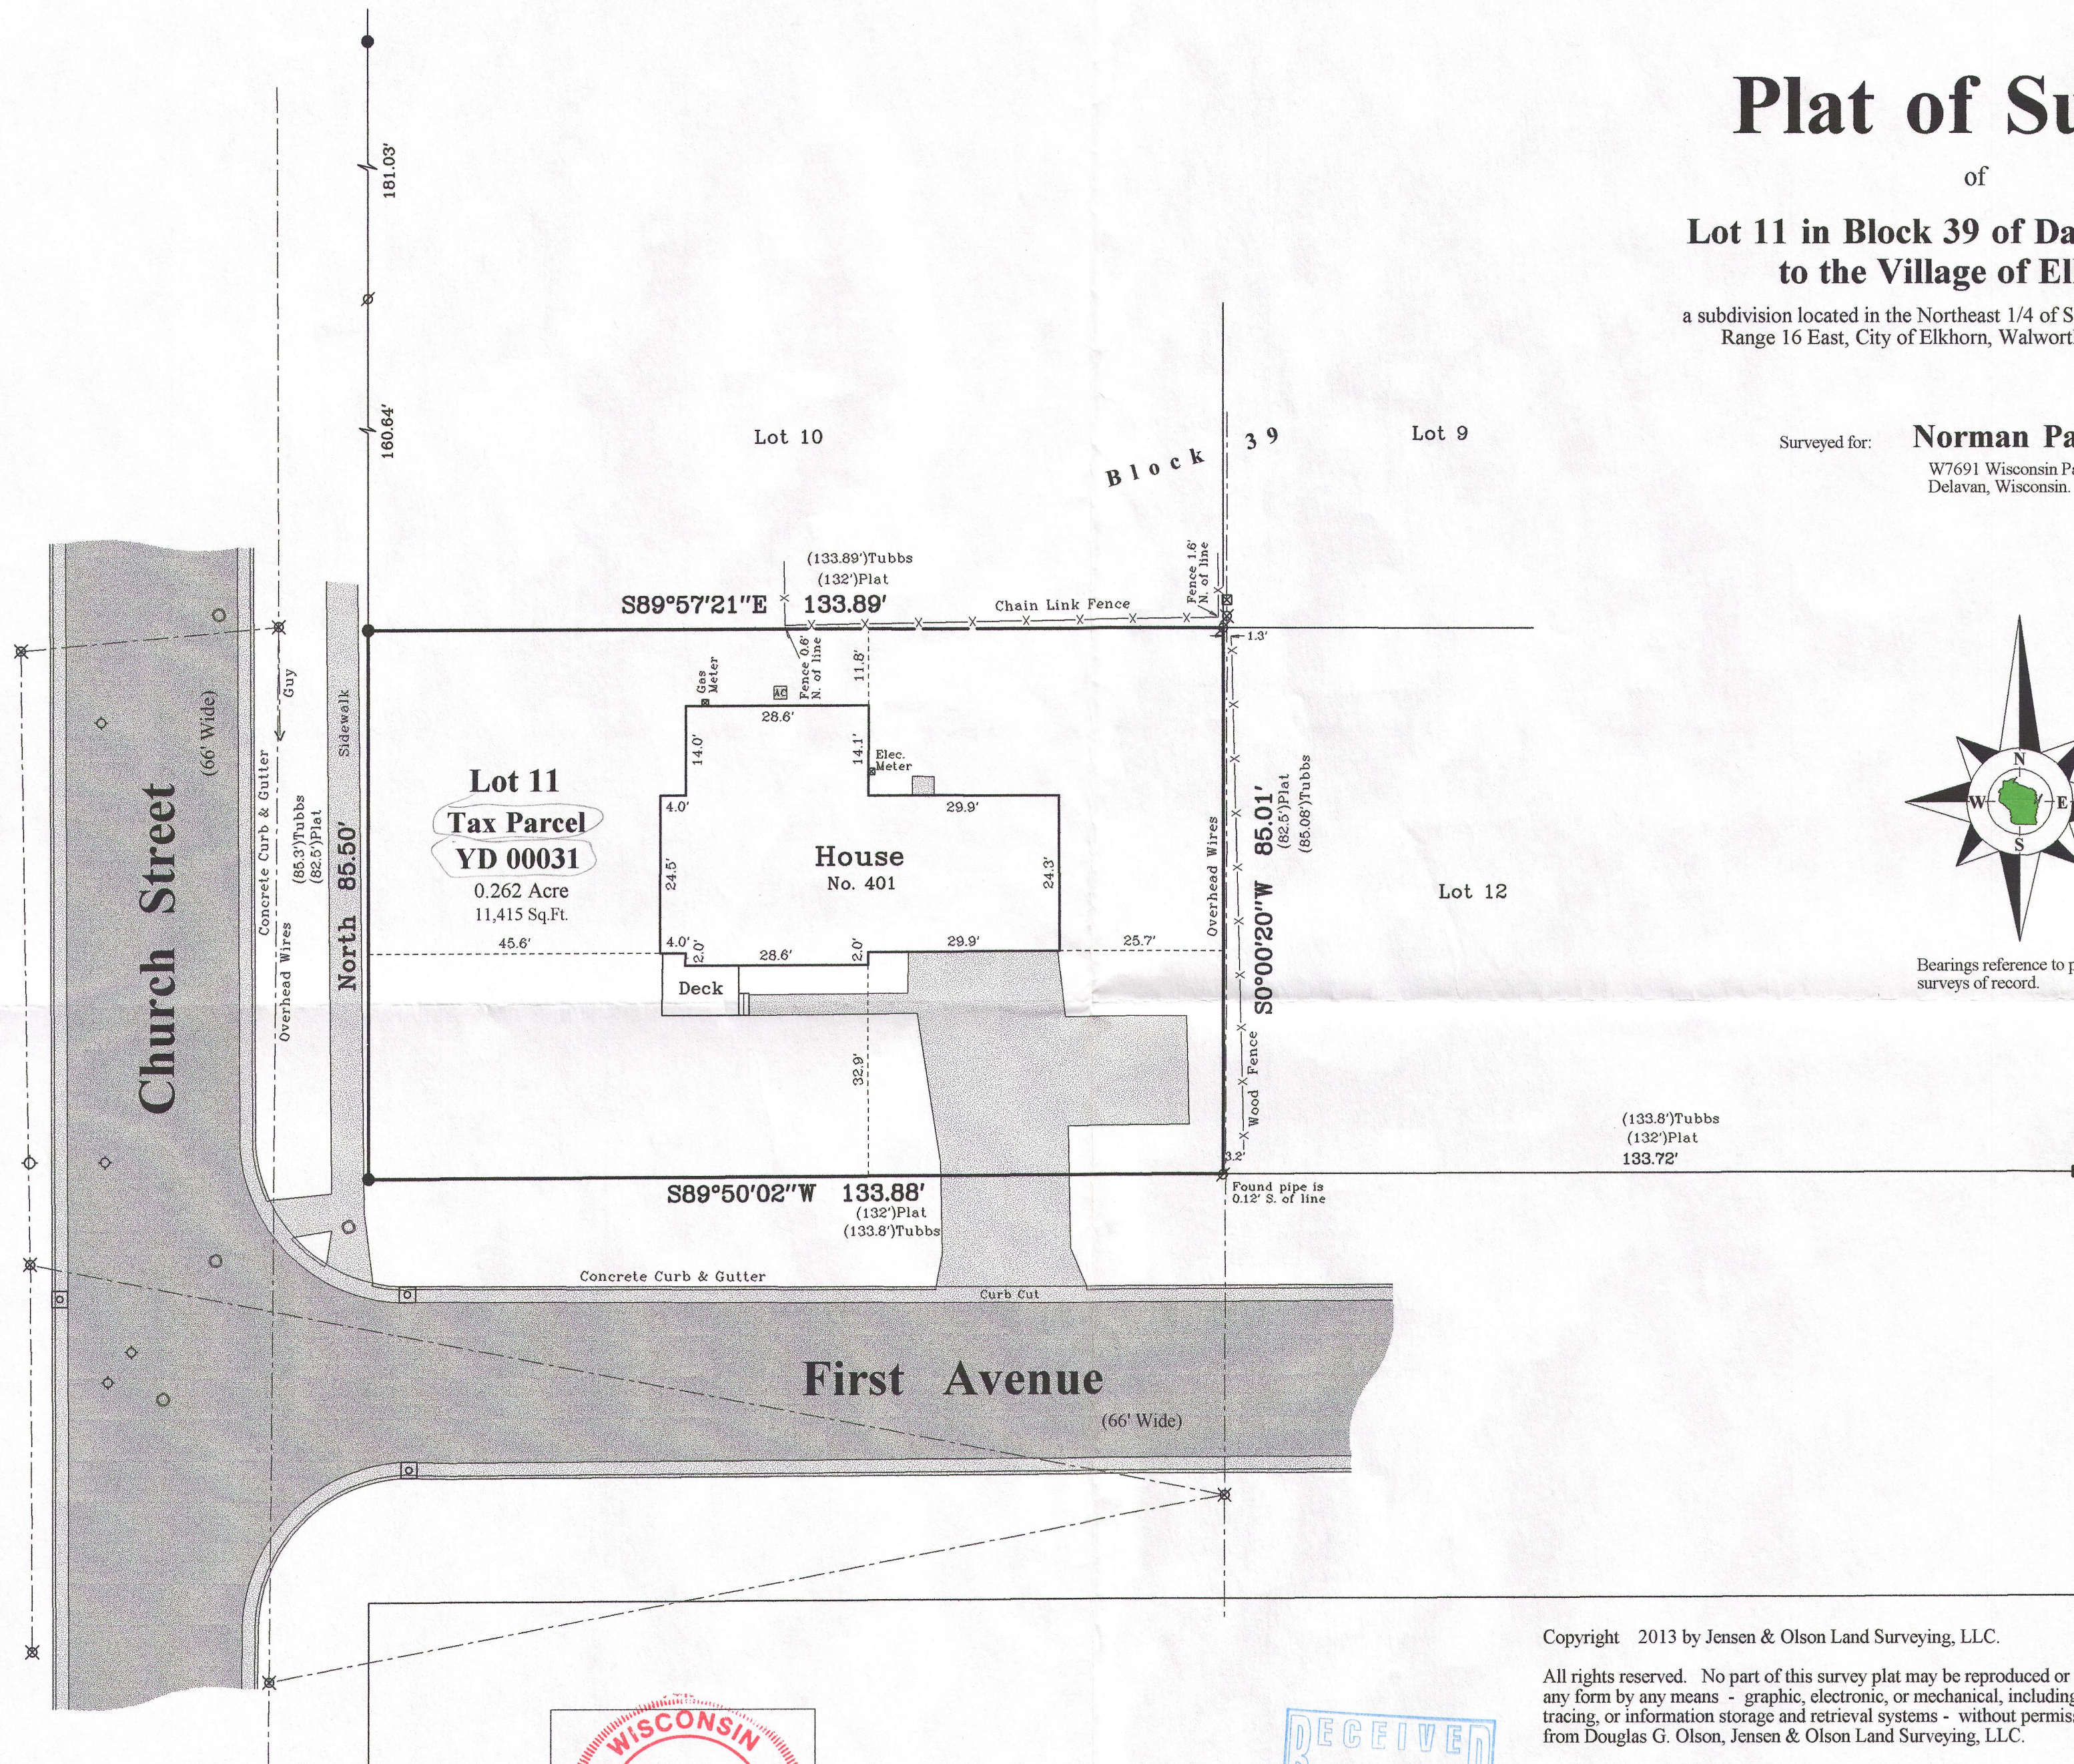
Bearings reference to previous  
surveys of record.

(88')Plat - Indicates dimension as shown on the Original Plat of the City of Elkhorn.  
(88.7')Tubbs - Indicates dimension as shown on Mr. Tubbs' survey of the  
City of Elkhorn.

I hereby certify that I have surveyed the above described property and the map hereon is correct to the best of my professional knowledge and belief and shows the size and location of the property, its exterior boundaries, the location and dimensions of all visible structures thereon, boundary fences, apparent easements and roadways and visible encroachments, if any.
