# Plat of Survey

## Unit 25 in Abbey Springs Condominium No. 1,

located in the Southwest 1/4 and the Southeast 1/4 of the Southeast 1/4 of Section 13, Town 1 North, Range 16 East, Village of Fontana-on-Geneva Lake, Walworth County, Wisconsin.

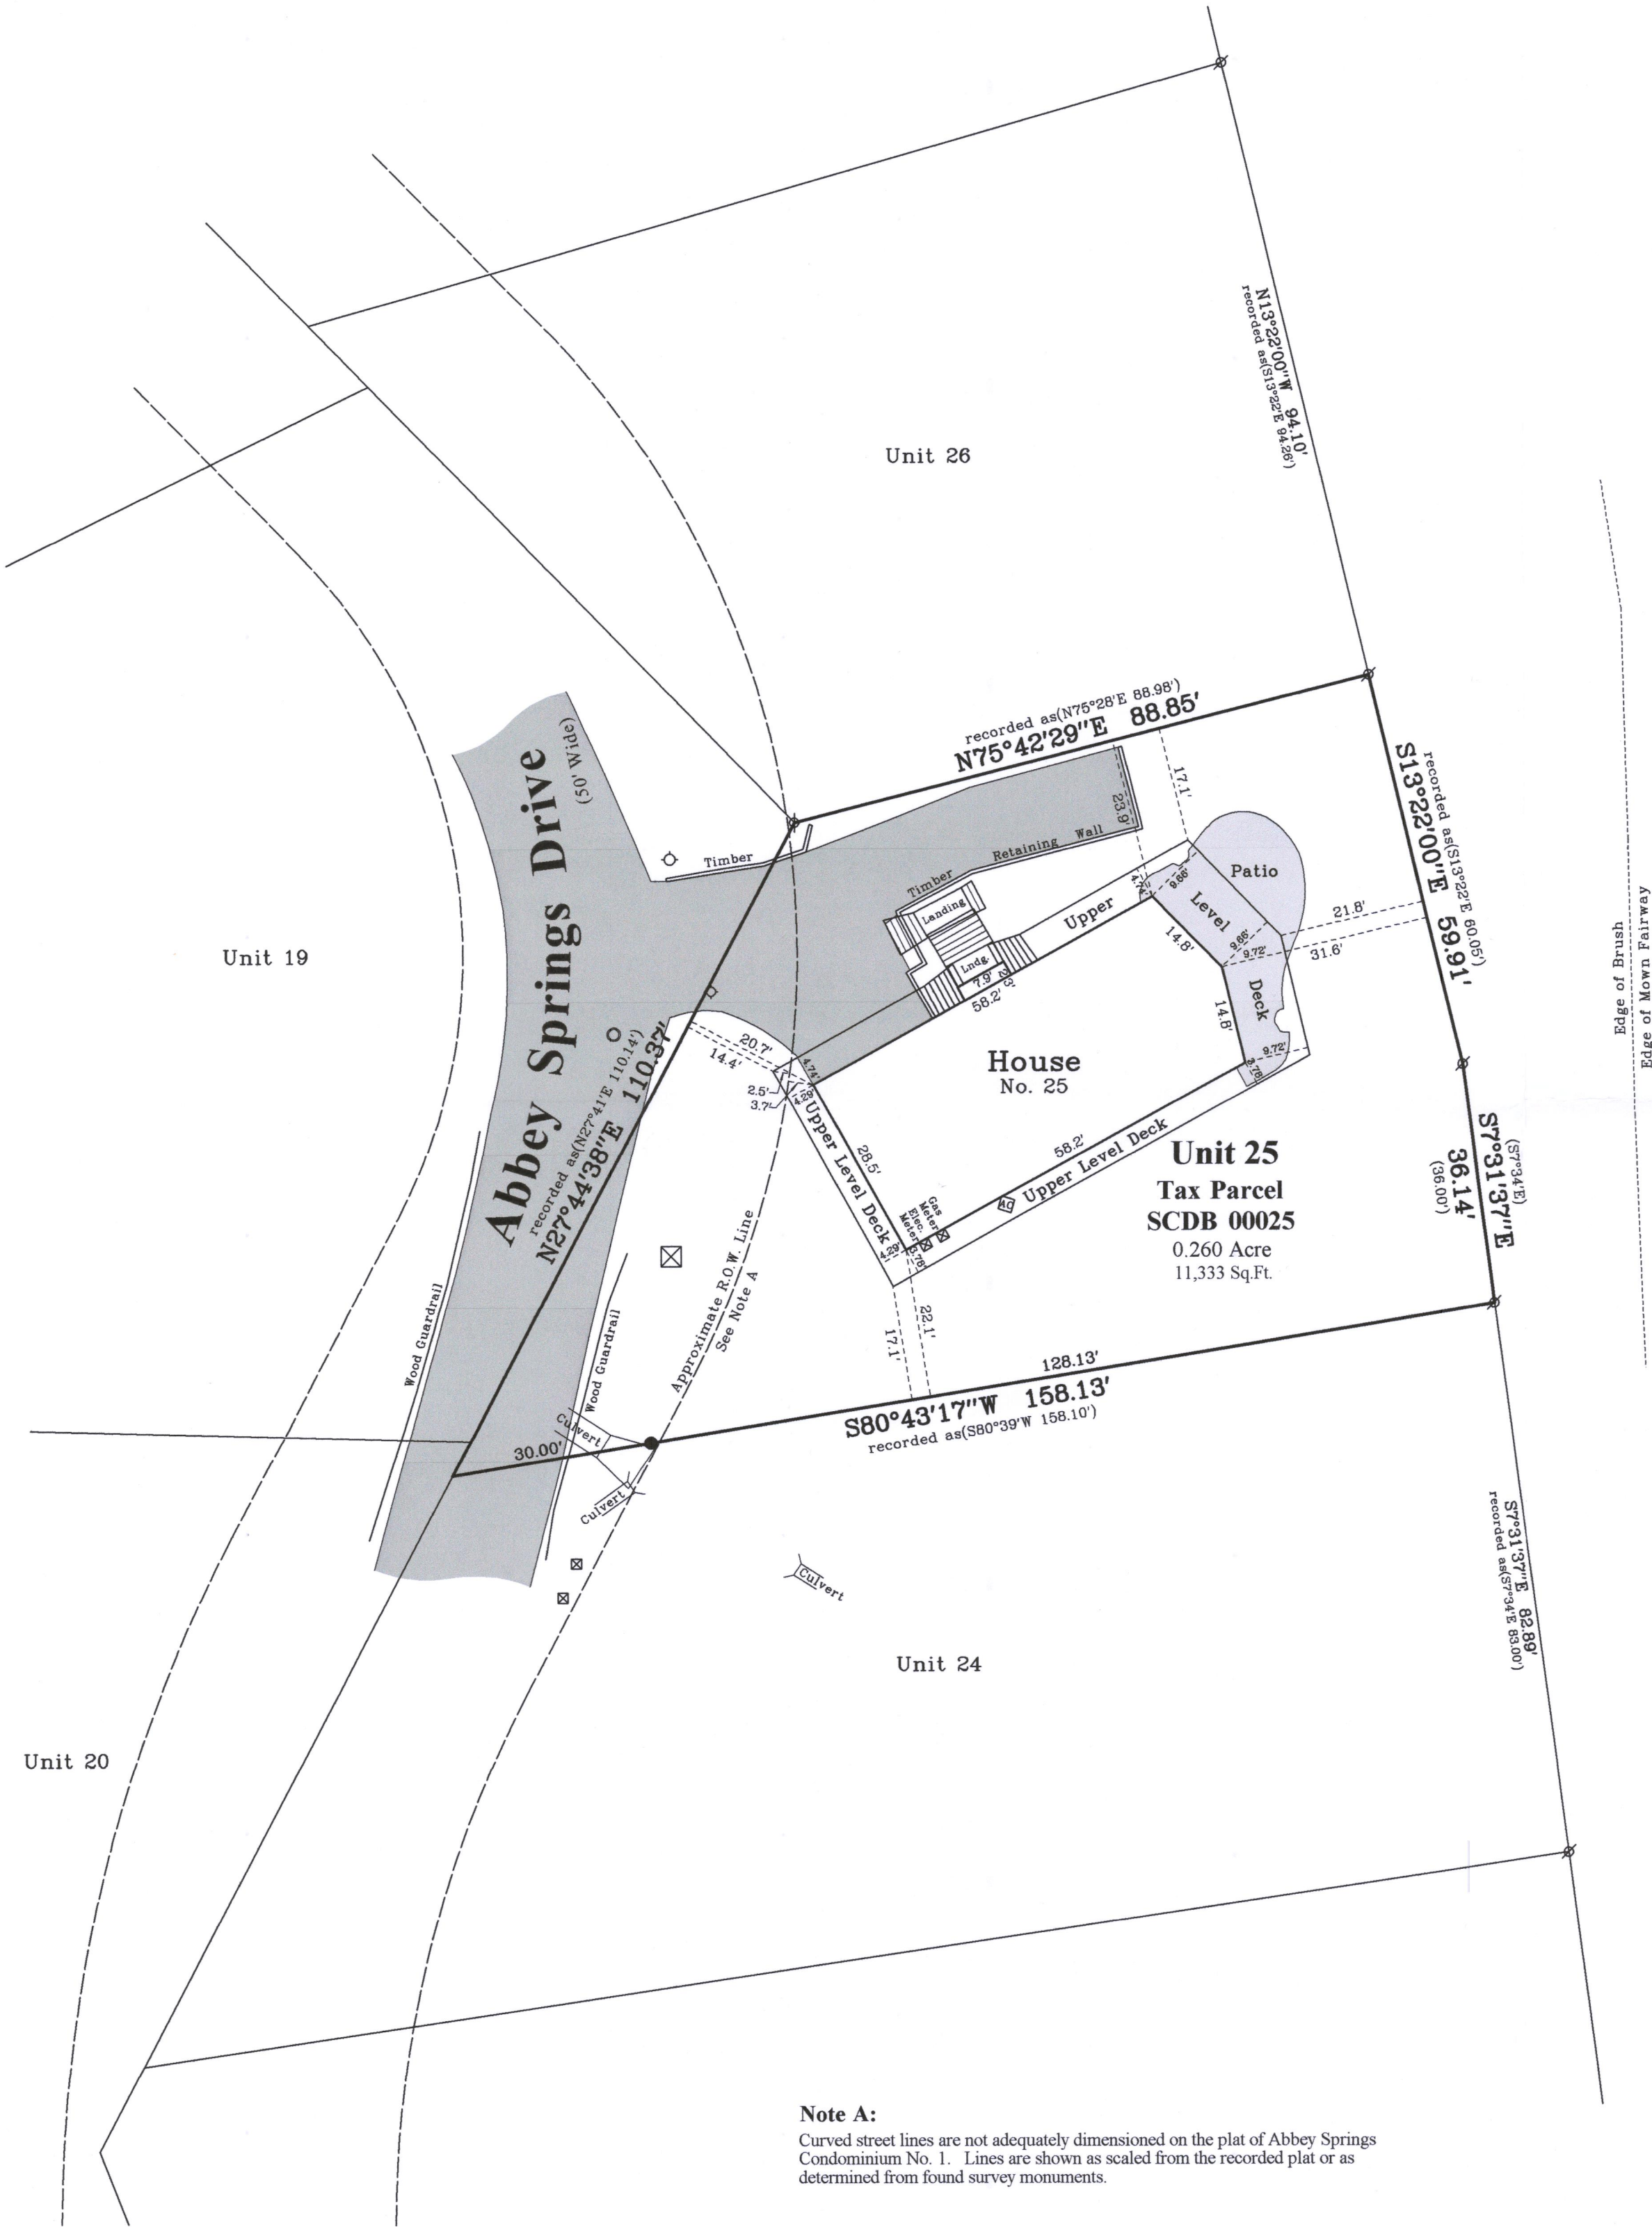
Bearings referenced to the East line of Units 25 and 26, recorded as S13°22'E on the plat of Abbey Springs Condominium No. 1.
