Topographic Map

Part of Lot 1 of Certified Survey Map No. 3321,

recorded in Vol. 19 of Certified Survey Maps of Walworth County on Page 20 and located in the Southwest 1/4 of Section 11, Town 1 North, Range 17 East, Town of Linn, Walworth County, Wisconsin.

Sheet 1 of 2 Sheets.
Job Reference Number
2006.120

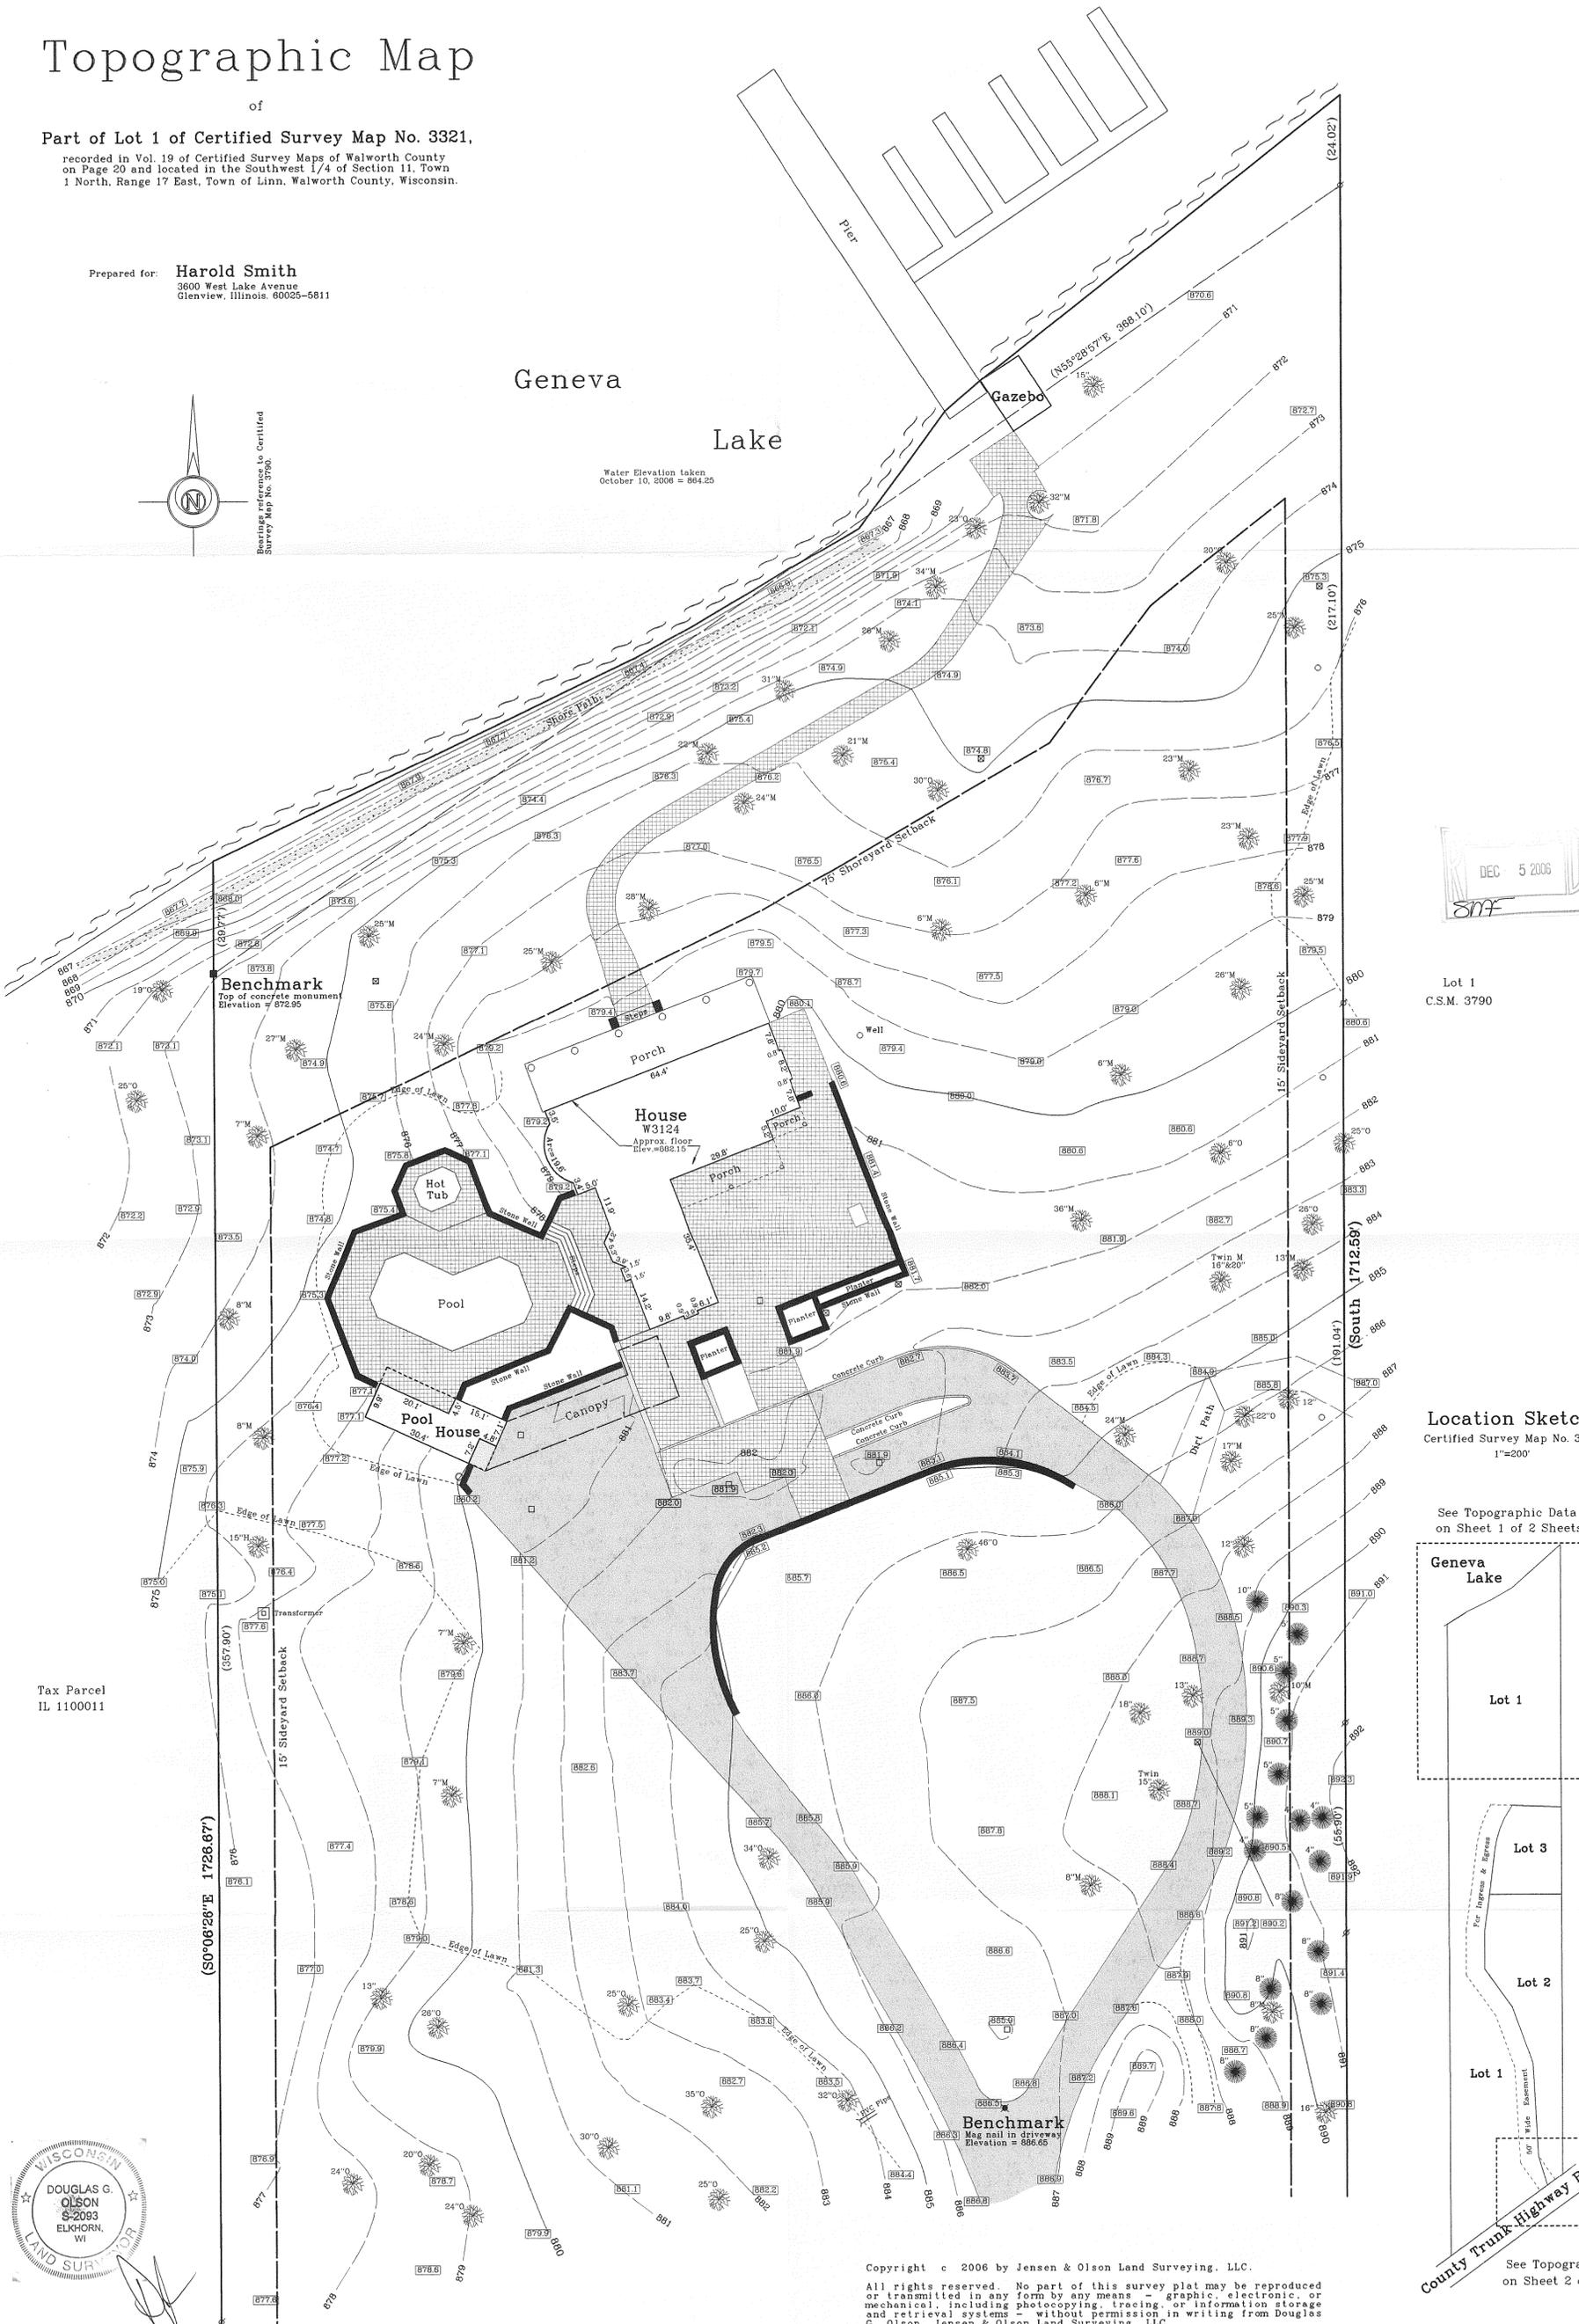
Geneva Lake

Water Elevation Taken
October 10, 2006 = 884.25

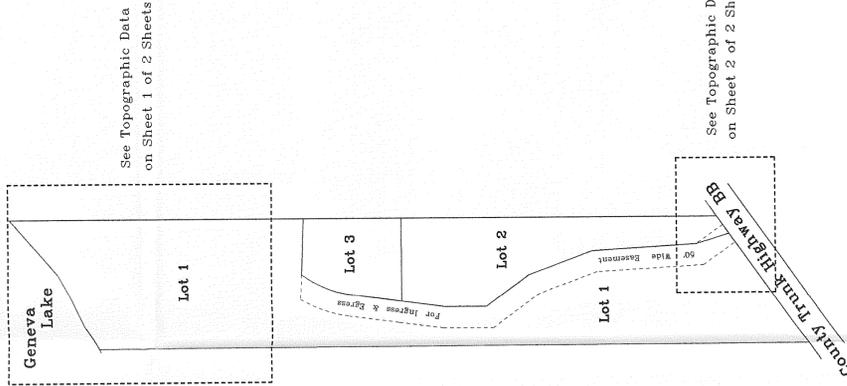
Location Sketch
 Certified Survey Map No. 3321

1" = 200'
