# Plat of Survey

## Lots 1 & 2 in Block 8 of Genevista,

a subdivision located in the Southwest 1/4 of the Southwest 1/4 of Section 10, Town 1 North, Range 17 East, Town of Linn, Walworth County, Wisconsin.

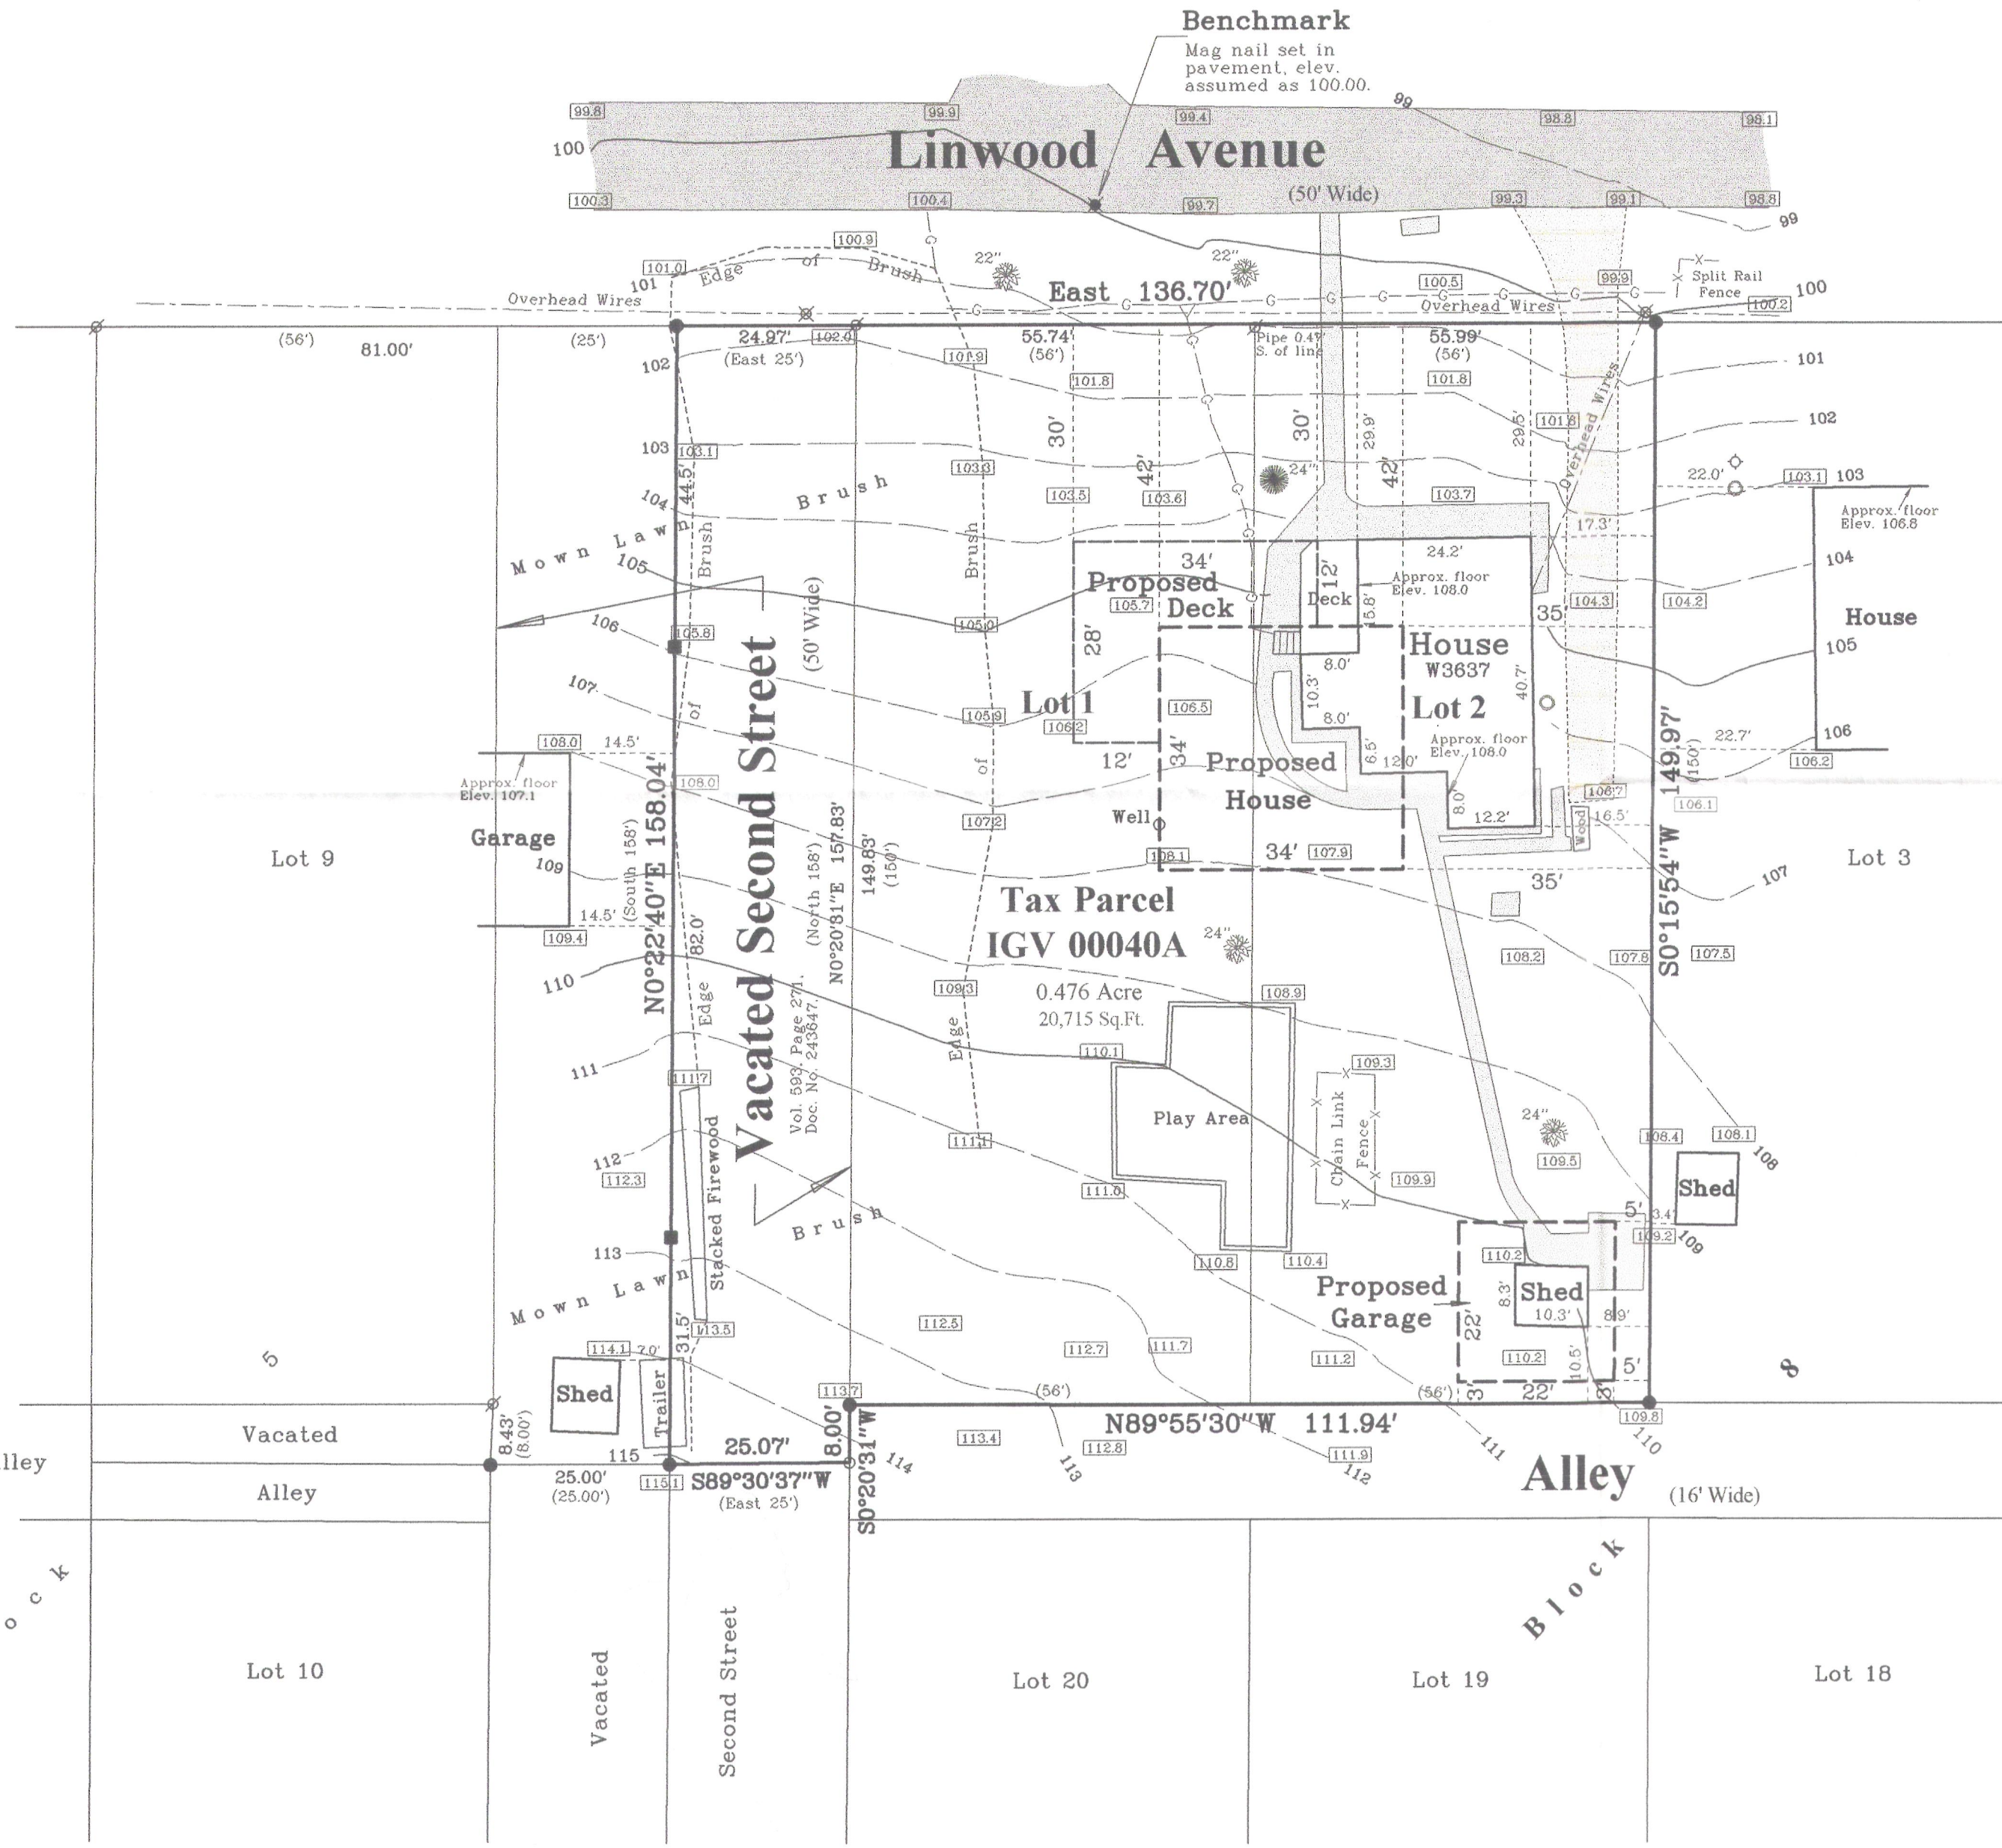
Beginning at the Northwest corner of Lot 1, Block 8, Genevista Subdivision; thence East 25 feet to the centerline of the vacated roadway; thence South 158 feet along the centerline of said roadway; thence East 25 feet; thence North 158 feet along the West line of said lot to the point of beginning.
