# Plat of Survey

## Lot 17 of Camp Sybil,

a subdivision located in the Northeast 1/4 of Section 18, Town 1 North, Range 17 East, Town of Linn, Walworth County, Wisconsin.

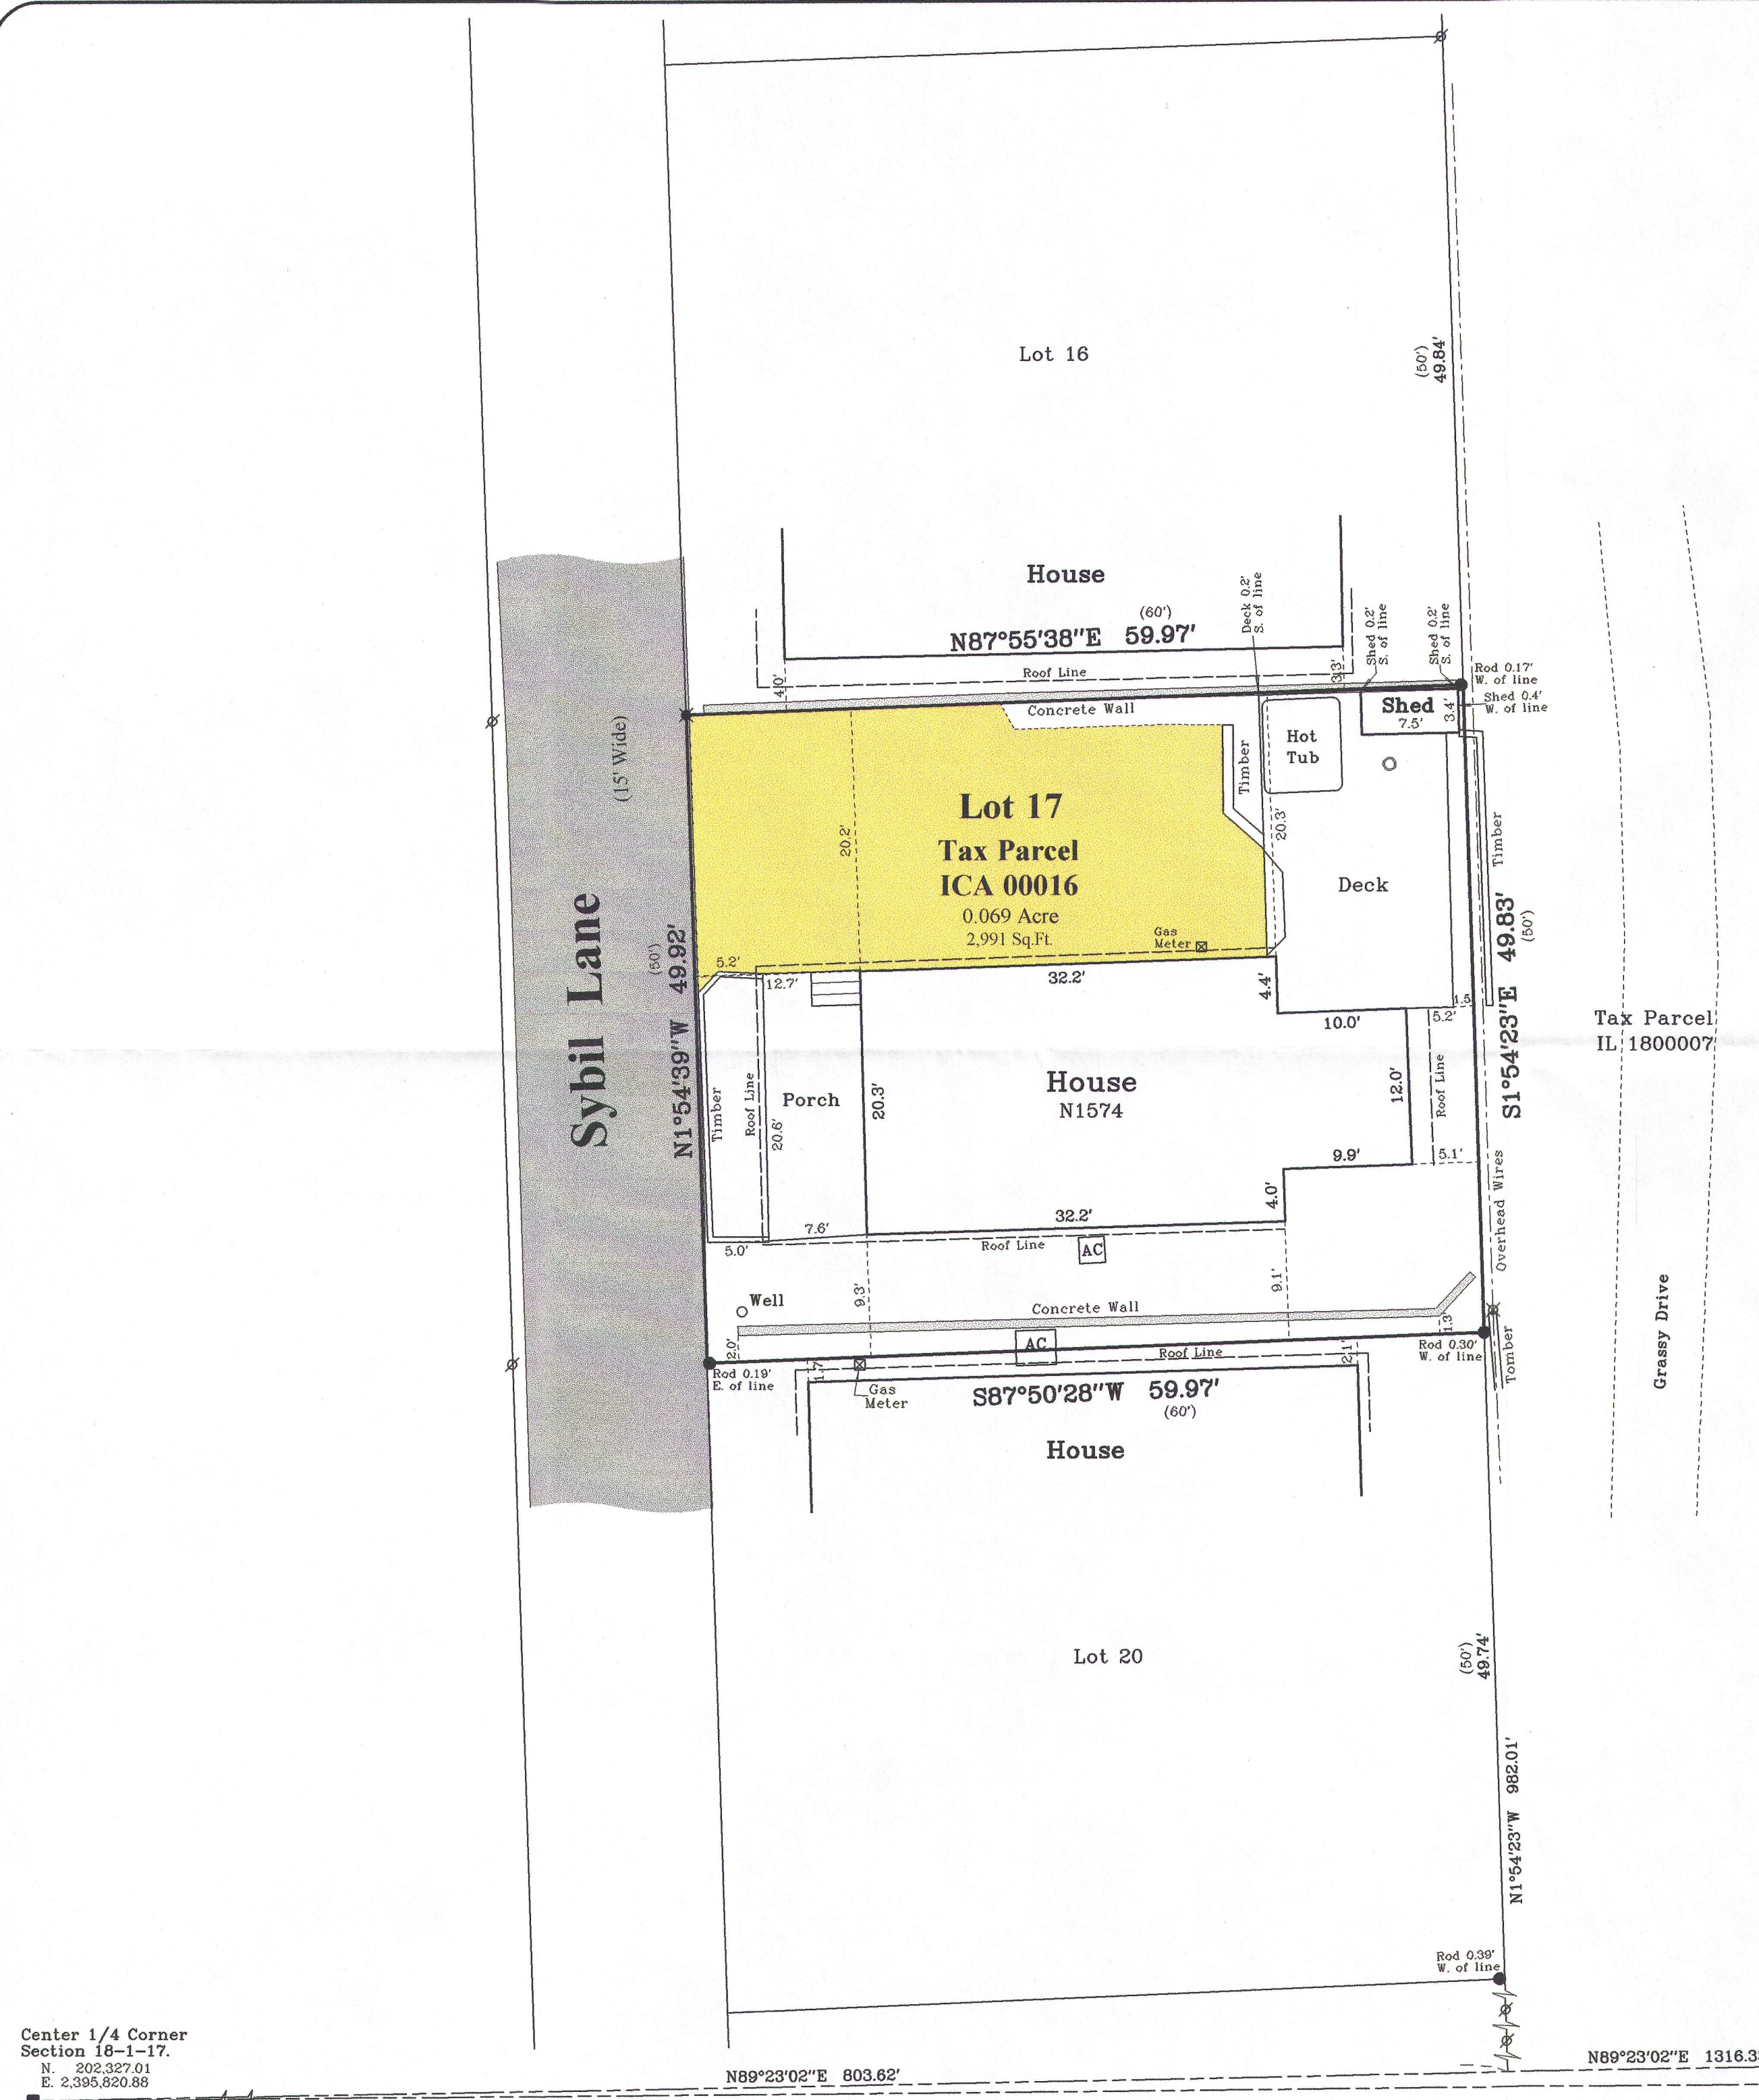
South 1/8 Corner of the Northeast 1/4 of Section 18-1-17.

East 1/4 Corner Section 18-1-17.  
N. 202,349.48  
E. 2,398,457.54

Center 1/4 Corner Section 18-1-17.  
N. 202,327.01  
E. 2,395,820.88

N89°23'02"E 803.62'

N89°30'42"E 2636.77'  
(N89°30'42"E 2636.77')State Plane
