PLAT OF SURVEY OF

Lots 14 & 15 of the Plat of Point Comfort, part of the PARKS of the Plat of Point Comfort, located in the Southeast 1/4 of Section 22, T 2 N, R 16 E, and part of the Northeast 1/4 of Section 27, T 2 N, R 16 E, Walworth County, Wisconsin.

FPC-11

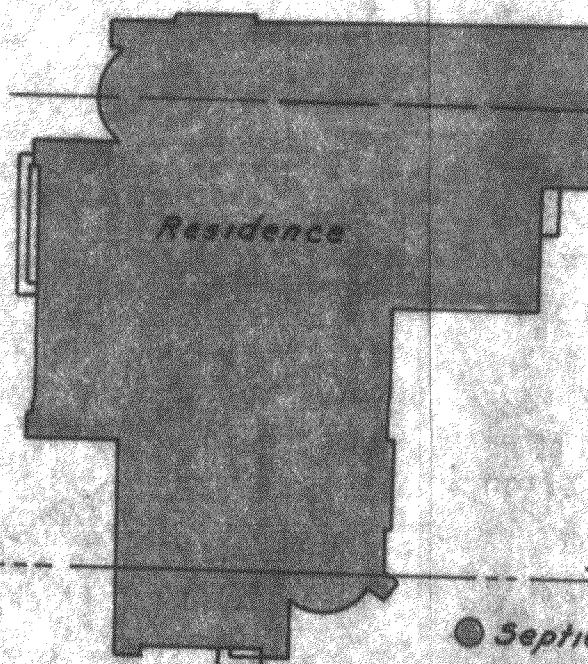
128' Conc. Sea Wall

Boat House

Residence

Septic Tank

Edges of Garage  
Encroach 0.5'

Garage

Covered Pit
