# Plat of Survey

## Lot 8 in Block 6 of Delmar,

a subdivision located in the Southwest 1/4 of Section 27, Town 2 North,  
Range 16 East, Town of Delavan, Walworth County, Wisconsin.

Surveyed for: **Chris Moore**  
4115 Ash Avenue  
Delavan, Wisconsin. 53115

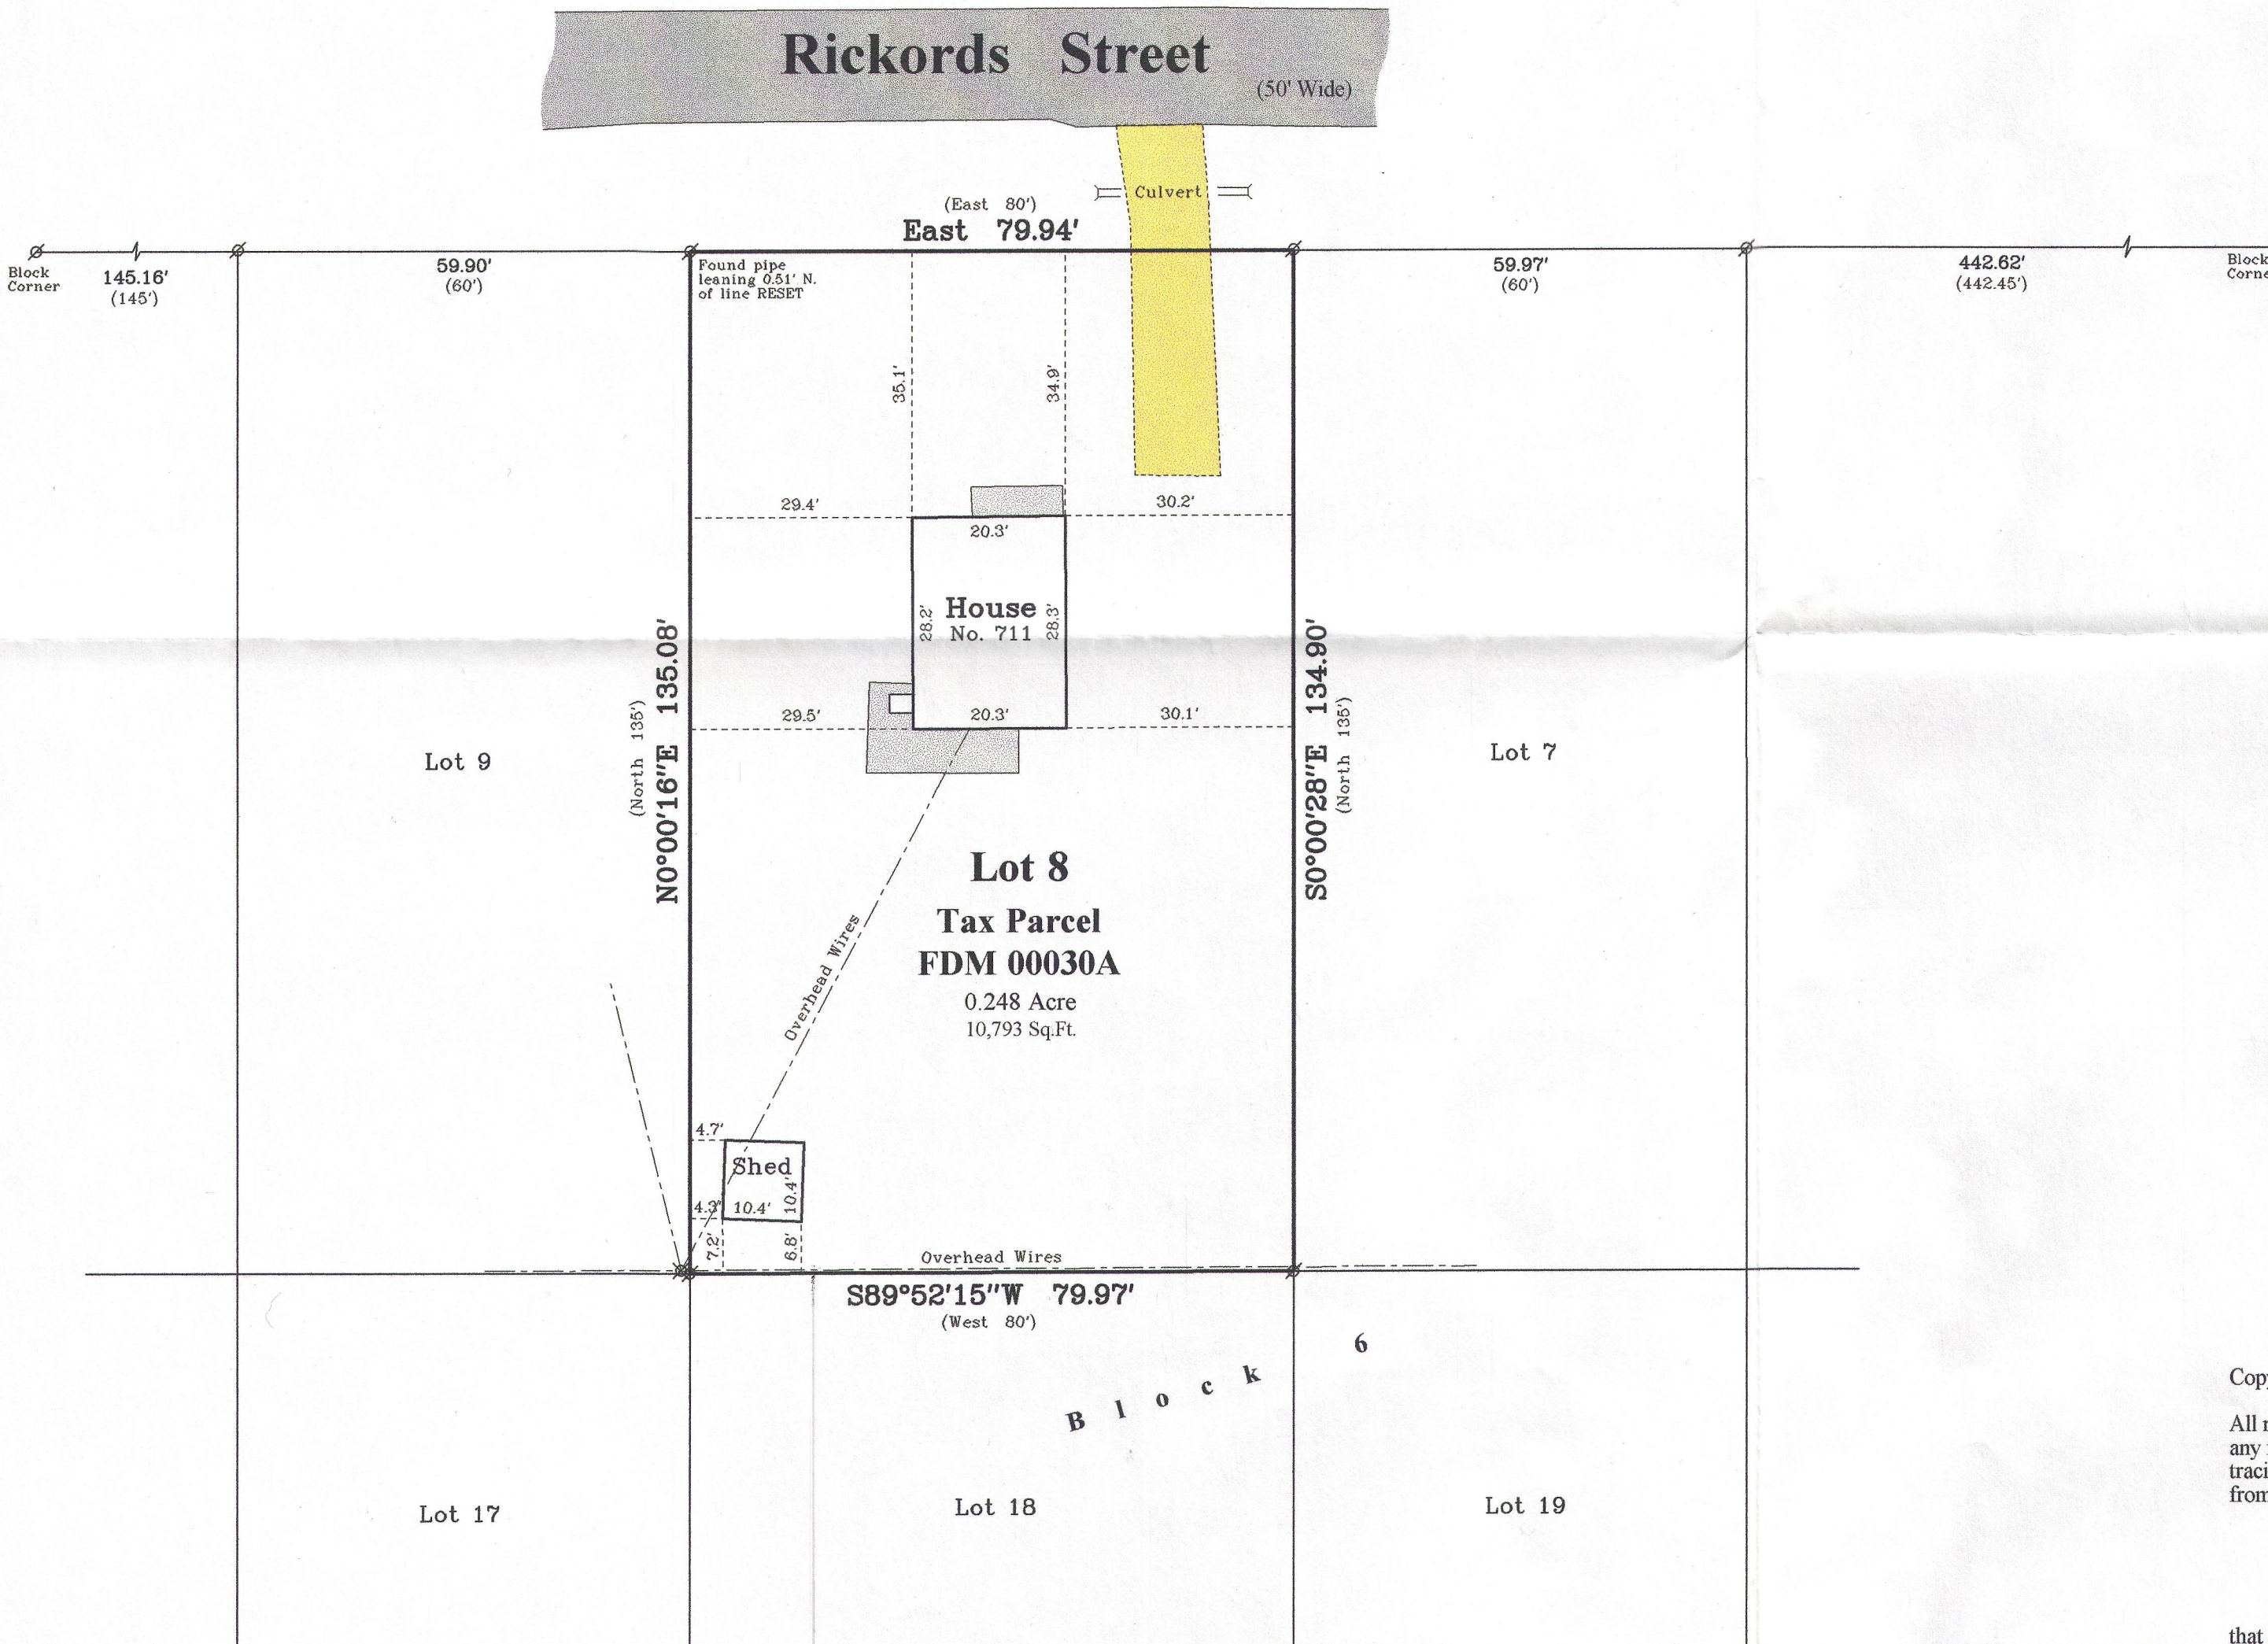
Bearings reference to the South line of Rickords Street recorded as East on the plat of Delmar.
