# Plat of Survey

## Part of Lots 9, 10, 11 and 12 of Cedar Point Subdivision,

located in Government Lot 1 in the Northeast 1/4 of Section 28, Town 2 North, Range 16 East, Town of Delavan, Walworth County, Wisconsin.

**Delavan Lake Yacht Club**  
 1501 Cedar Point Drive \* P.O. Box 482  
 Delavan, Wisconsin 53115

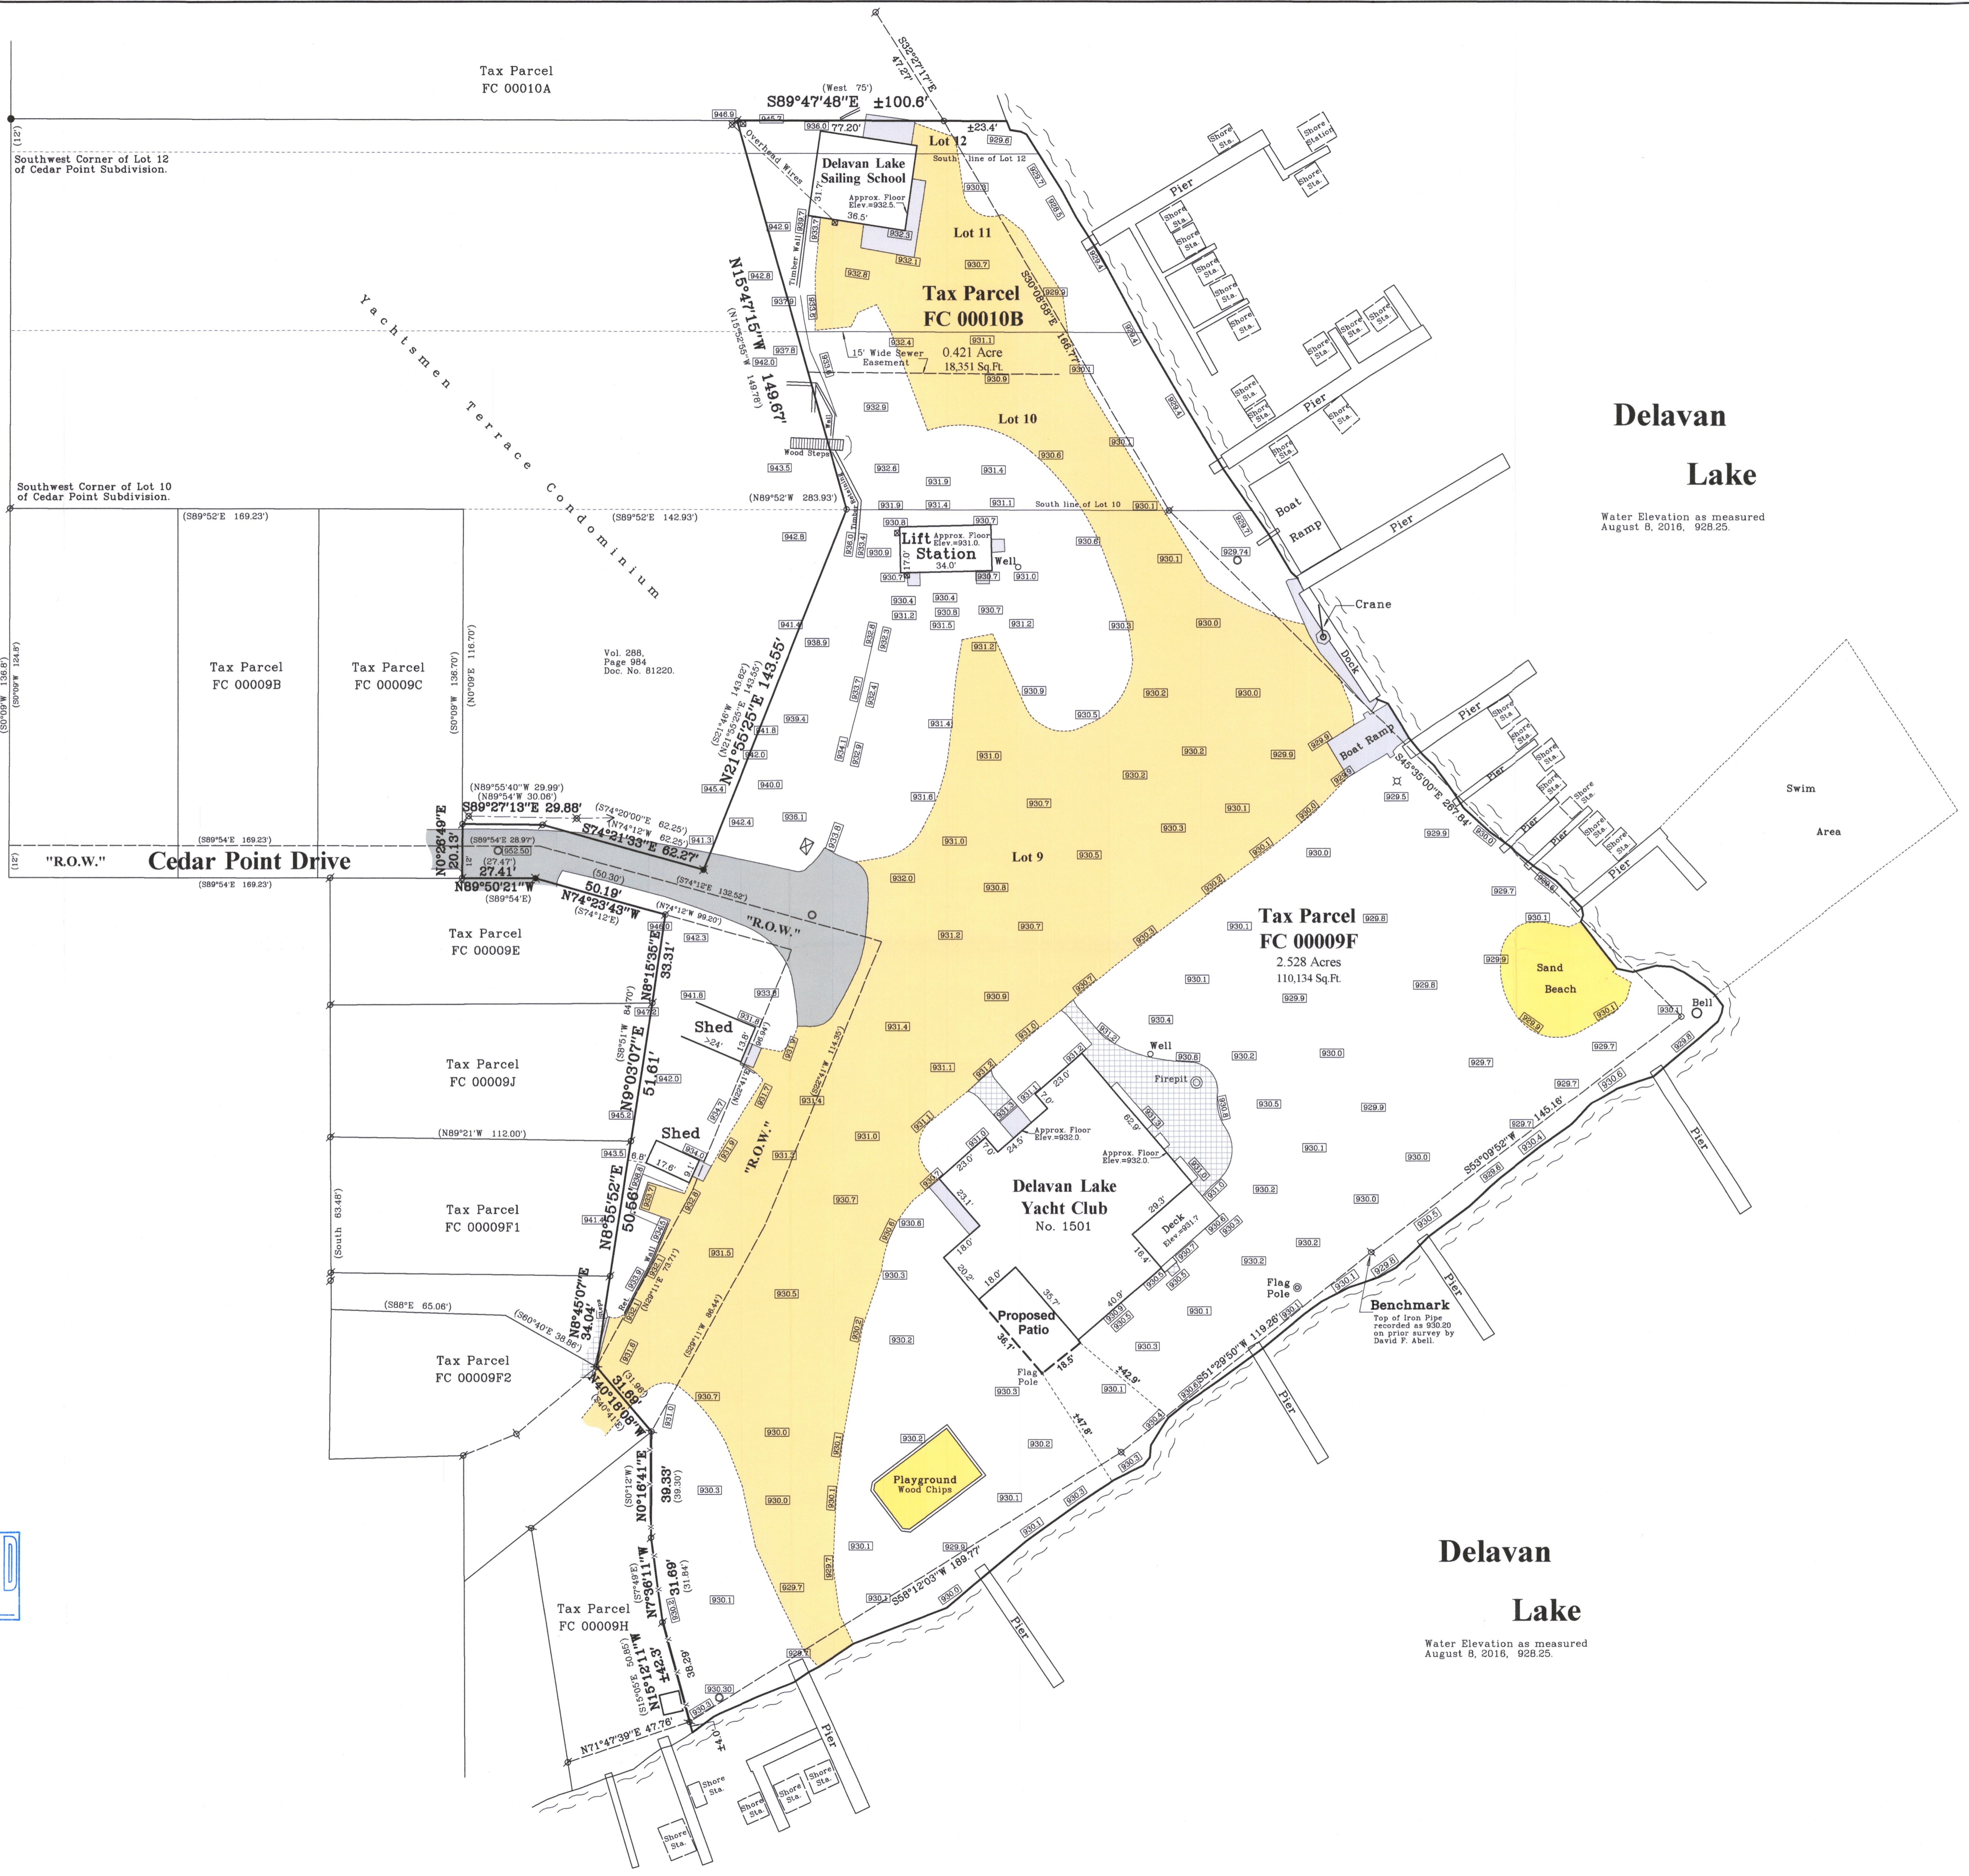
Bearings reference to prior surveys of record.

**Delavan Lake**  
 Water Elevation as measured August 8, 2016, 928.25.
