# Plat of Survey

Lot 16 of Lake Forest Estates, a subdivision located in Section 26, Town 2 North,  
Range 17 East, Town of Geneva, Walworth County, Wisconsin.

Surveyed for:

**Arbor Venture**

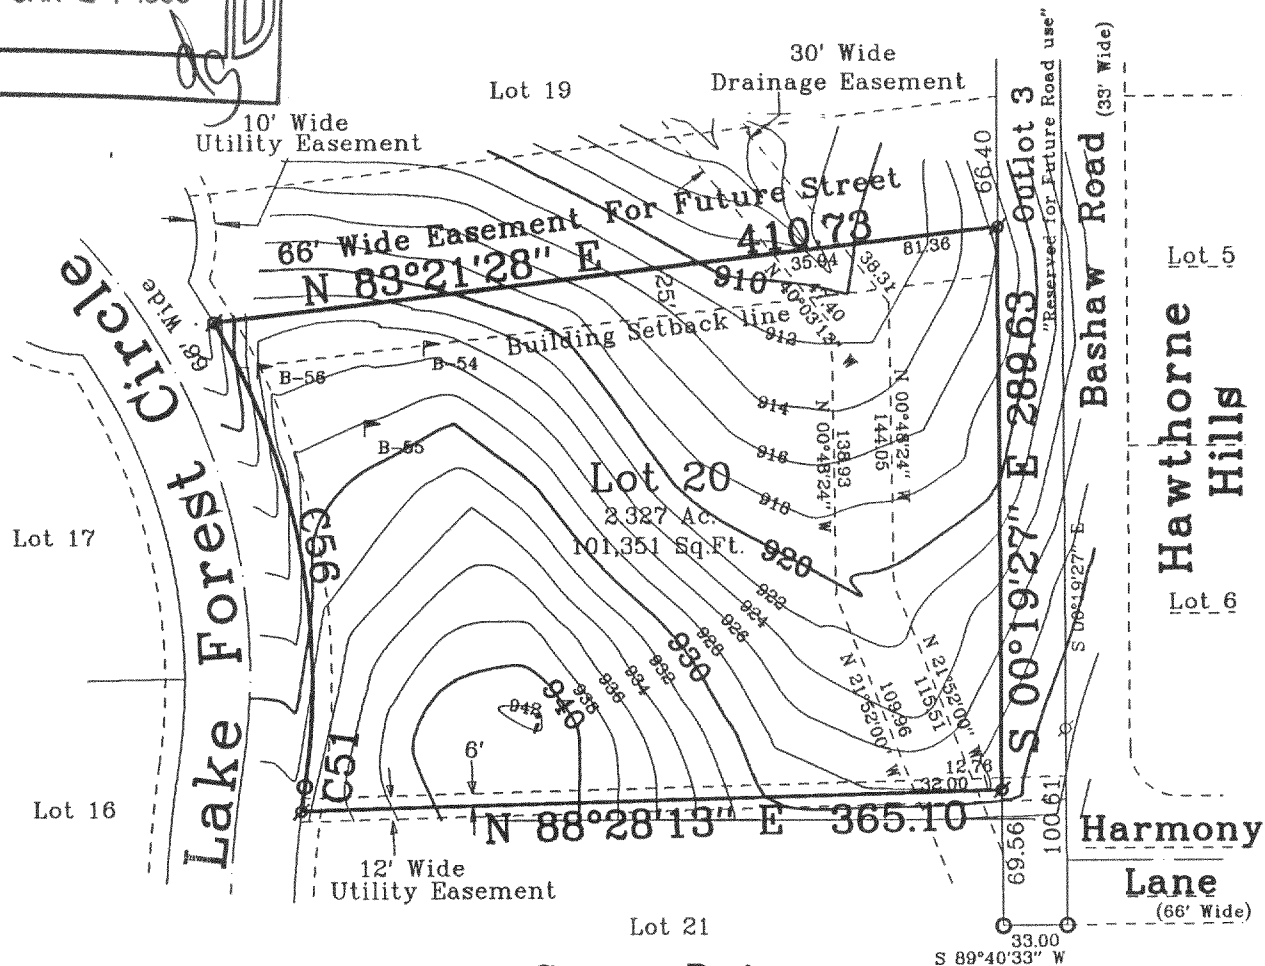
1. Bearings referenced to the Subdivision Plat.
2. Soil borings shown were made by Private Sewage Consultants, Lake Geneva, and were adequate for a mound system. The location of these borings is the area of the mound system approved by Walworth County.
3. Perc tests are no longer used in Walworth County. Evaluations are made by visual inspection.
