Plat of Survey

Lots 9 through 13 and 15 through 17 in Block 1 of Skansen Swedish Tribune News Subdivision,

located in the Northwest 1/4 and the Southwest 1/4 of Section 9, Town 3 North, Range 15 East, Town of Richmond, Walworth County, Wisconsin.

Surveyed for: **Emil Arens**
W8690 Lake Road
Delavan, Wisconsin. 53115

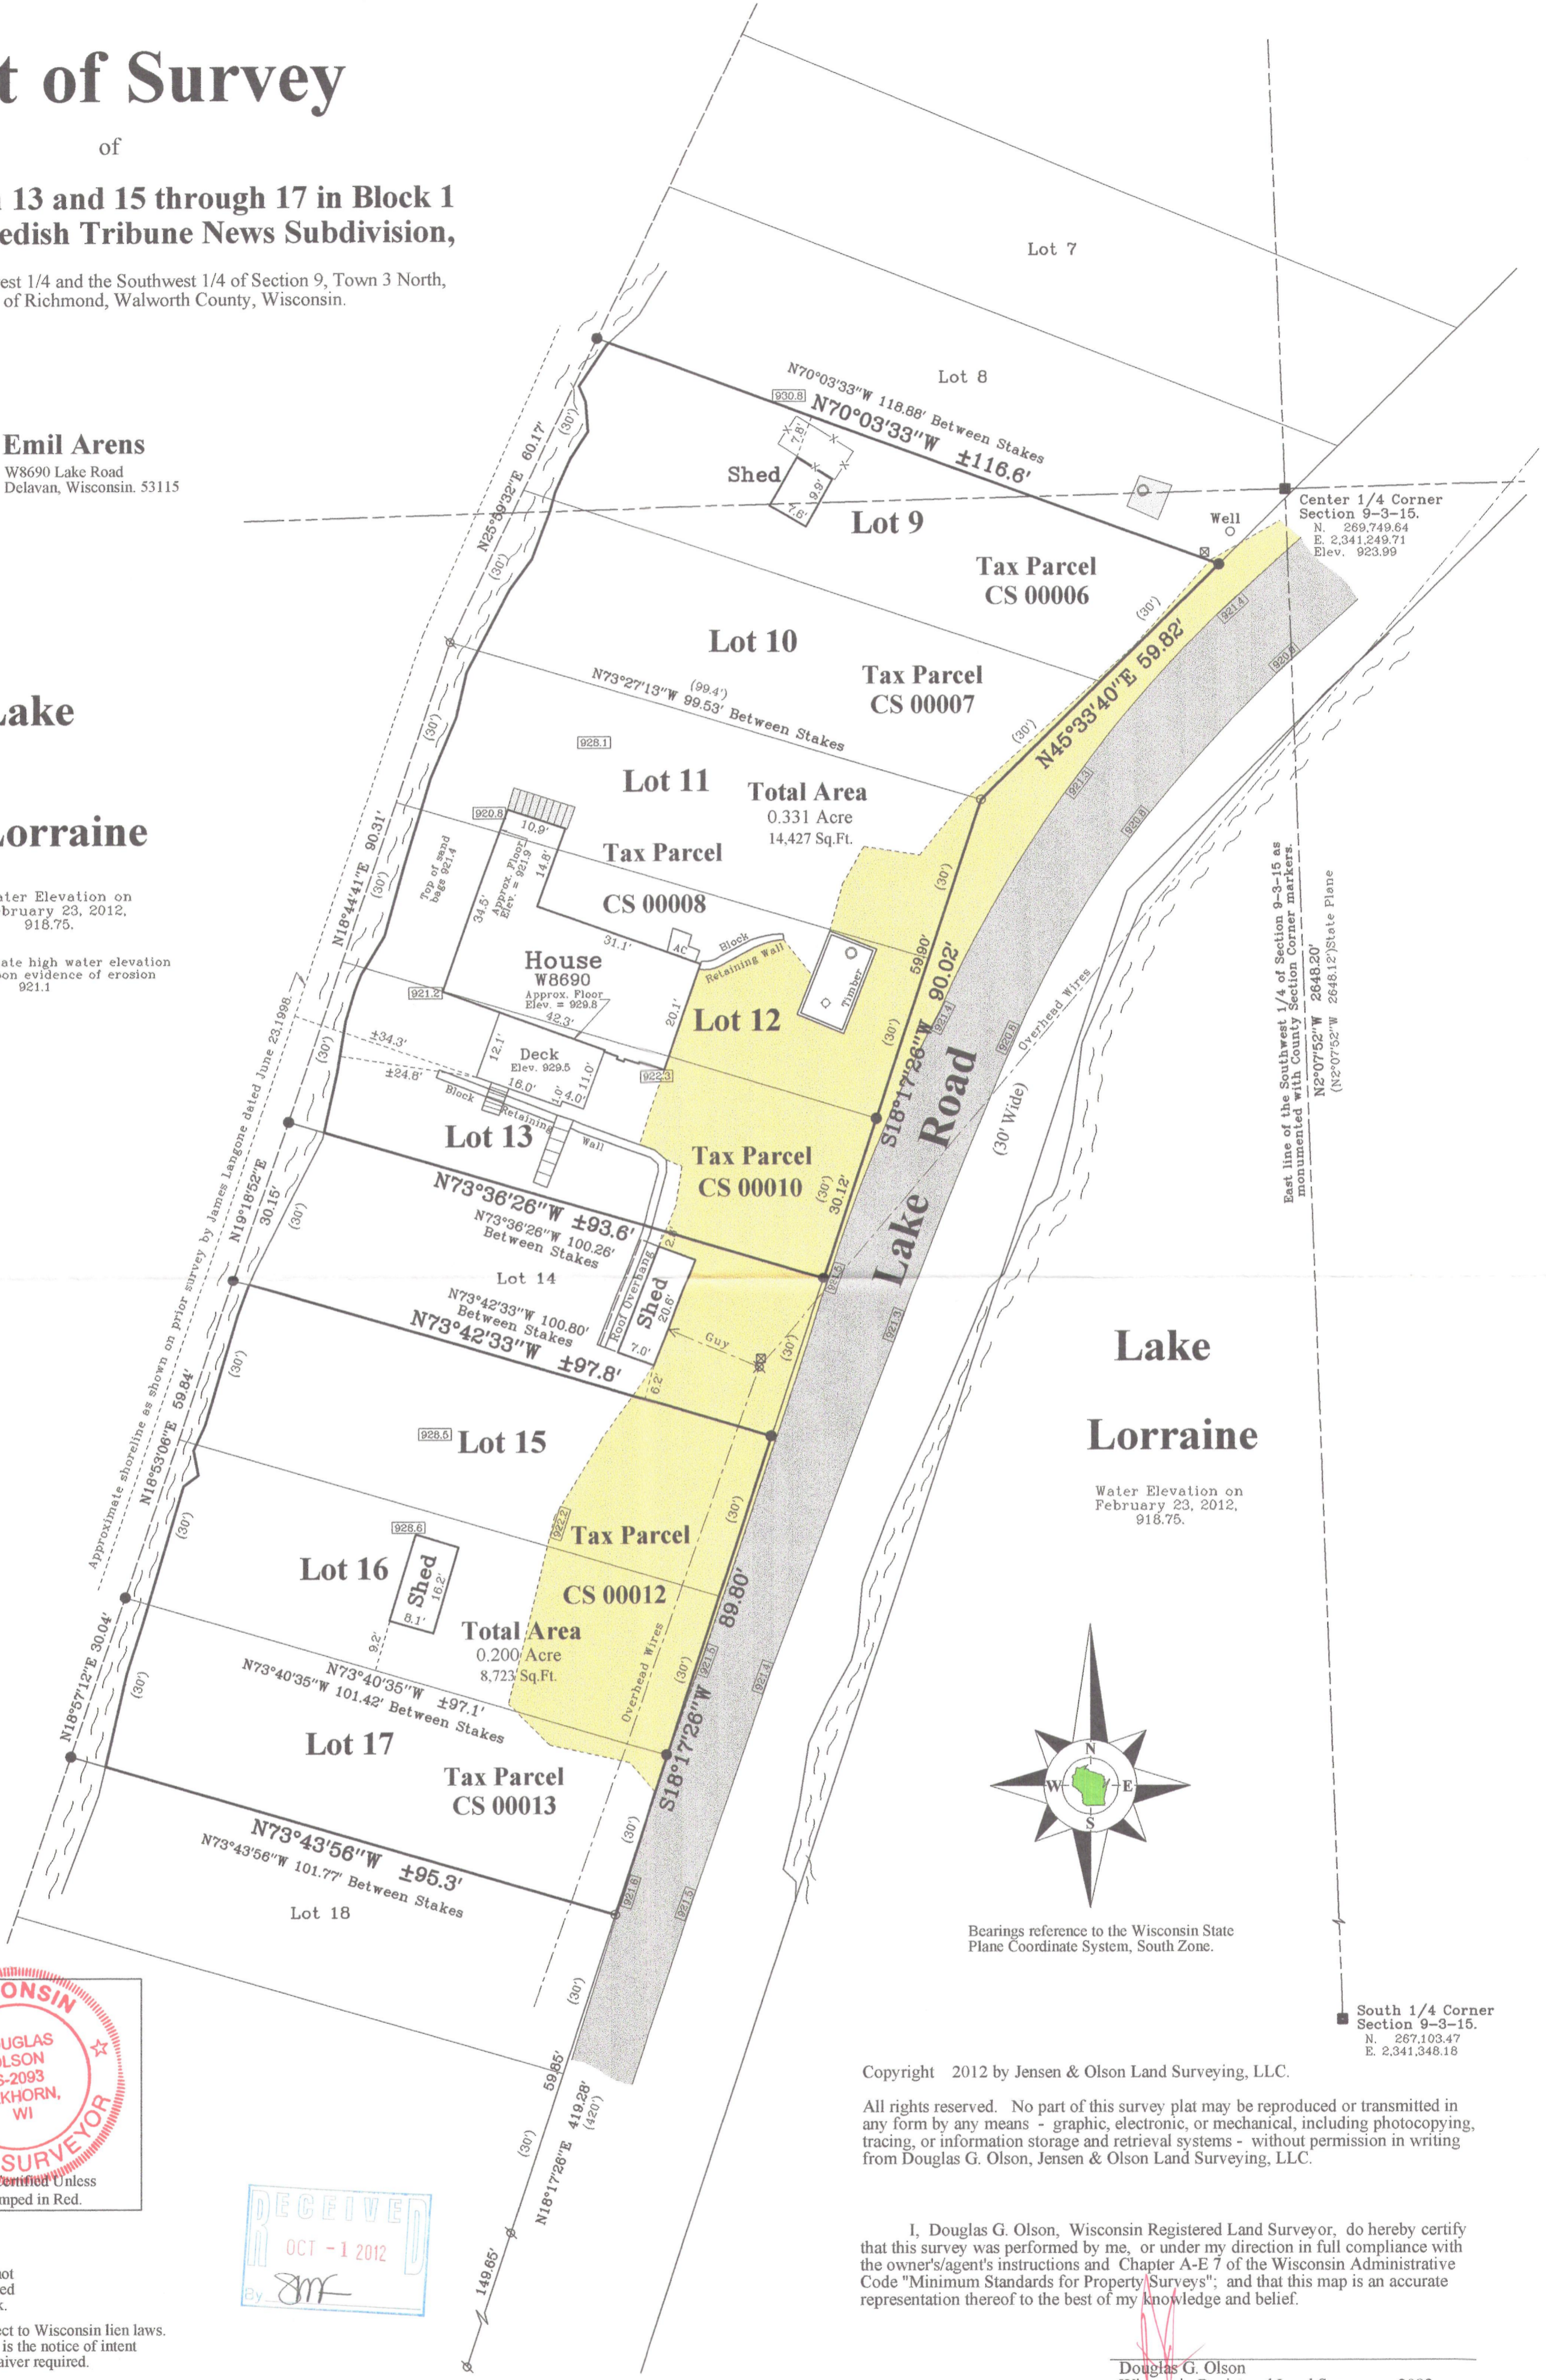
Water Elevation on February 23, 2012, 918.75.

Approximate high water elevation based upon evidence of erosion 921.1
