# Plat of Survey

## Lot 74 of Baywood Estates 3rd Addition,

recorded April 14, 1980 in Cab. B of Plats of Walworth County on Slide 47 as Document Number 57431 and located in the Northeast 1/4 of the Northwest 1/4 of Section 1, Town 3 North, Range 16 East, Town of Sugar Creek, Walworth County, Wisconsin.

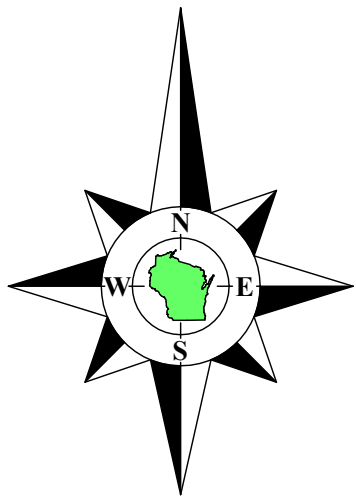
Bearings referenced to the South line of Lots 74 and 75,  
recorded as N87°46'05"W on the plat of Baywood Estates  
3rd Addition.
