Survey and Plat ordered by John Huling

PLAT OF SURVEY

Part of the South line of the John Huling property located in Lot 6 of Merril Park, Section 26, Town 4 North, Range 16 East, Walworth County, Wisconsin

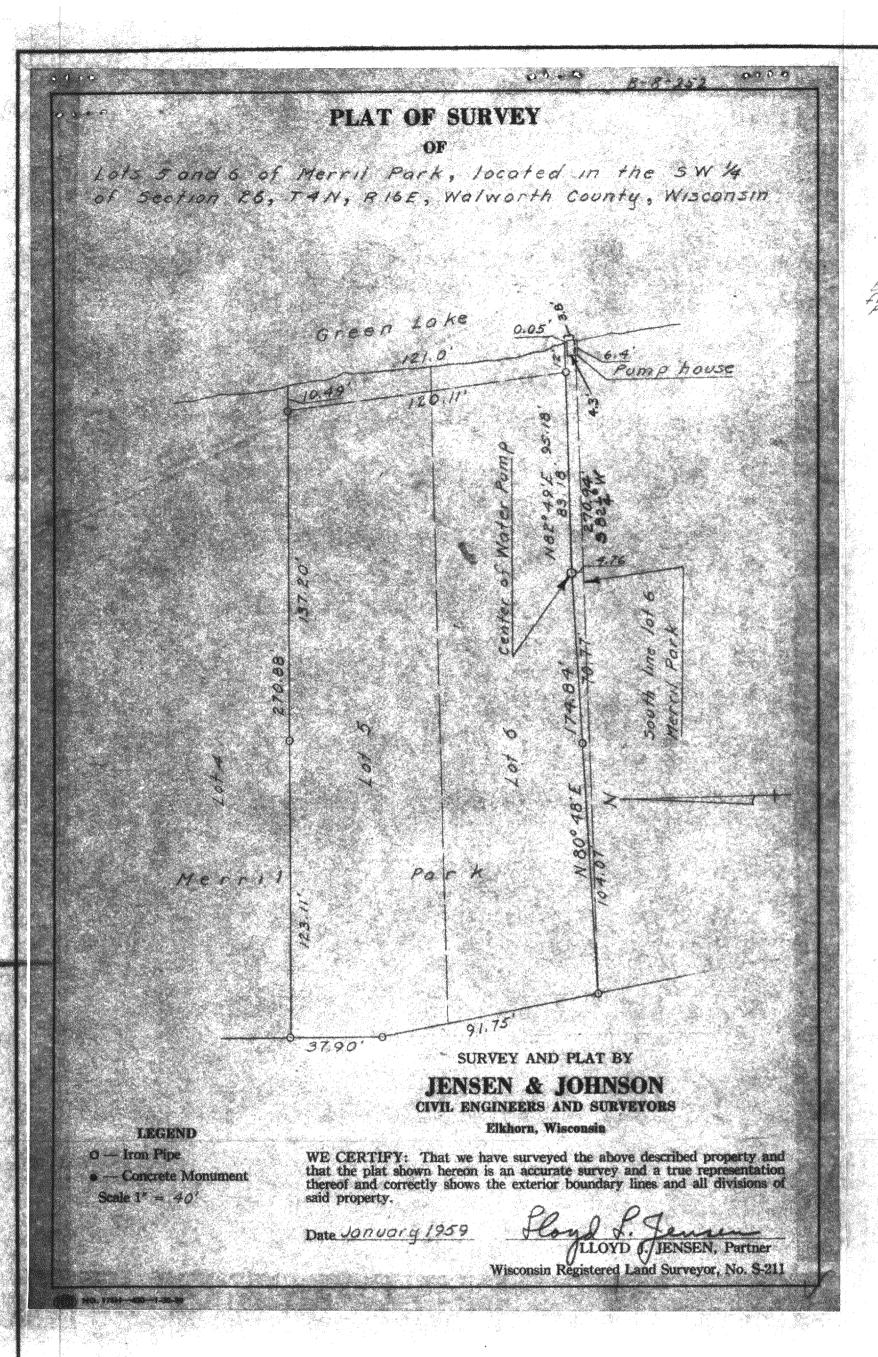
Roof Overhang of Pump House Encroaches on Huling Property 0.07. 1.65' from Property Line to Building Wall -0.5' Found 1" O.D. Iron Pipe 9.3' from Lake Shore From Joon Pipe Property Line Monument Z Setaining Wall Encroaches on Huling Property Note: All of the survey pipe and the water pump marking the south line of the Huling property as shown on the plat of survey to the left were found in place and apparently undisturbed on the 17th day of August, 1976. Found Water Pump On Concrete Base 10.0. Pipe Measurement to point where 8 10.0. Pipe Enters Top of Concrete Base

I. Lloyd L. Jensen, surveyor, do hereby certify that under my direction part of the south line of the above survey dated January 1959 has been resurveyed and mapped, and that this plat of survey of that south line is a true and accurate representation of the property line to the best of my knowledge and belief.
