# Plat of Survey

A parcel of land located in Beulah Lake Park Subdivision, which Subdivision is located in Section 4, T 4 N R 18 E of Walworth County, Wisconsin, described as follows, to-wit: Beginning at the Southeast corner of lot 4 of said Subdivision; thence South 89° 15' West along the South line of said Lot 4, 288.90 feet to the shore of Beulah Lake; thence Northeasterly along the shore 81 feet; thence South 87° 26' East 211.96 feet; thence North 0° 34' West 19.45 feet; thence North 89° 20' East 40.00 feet to the East line of Lot 3 of said Subdivision; thence South 0° 34' East along the East line of said Lots 3 and 4, 80.34 feet to the place of beginning.

Surveyed for: Mrs. Margaret Miner  
803 Beulah Park Road  
East Troy, WI 53120

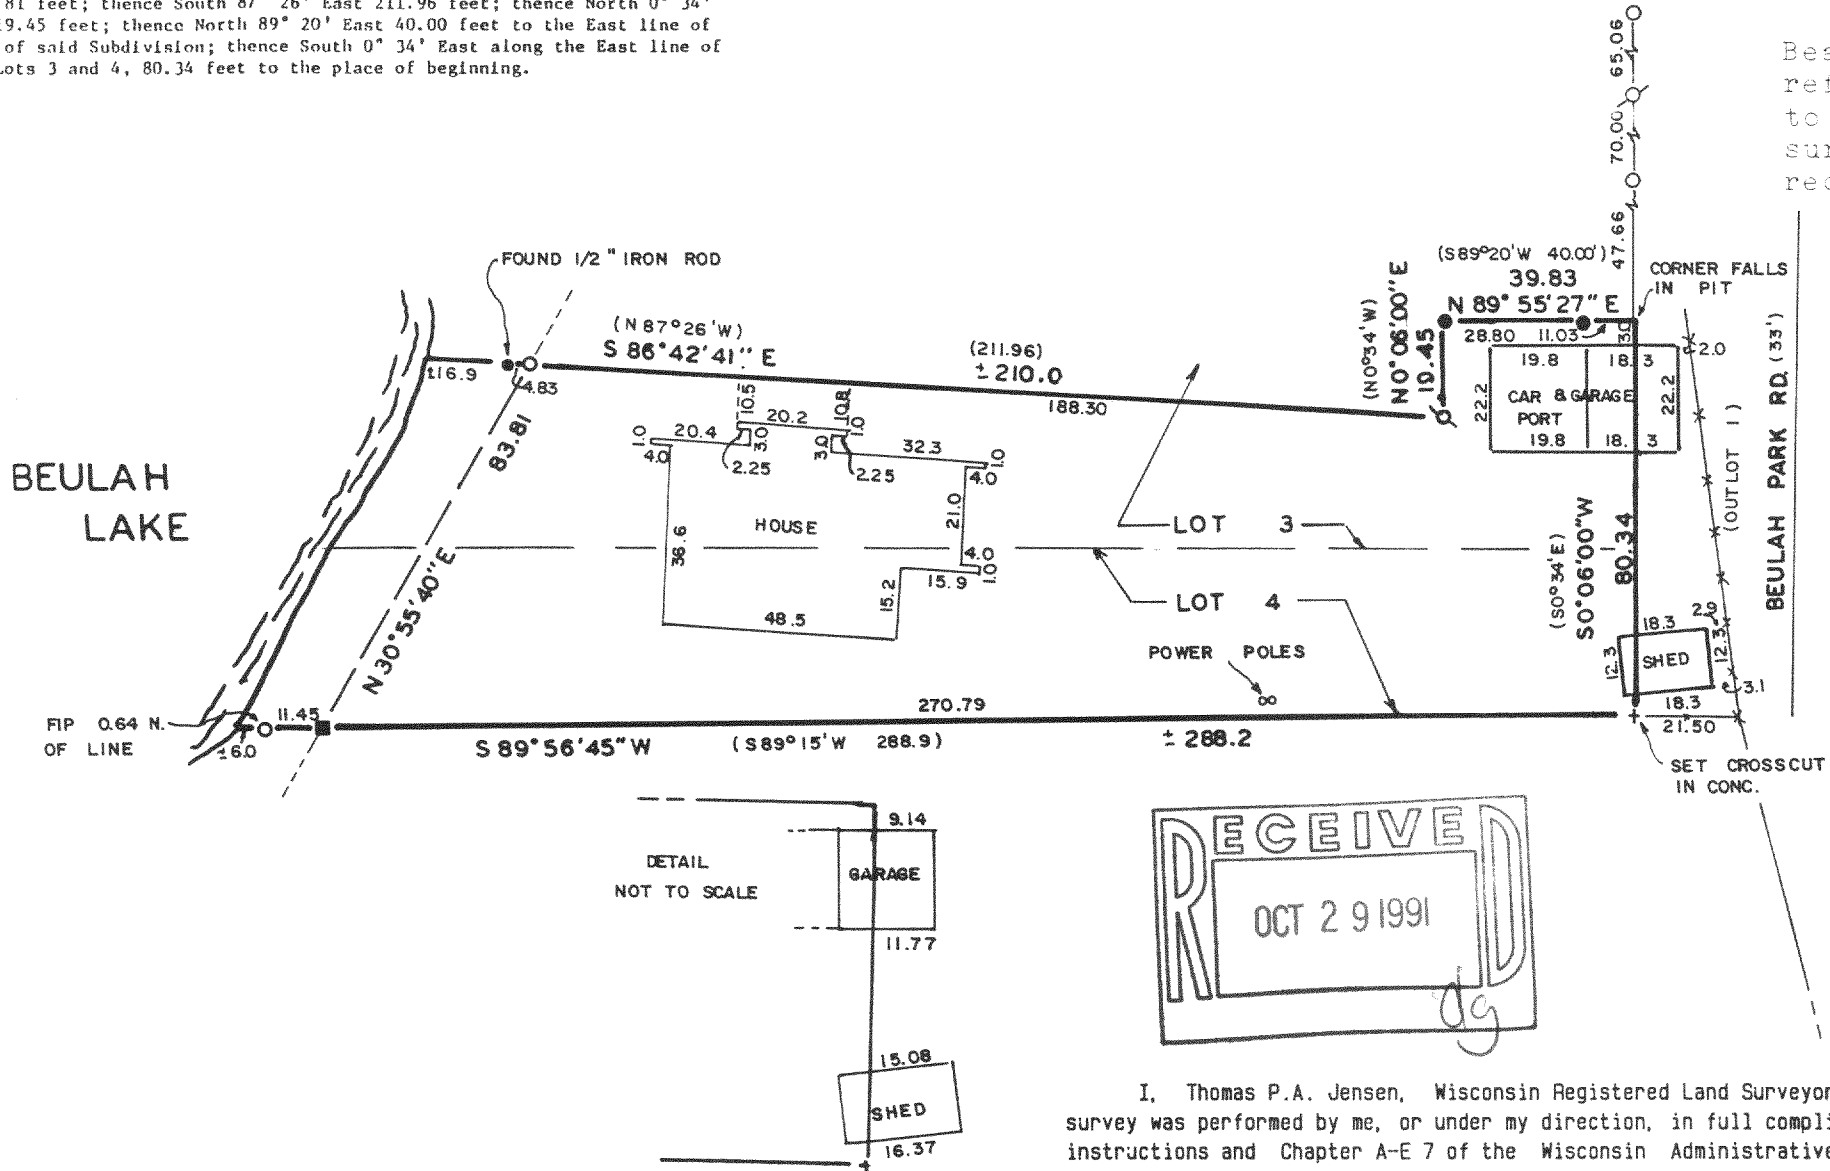
Sheet 1 of 1 Sheets

Bearings  
referenced  
to previous  
surveys of  
record
