## Tax Parcel XSV 00013A, being part of Lots 13 & 14 in Block 2 of Sunset View Subdivision,

located in the Southwest 1/4 of Section 18, Town 2 North, Range 16 East, City of Delavan, Walworth County, Wisconsin.

## Surveyed for: Shorewest Realtors

Job Reference Number 2014.004

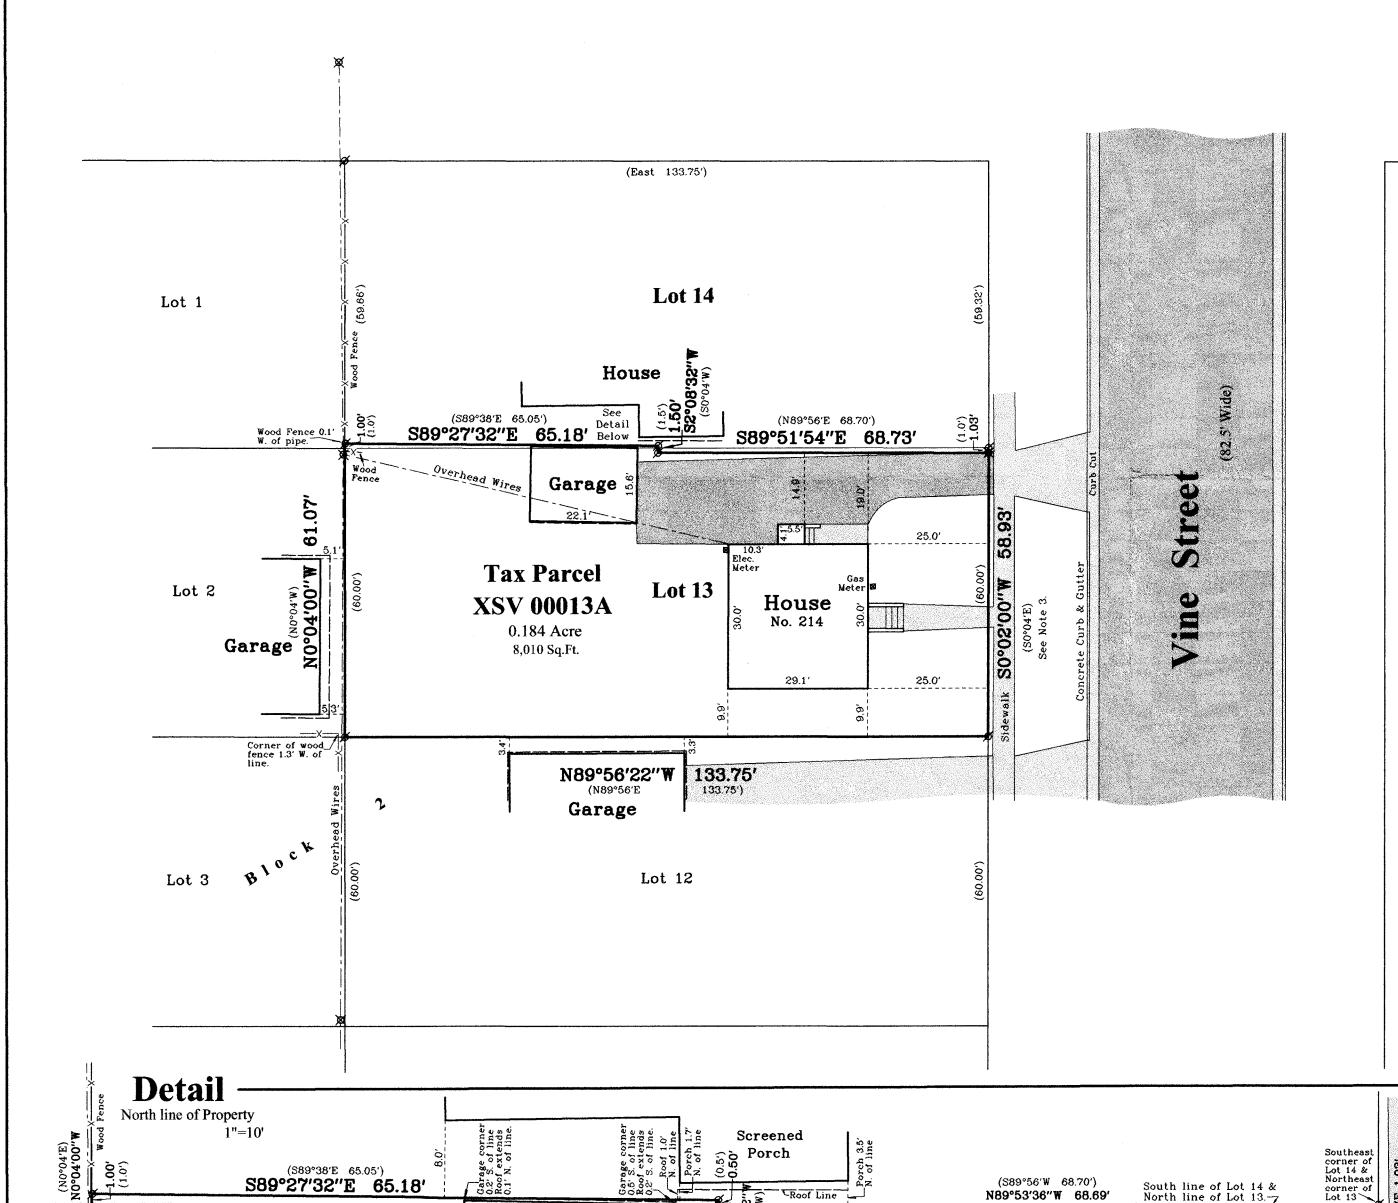
A parcel of land described in a Warranty Deed recorded July 31, 1974 in Vol. 119 on Page 77 as Document No. 681368, as shown below:

Lot 13 in Block 2 of Sunset View Subdivision of the City of Delavan, County and state aforesaid, excepting therefrom the following described parcel of land, to-wit: Beginning at the Northeast corner of said Lot 13; thence South 89°56' West along the North line of said Lot 13, 68.70 feet; thence South 0°04' West 1.0 feet; thence North 89°56' East 68.70 feet to the East line of said Lot 13. thence North 0°04' East along the East line of said Lot 13, 1.0 feet to the place of beginning.

Also part of Lot 14, of Block 2, of Sunset View Subdivision in the City of Delavan, Walworth County, Wisconsin, described as follows, to-wit: Commencing at the Southeast corner of said Lot 14; thence South 89°56' West along the South line of said Lot 14, 68.70 feet to the place of beginning; thence continue along the lot line south 89°56' West 65.05 feet to the Southwest corner of said Lot 14; thence North 0°04' East along the lot line 1.0 feet; thence South 89°38' East 65.05 feet; thence South 0°04' West 0.5 feet to the place of beginning.

Bearings reference to the plat of Sunset View Subdivision.

I hereby certify that I have surveyed the above described property and the map hereon is correct to the best of my professional knowledge and belief and shows the size and location of the property, its exterior boundaries, the location and dimensions of all visible structures thereon, boundary fences, apparent easements and roadways and visible encroachments, if any.
