DUNHAM SURVEYING, S.C. SURVEYING & SURDIVIDING DELAVAN, WISCONSIN 53115

I, George T. Dunham, Surveyor, certify that I have surveyed the property described as follows,

Lot 1 of Certified Survey Map Number 594, recorded in Volume 3, on Page 52 of Certified Survey Maps in and for the Office of the Register of Deeds, Walworth County, Wisconsin, Land located inCity of Delavan. and that the map shown hereon is a correct representation thereof and shows the size and location of the property, its exterior boundaries, the location of all visible structures and dimensions of all principal buildings thereon, boundary fences, apparent easements, roadways and visible encroachments, if

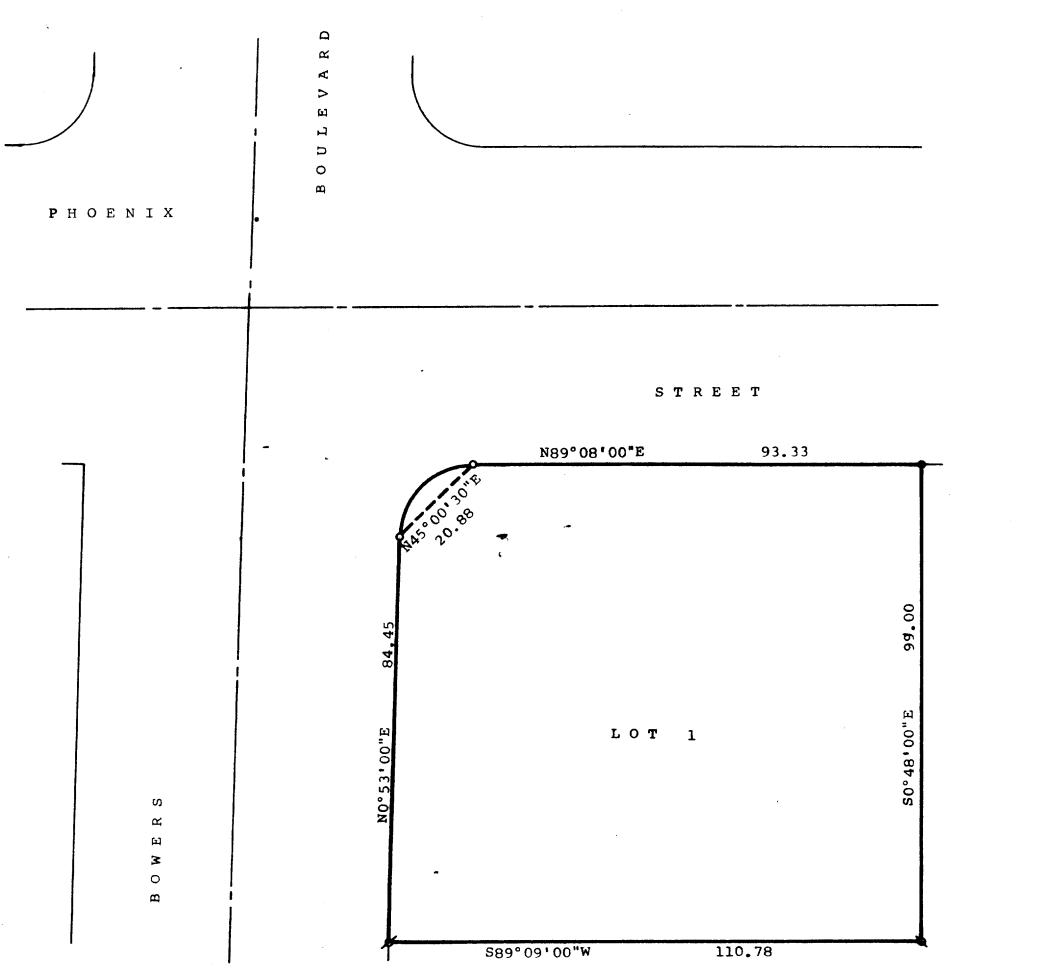
Scale - 1" = 20'• = Broken Concrete Monument Found and Reset with 1"x24" Iron Pipe o = 2" Dia. Iron Pipe Found # = 1 Dia. Iron Pipe Found a = 3/4" Dia. Iron Pipe Found

> Bearings are those of record. Owner: Lawrence Loudon 339 Bradley Avenue Delavan, Wi 53115
