Survey Ordered by:  
George Levison for  
Bay Realty

Plat of Survey of Lots 14, 15, and 16 of Glenwood Springs,  
a subdivision located in the Southeast Fractional Quar-  
ter of Section 14, T1N, R16E, Village of Fontana on Geneva  
Lake, Walworth County, Wisconsin.

Drawing No.  
1353

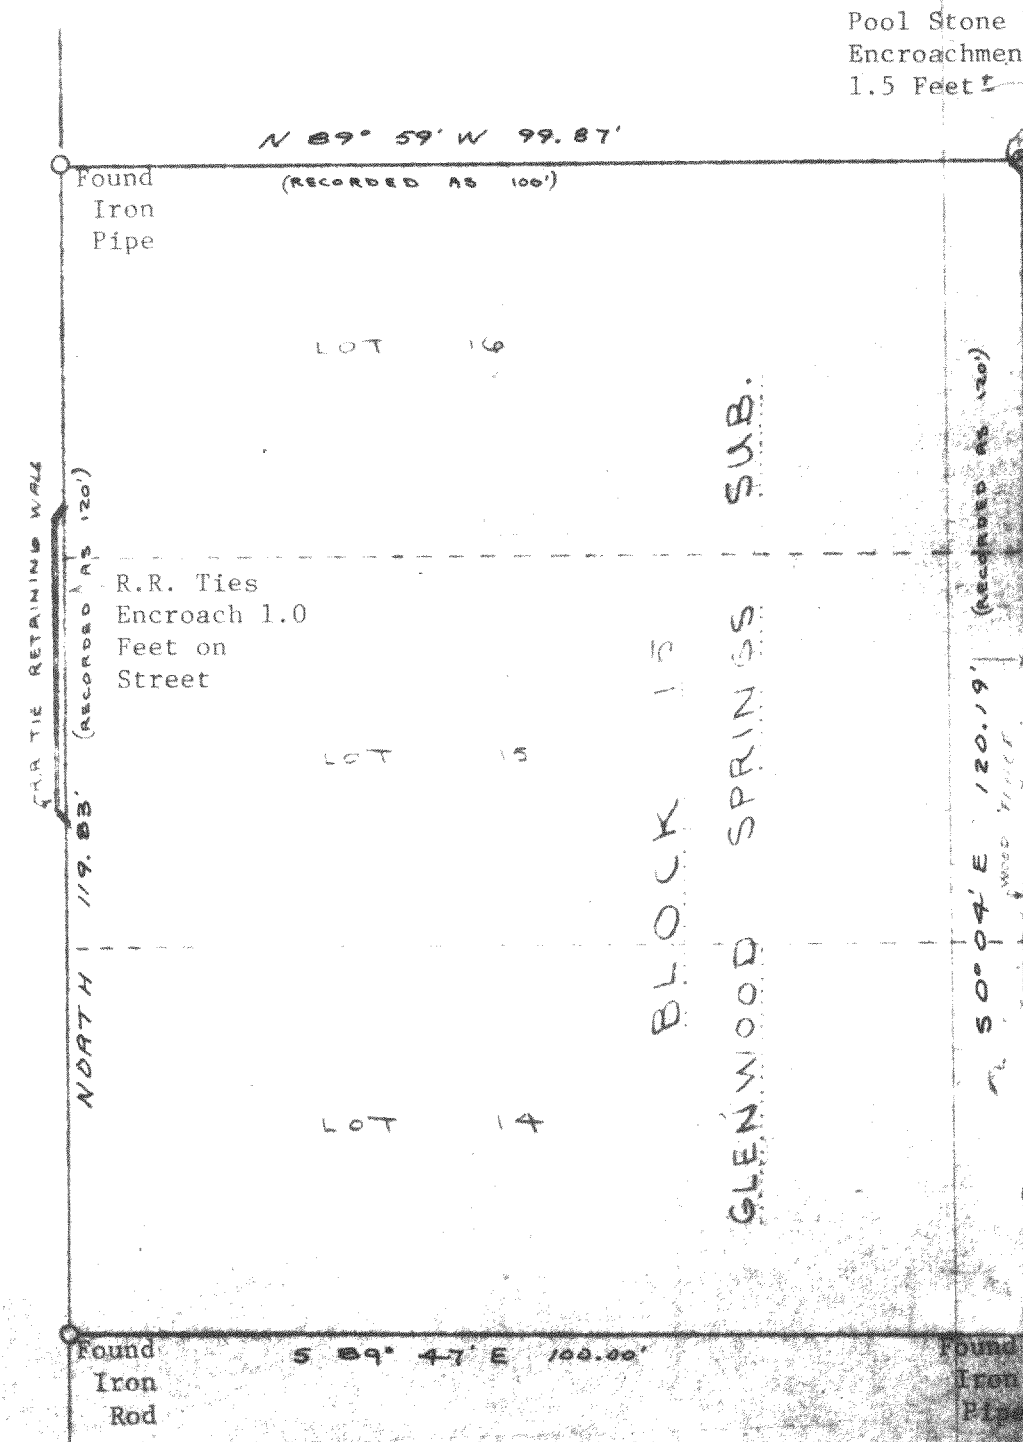
Pool Stone Work  
Encroachment of  
1.5 Feet

Found Spike  
Driven in Top  
of High Point of  
West Wall of  
Ornamental Pool

East line of Linden  
Avenue Assumed to Bear  
North

Garage Encroachment  
of 1.0 Feet
