# Plat of Survey

## Lot 26 of the subdivision of Block 6 of Indian Hills,

located in the Southeast 1/4 of Section 14, Town 1 North, Range 16 East,  
Village of Fontana-on-Geneva Lake, Walworth County, Wisconsin.

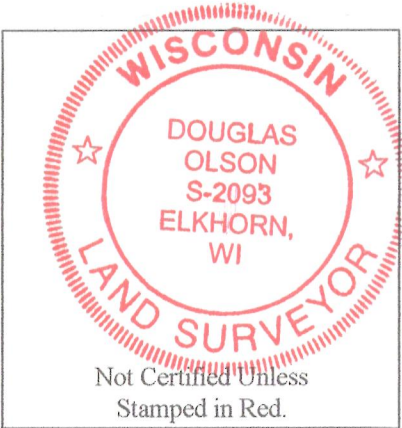
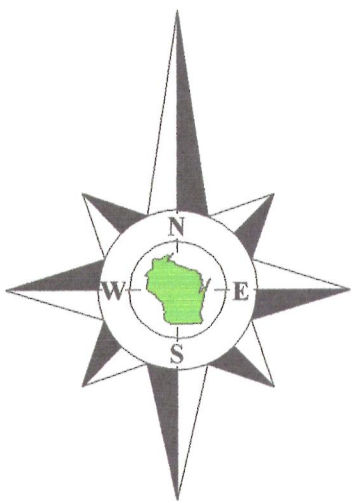
Bearings reference to the North line  
of Lot 27, recorded as N87°30'E on  
previous surveys of record.

Survey Date: May 18, 2010.  
Revisions: No. 1 - Proposed house, entry porch, deck & stairs  
No. 2 - Concrete Foundation  
No. 3 - Building Height
