Plat of Survey

A parcel of land described in a Warranty Deed recorded in Vol. 661 on Page 26 as Document No. 405779 as shown below:
A piece or parcel of land situated in the Village of Williams Bay, Walworth County, Wisconsin, described as a part of Lot 5 Pearson's Subdivision more particularly described as follows, to-wit: Beginning at the Northwest corner of Pearson's Subdivision; thence East on the North line of said subdivision 100 feet; thence South parallel with the West line of said subdivision 133 feet; thence Westerly 100 feet, more or less, to the West line of said subdivision; thence North on said West line 137 feet to the point of beginning.

Surveyed for:

Joe Pizzo
227 West Geneva Street
Williams Bay, Wisconsin. 53191

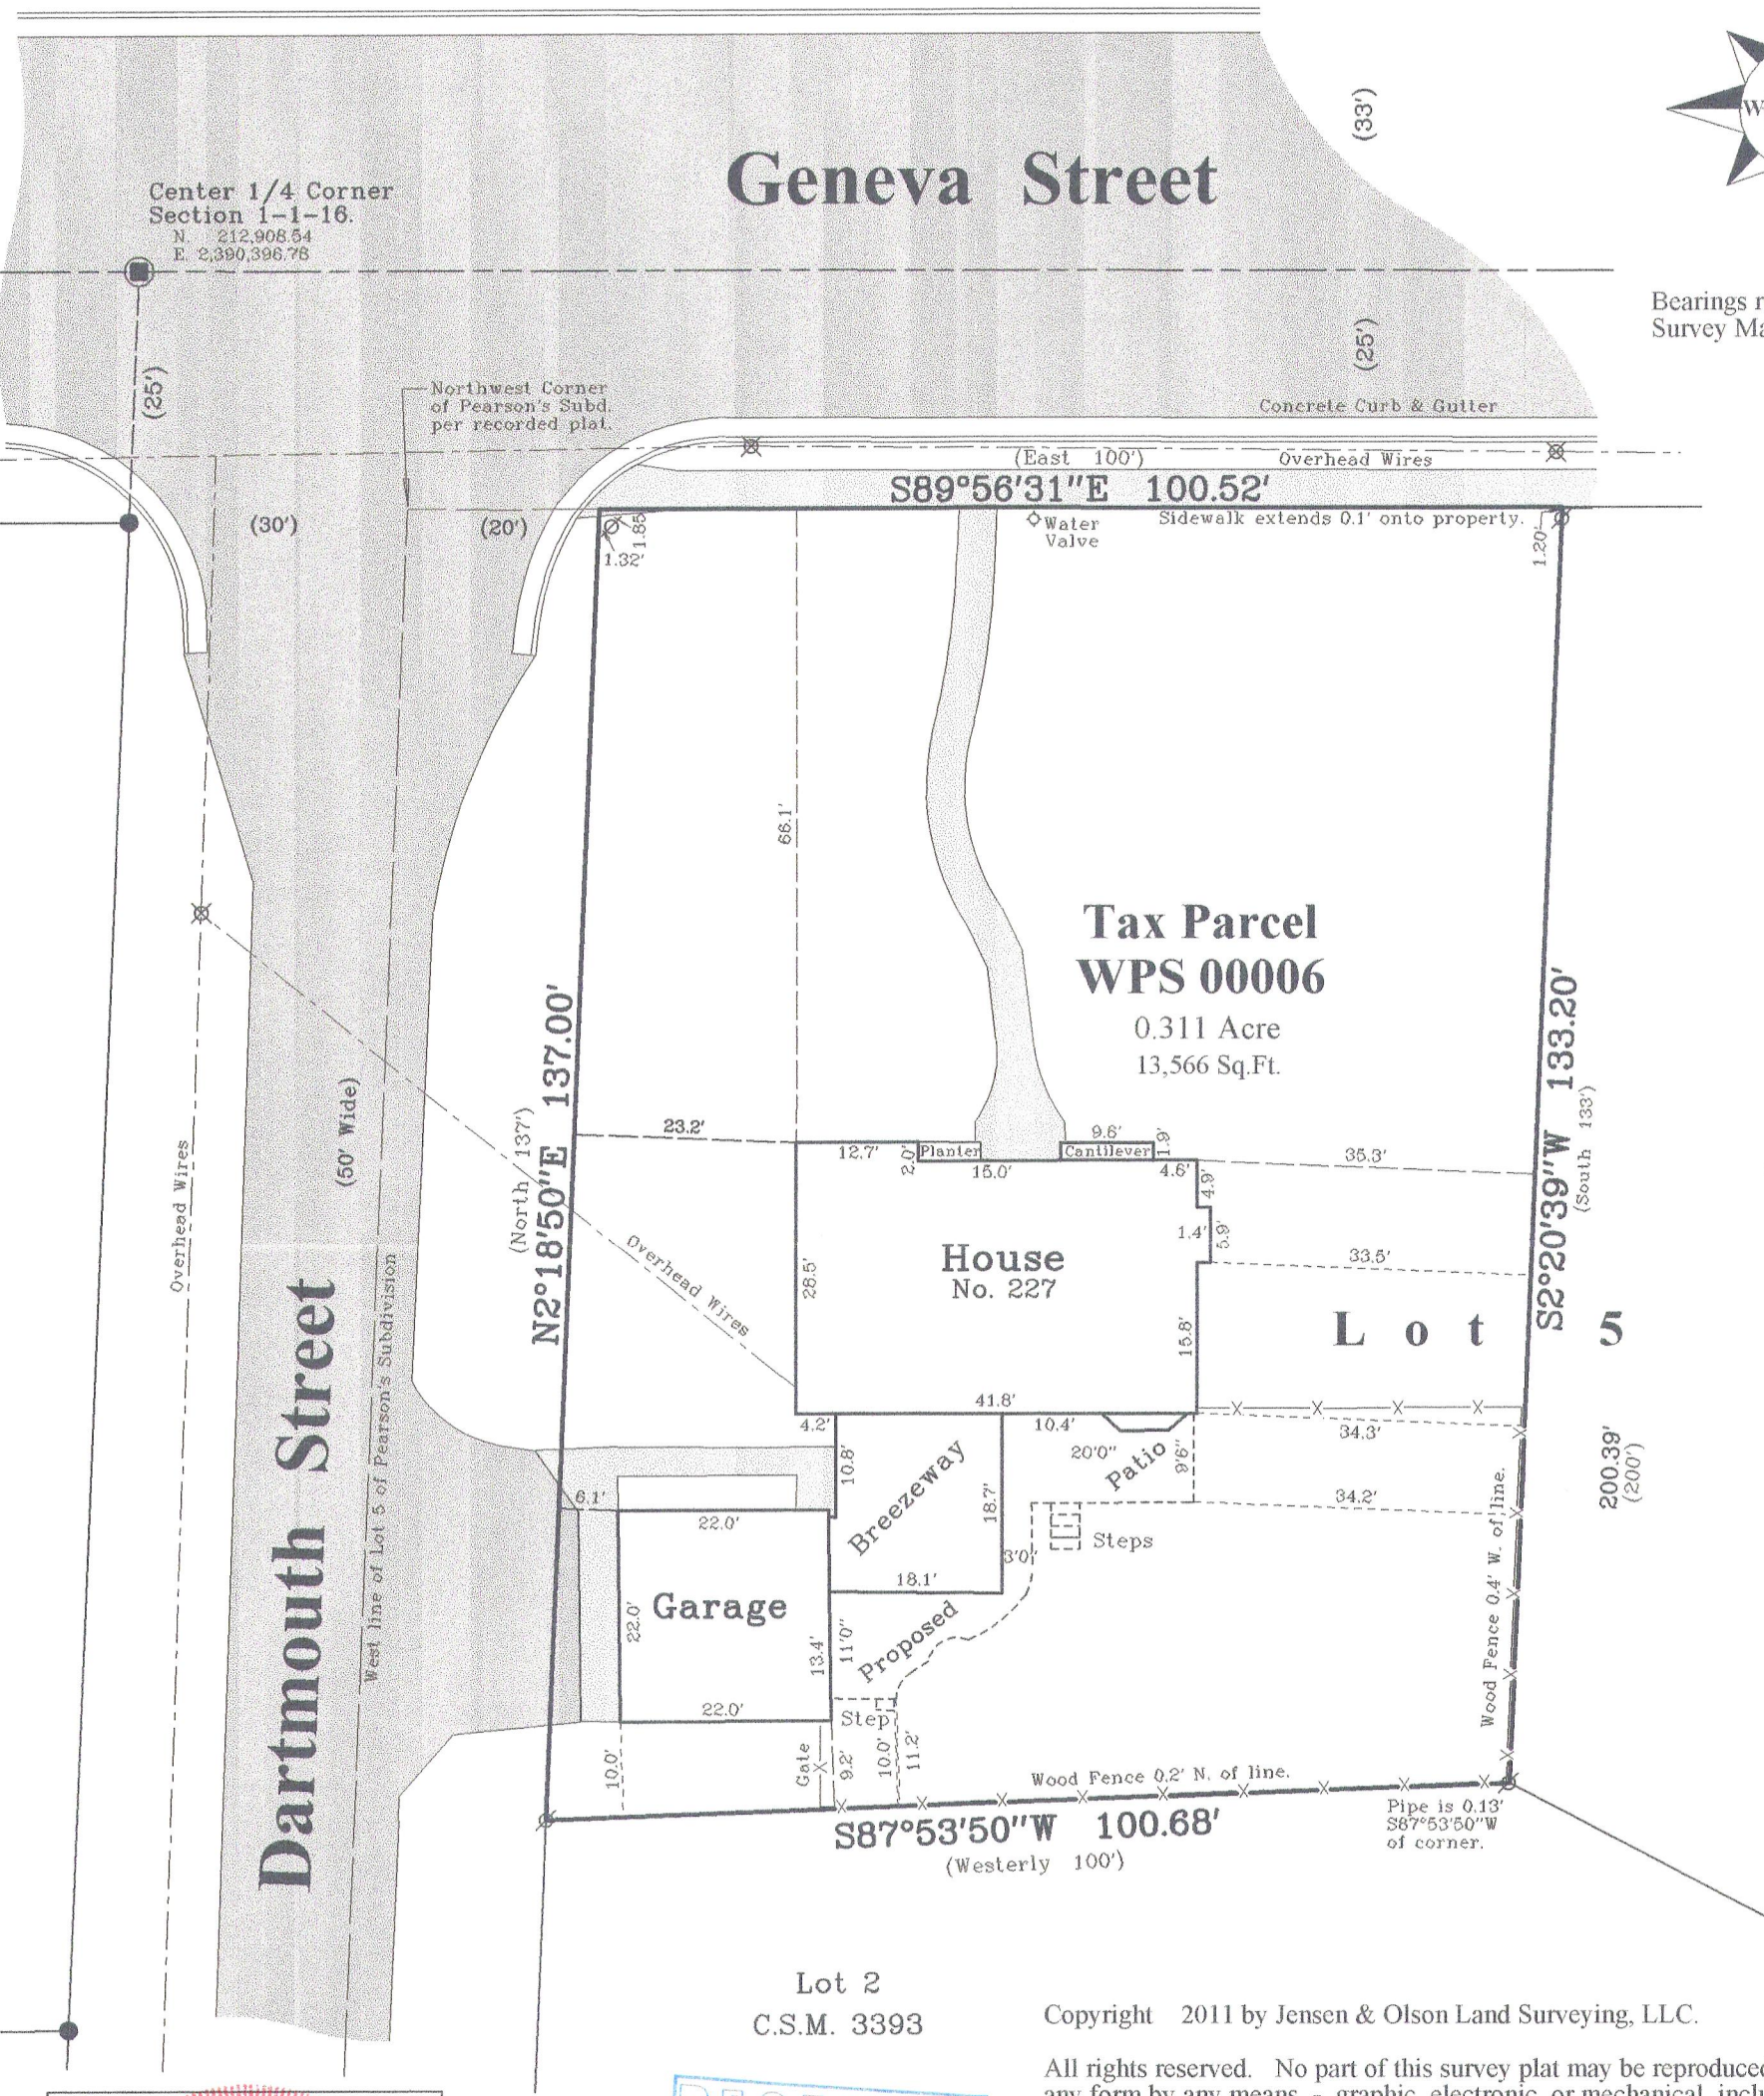
Note: Parcel surveyed as previously surveyed, monumented and occupied. Parcel appears to begin 20' East of the Northwest Corner of Pearson's Subdivision as platted.

Bearings reference to Certified Survey Map No. 2075.
