PLAT OF SURVEY -OF-

THE NORTH 37 FEET OF LOT 21 OF JOHNSON'S ADDITION TO THE VILLAGE OF WILLIAMS BAY, A SUBDIVISION BEING PART OF THE NORTHEAST 1/4 OF SECTION 1, TOWNSHIP 1 NORTH, RANGE 16 EAST OF THE FOURTH PRINCIPAL MERIDIAN, IN THE VILLAGE OF WILLIAMS BAY, COUNTY OF WALWORTH AND STATE OF WISCONSIN.

SURVEY FOR: KATHY BAUMBACH OF SHOREWEST REALTORS
SURVEY ADDRESS: 14 N. WALWORTH AVENUE, WILLIAMS BAY, WI 53191

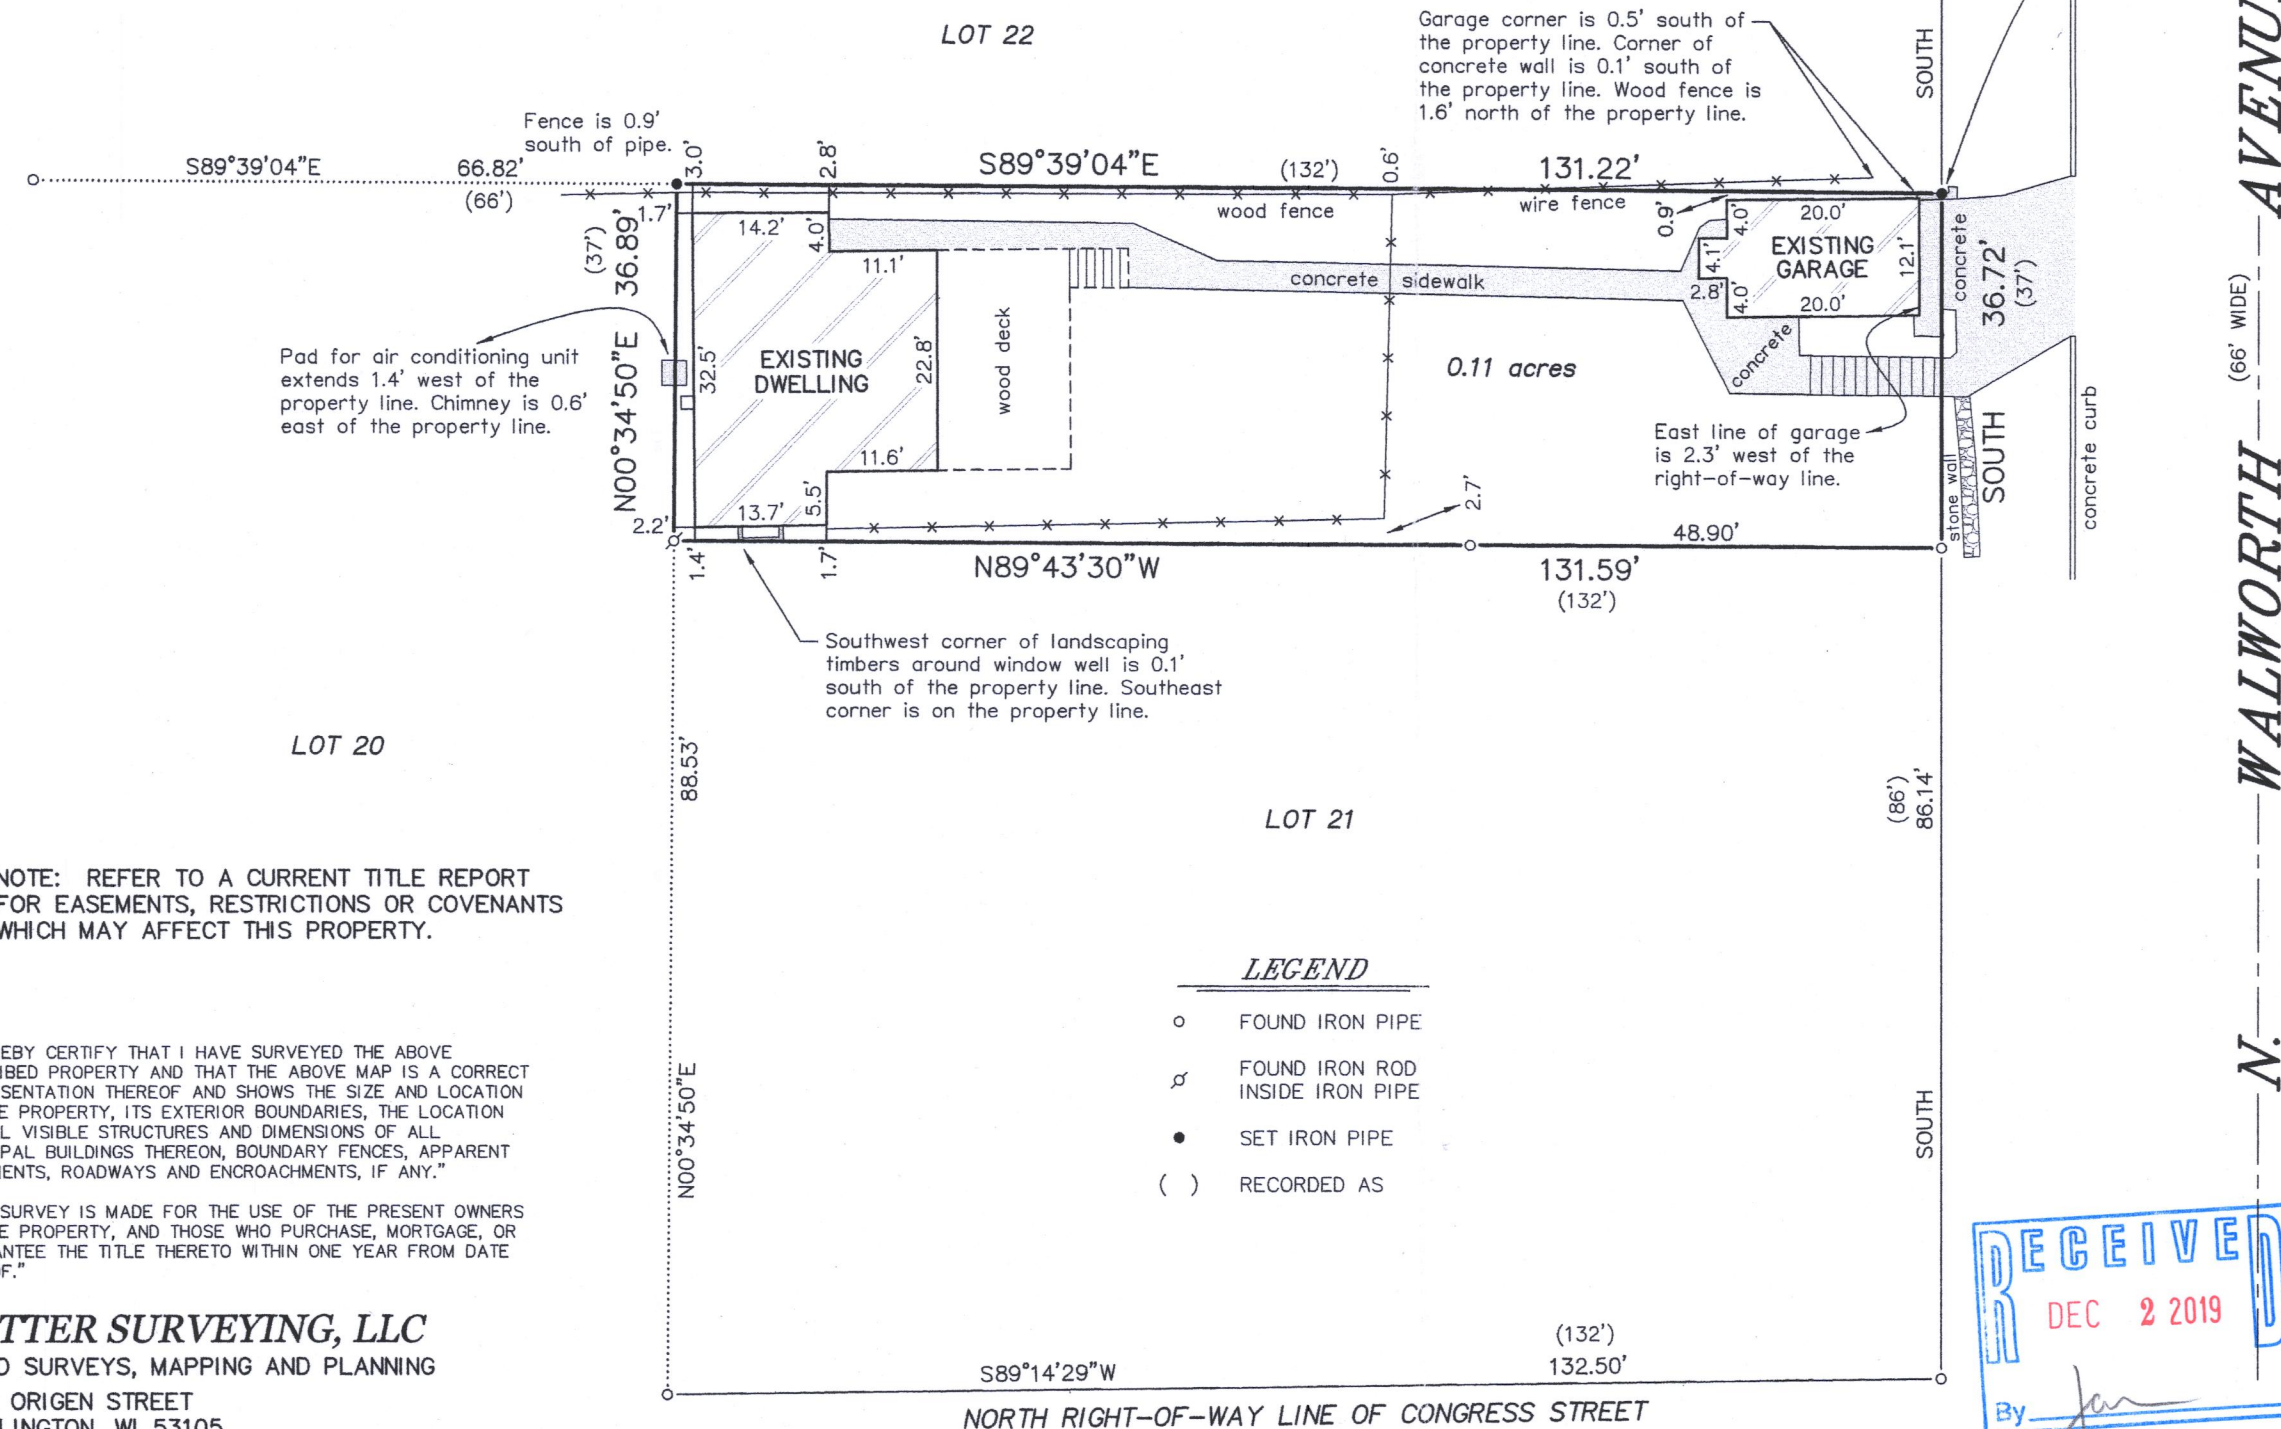
Set an iron pipe at the base of the concrete wall 0.14' north of actual corner. Previous surveys of record indicate a chiseled cut on the wall, but this office could not ascertain whether a cut existed on top of the wall. This office did not want to make a new chiseled cut in the wall at risk of damaging said wall due to the close proximity to the edge of the wall.

BEARINGS HEREON RELATE TO THE WEST RIGHT-OF-WAY LINE OF WALWORTH AVENUE. ASSUMED BEARING OF SOUTH.
