Survey No. 23.6001.05

PROPERTY DESCRIPTION: (per Doc. No. 973341)

LYNCH & ASSOCIATES
ENGINEERING CONSULTANTS, LLC

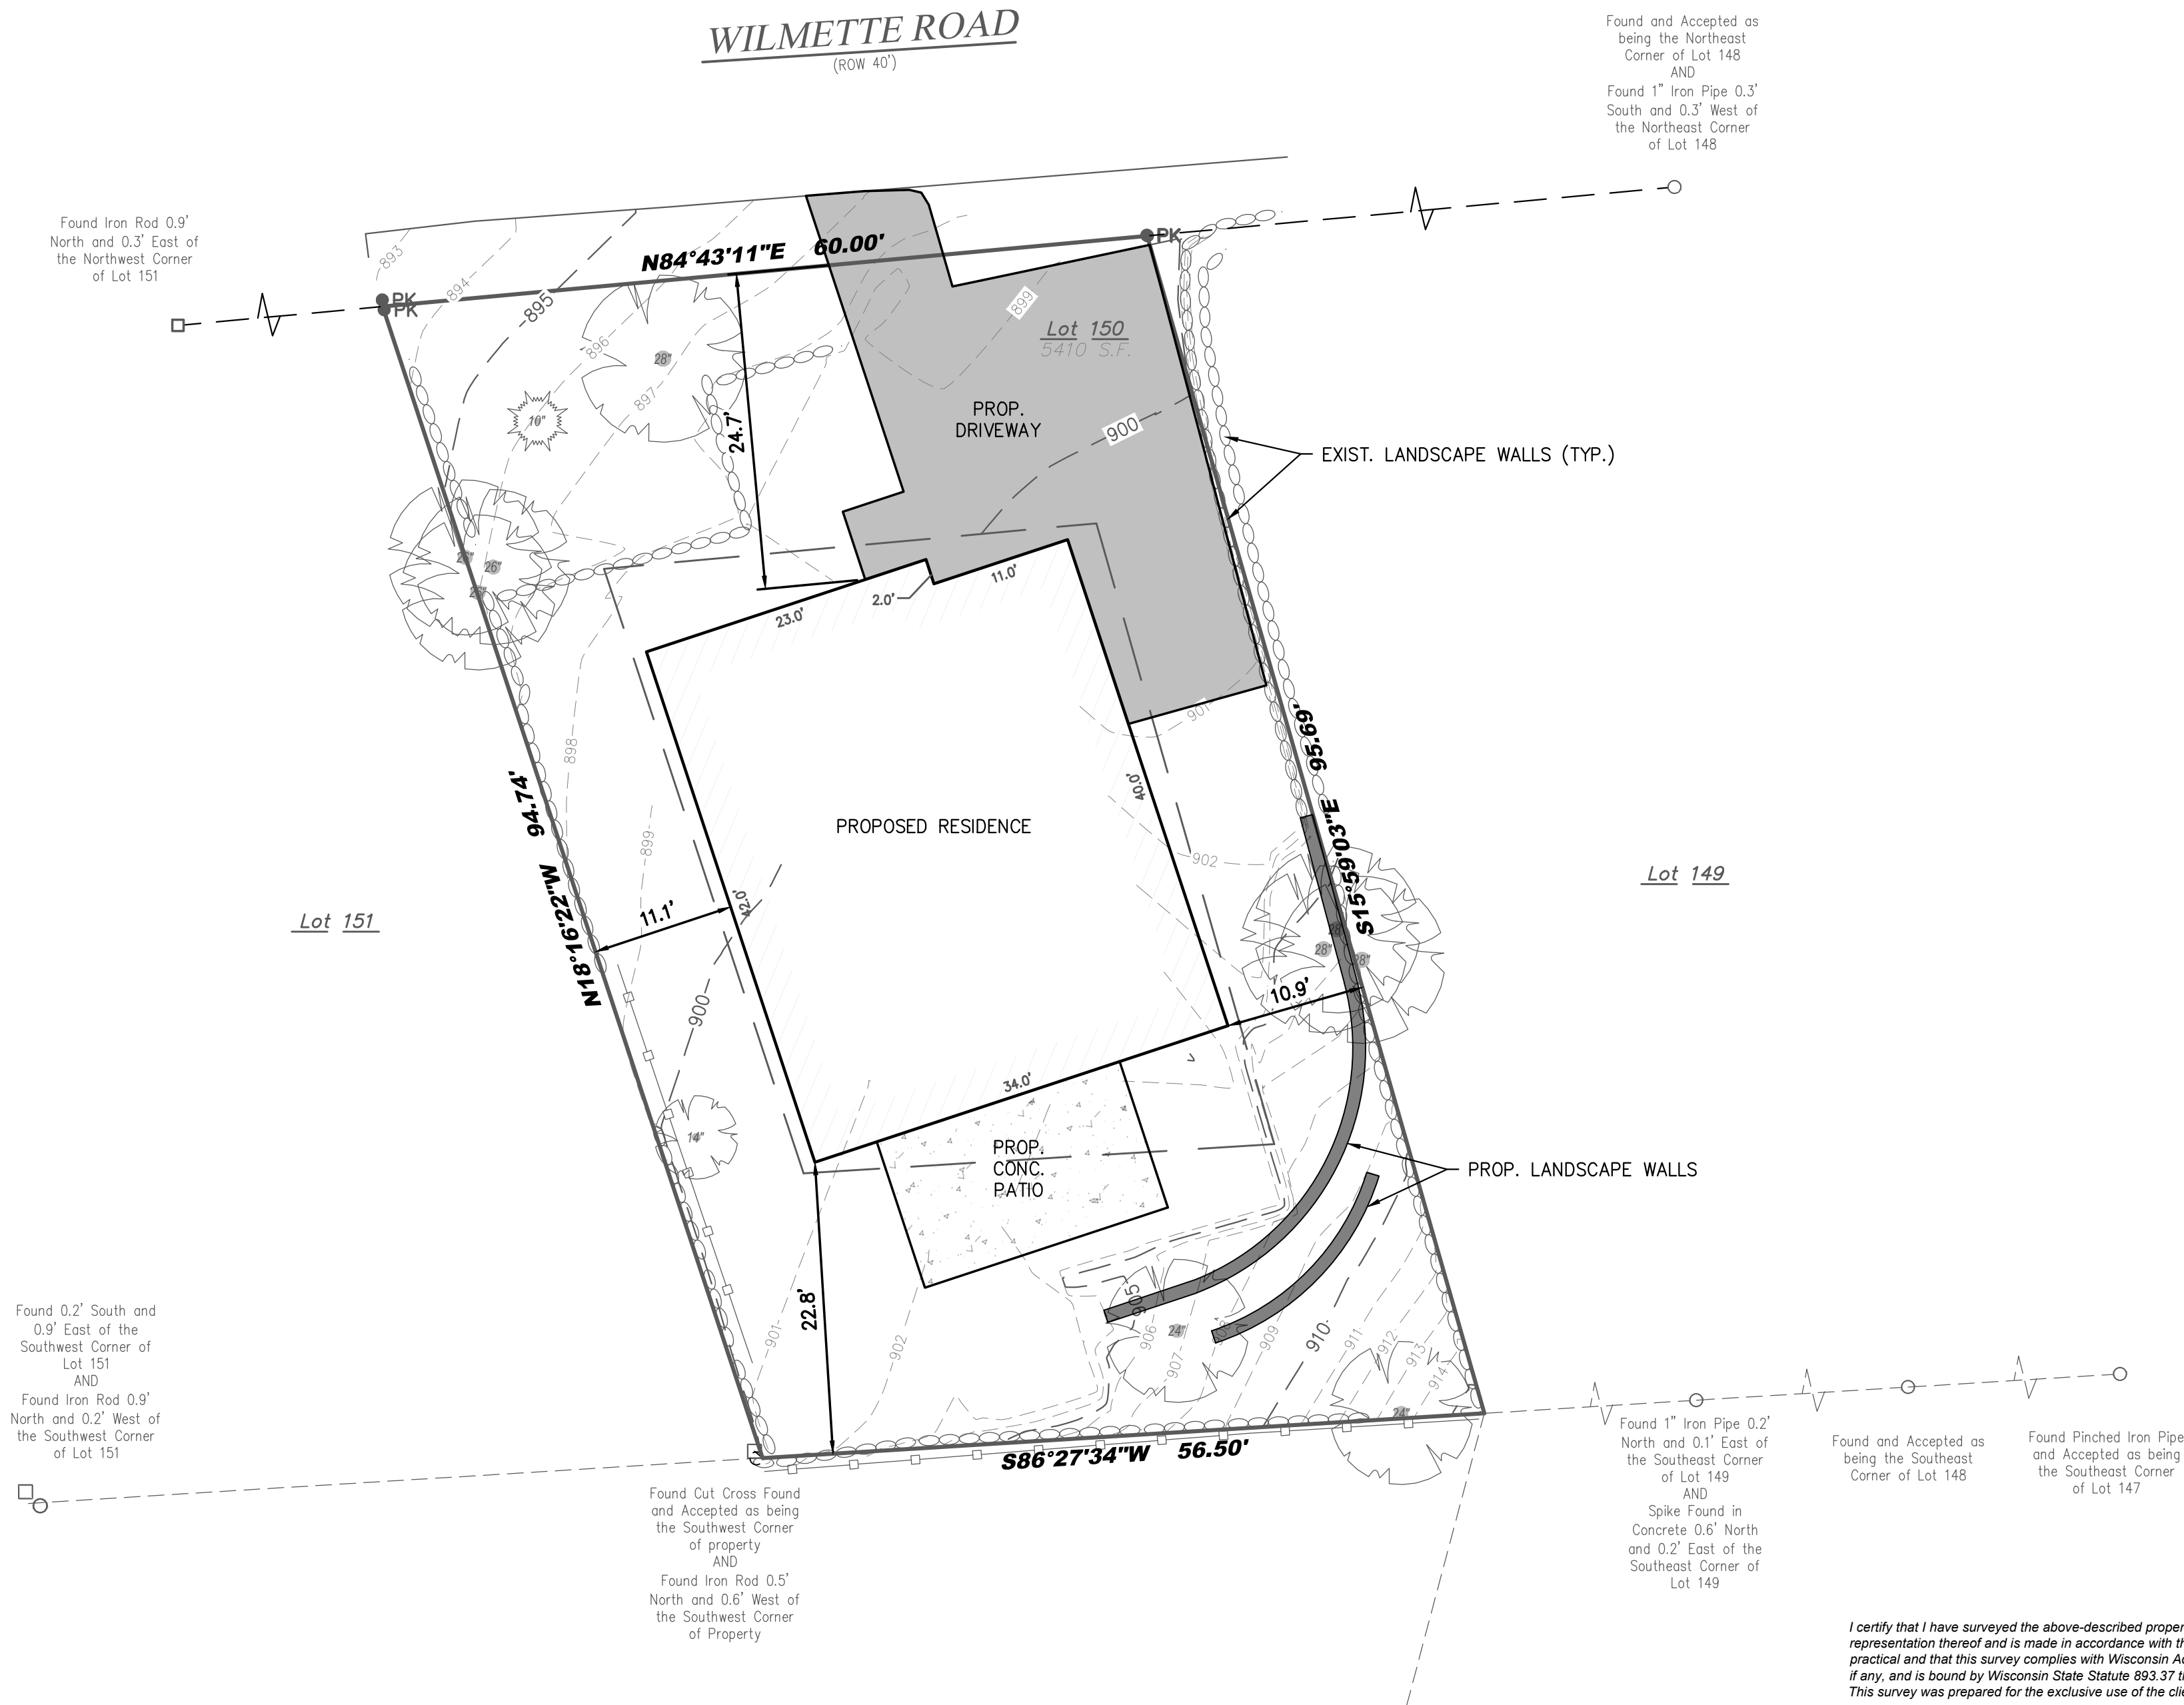
Found 0.2' South and
0.9' East of the
Southwest Corner of
Lot 151
AND

Found Iron Rod 0.9'
North and 0.2' West of
the Southwest Corner
of Lot 151

Found Cut Cross Found
and Accepted as being
the Southwest Corner
of property
AND
Found Iron Rod 0.5'
North and 0.6' West of
the Southwest Corner
of Property

Found 1" Iron Pipe 0.2' North and 0.1' East of the Southeast Corner of Lot 149
AND
Spike Found in Concrete 0.6' North and 0.2' East of the Southeast Corner of Lot 149

Found and Accepted as
being the Southeast
Corner of Lot 148

Found Pinched Iron Pipe
and Accepted as being
the Southeast Corner
of Lot 147
