Plat of Survey

of
A Proposed Lot Line Adjustment
between

Lots 1 and 2 of Certified Survey Map No. 3790,

recorded in Vol. 23 of Certified Survey Maps of Walworth County on Page 16 and located in Government Lot 3 in the Northeast 1/4 and the Southeast 1/4 of Southwest 1/4 of Section 11, Town 1 North, Range 17 East, Town of Linn, Walworth County, Wisconsin.

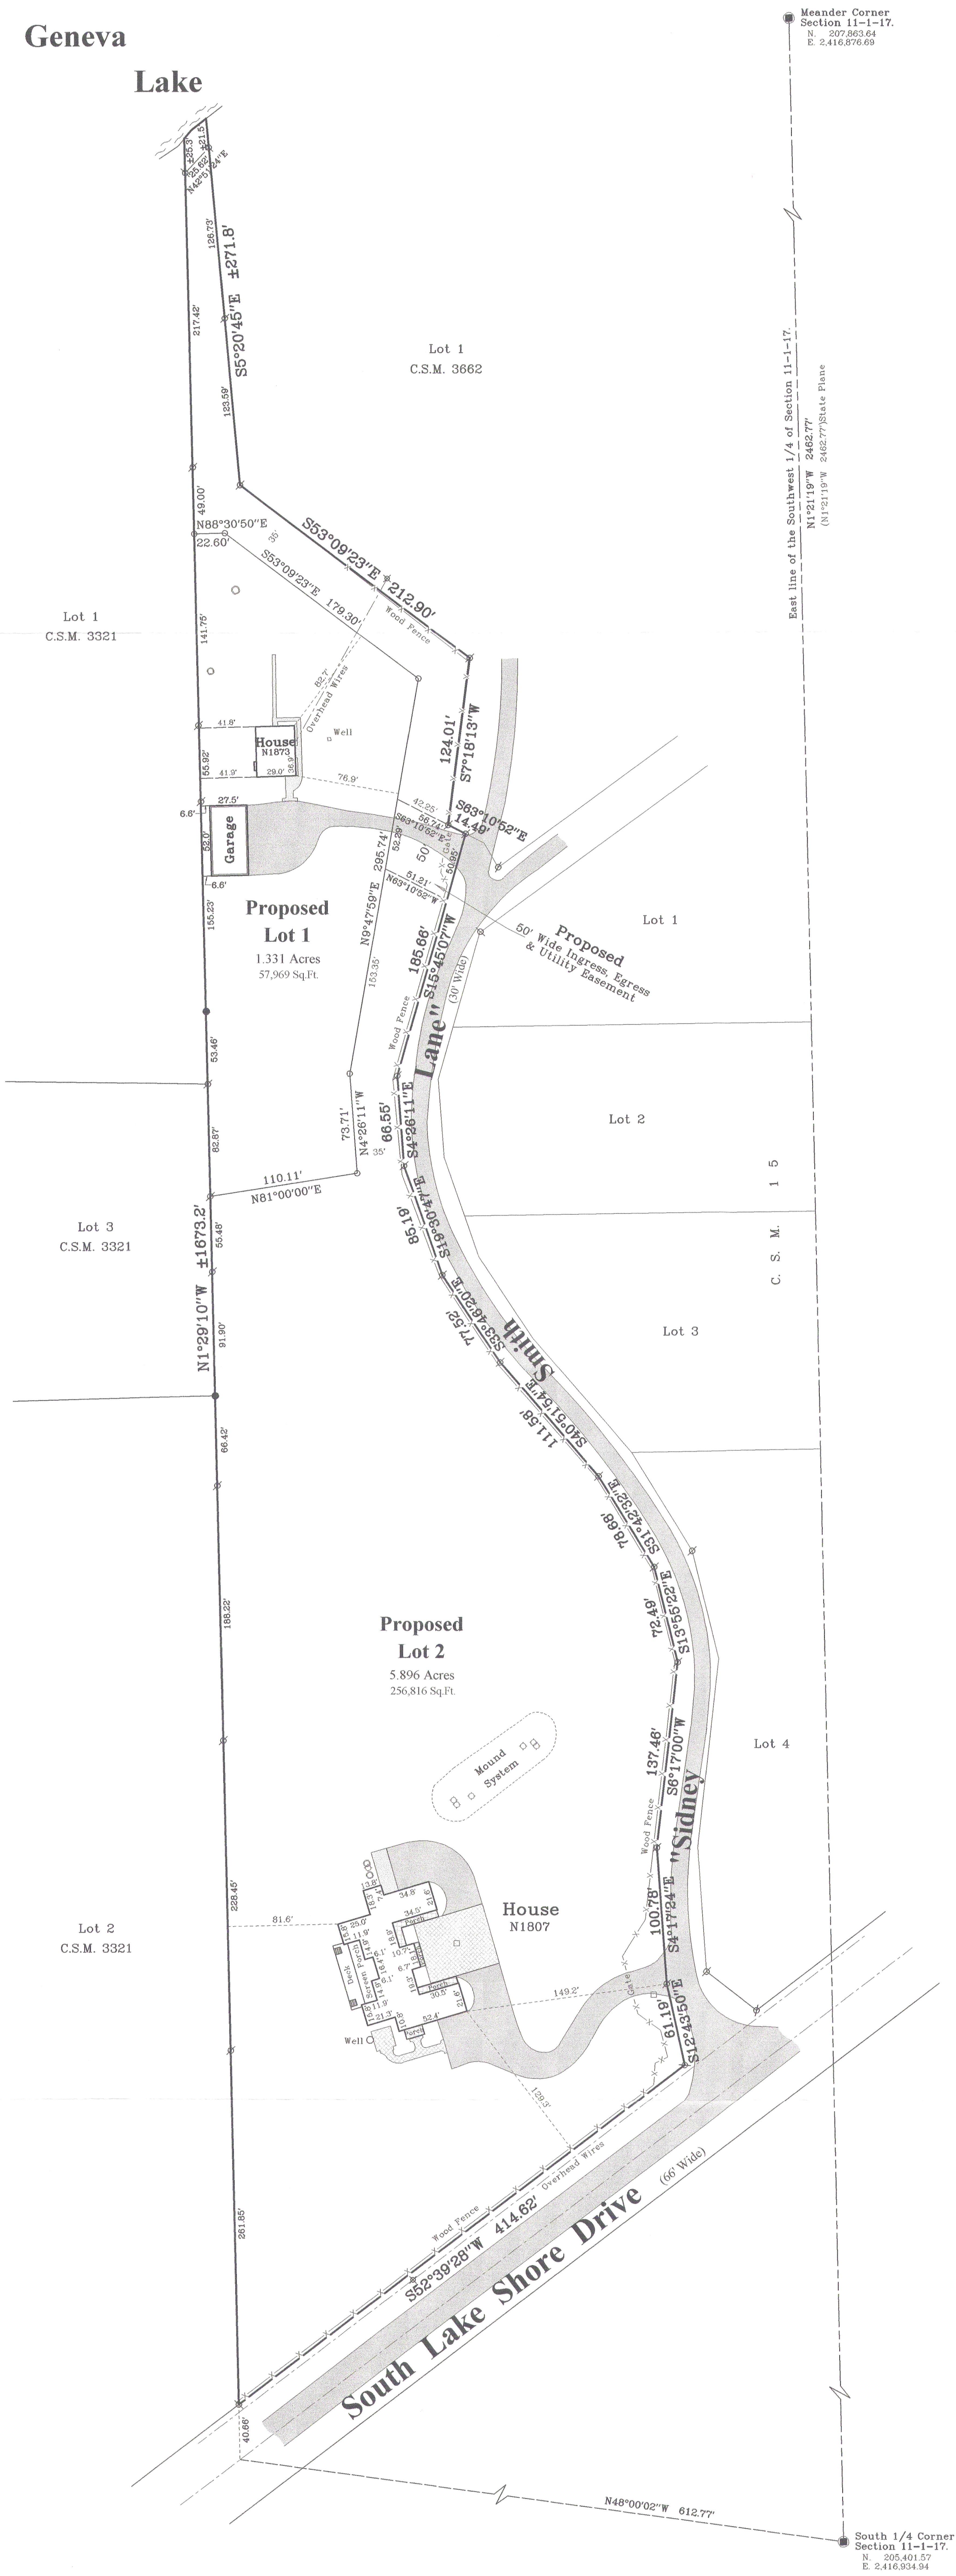
Sheet 1 of 1 Sheets

Legal Description of Proposed 50' Wide Ingress, Egress & Utility Easement

A 50 foot wide ingress, egress & utility easement on a portion of Lot 2 of Certified Survey Map No. _____ of Certified Survey Maps of Walworth County on Page _____ and located in Government Lot 3 in the Northeast 1/4 and the Southeast 1/4 of Southwest 1/4 of Section 11, Town 1 North, Range 17 East, Town of Linn, Walworth County, Wisconsin, described as follows: Commence at the Southeast corner of Lot 1 of said Certified Survey Map No. _____; thence North 4°26'11" West, along the East line of said Lot 1, 73.71 feet; thence North 9°47'59" East, along the East line of said Lot 1, 153.35 feet to the Point of Beginning; thence continue North 9°47'59" East, along said East line, 52.29 feet; thence South 63°10'52" East, 56.74 feet to a point on the West line of Sidney Smith Lane, a 30 foot wide right of way; thence South 15°45'07" West, along said West line, 50.95 feet; thence North 63°10'52" West, 51.21 feet to the Point of Beginning.

Note: Sydney Smith Lane is an existing 30' wide right of way described in a Warranty Deed recorded in Vol. 570 on Page 555 as Document No. 533264.
