# Plat of Survey

## Lot 14 of Oak Shores,

a subdivision located in Government Lot 3 in the Northwest 1/4 of Section 18,  
Town 1 North, Range 17 East, Town of Linn, Walworth County, Wisconsin.

**Paul Vogel**

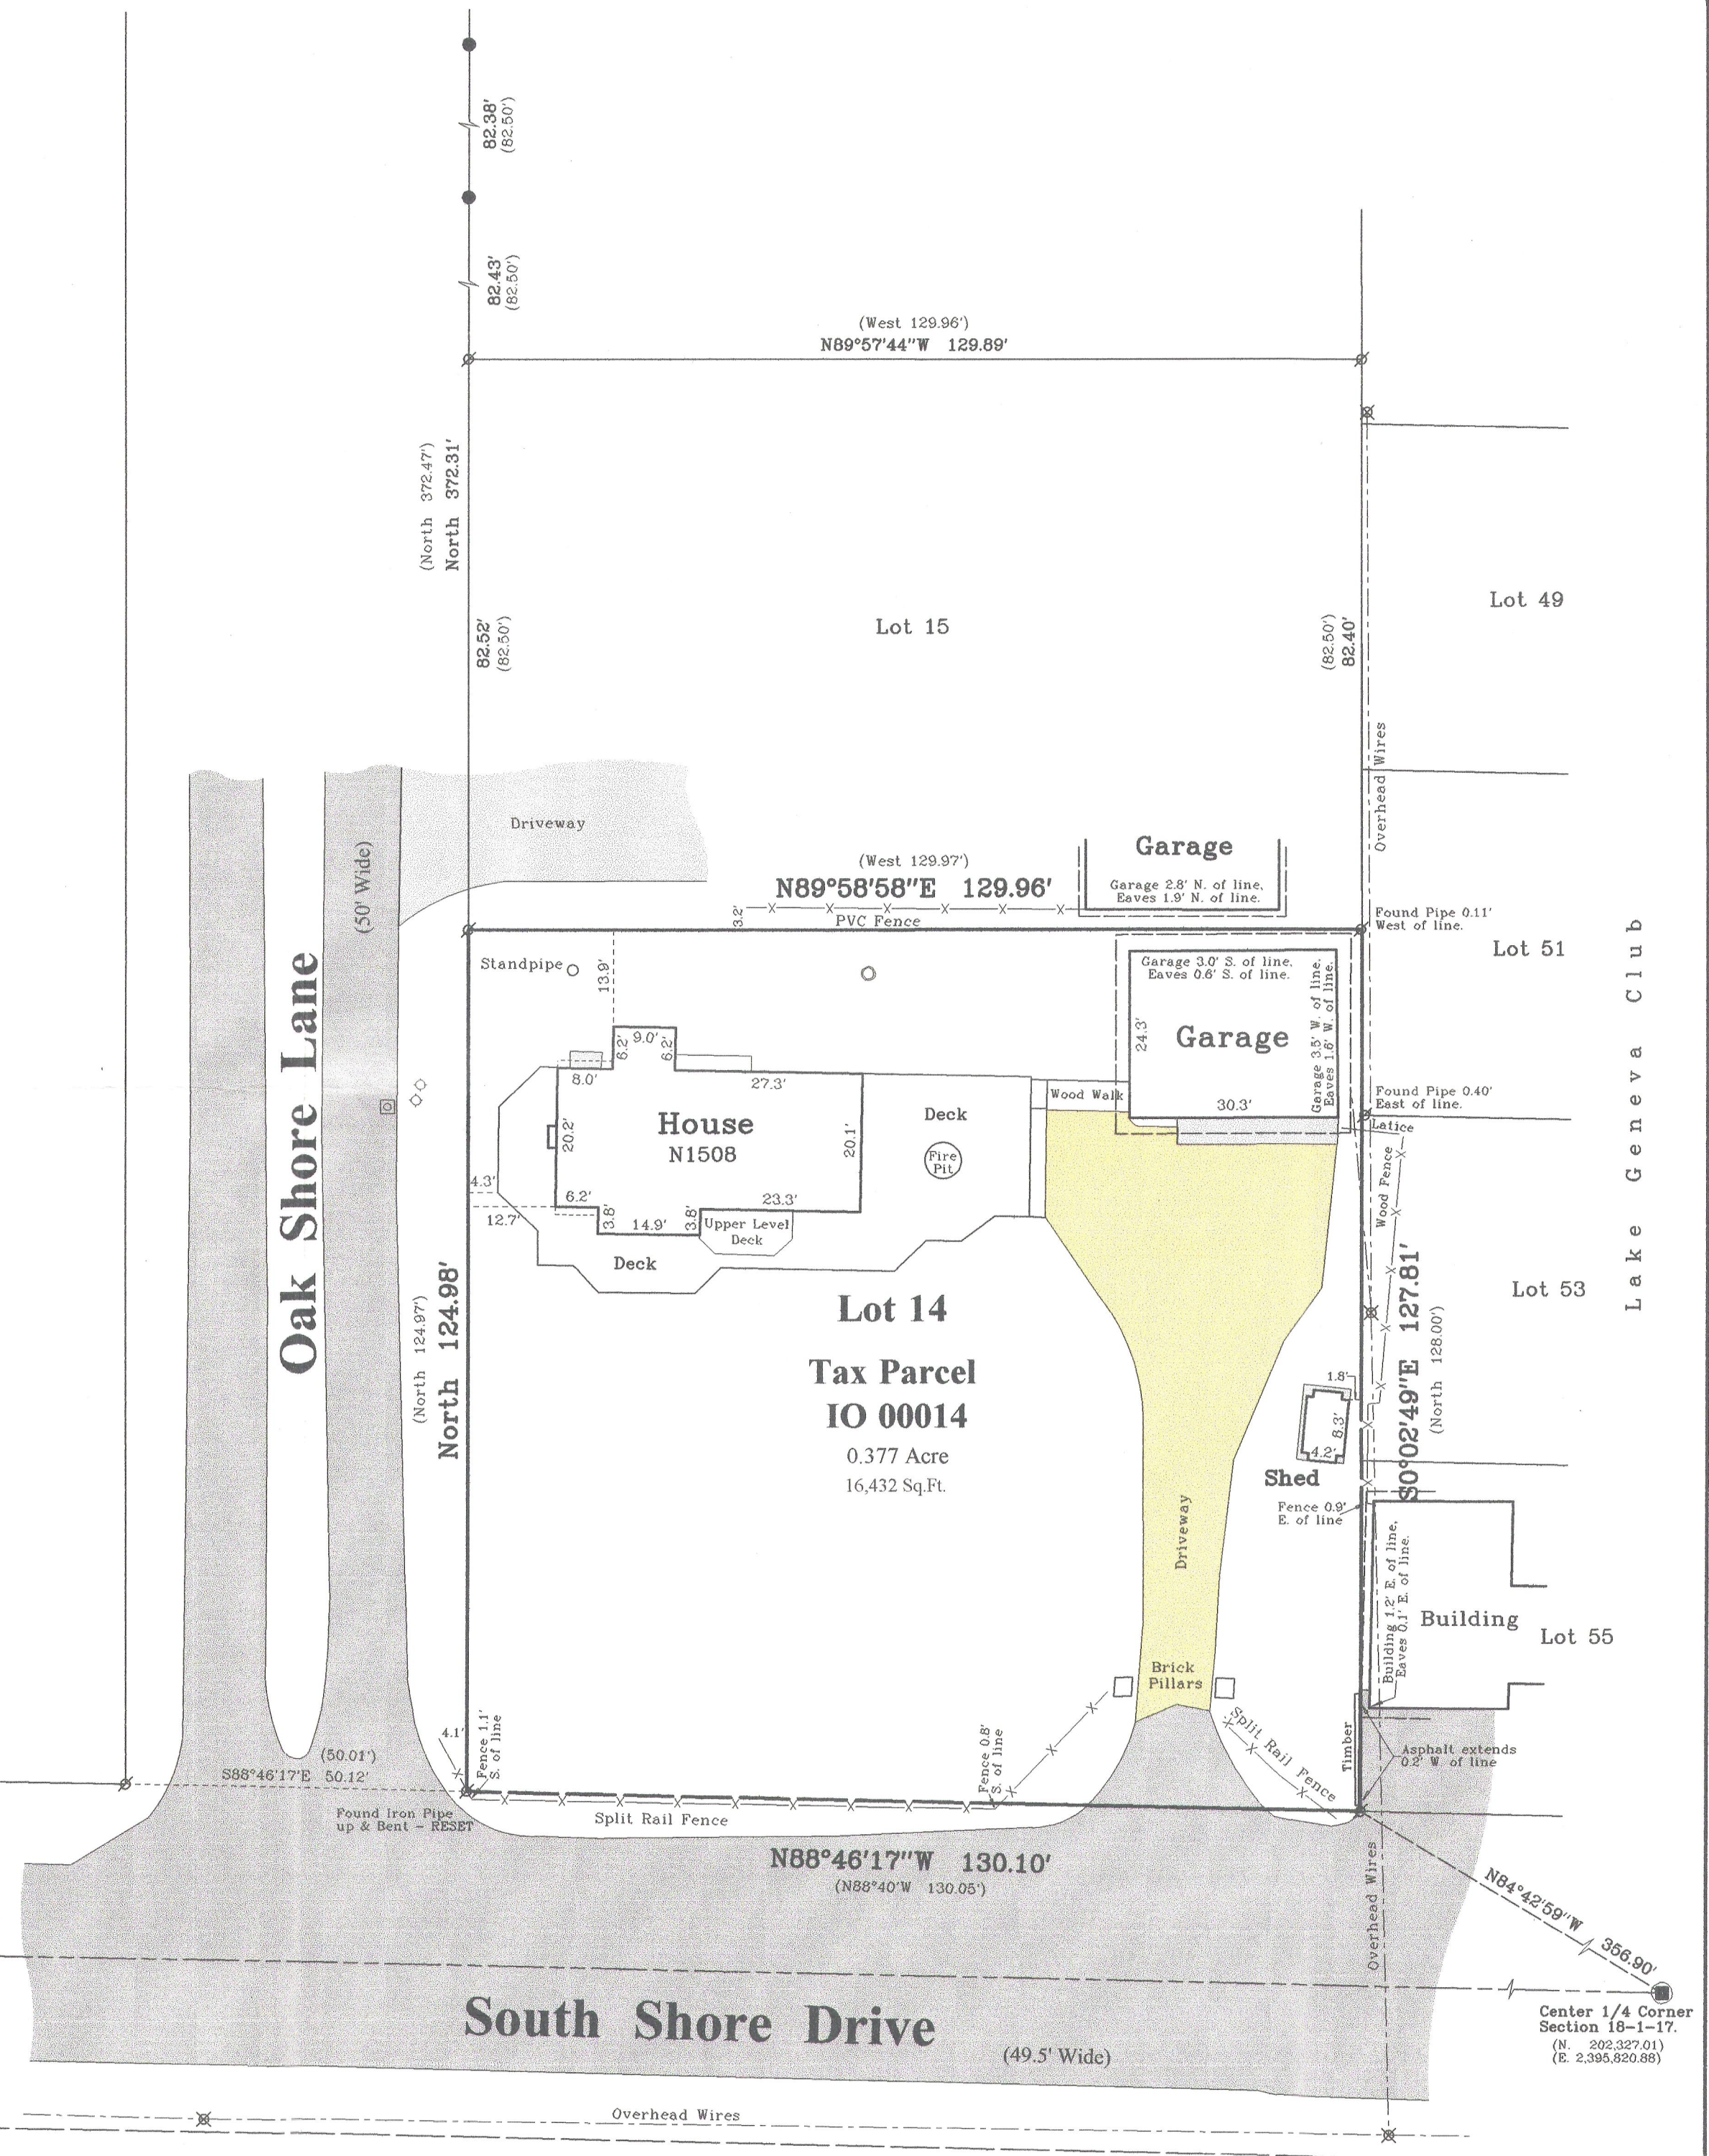
Bearings referenced to the East line of Oak Shore Lane recorded as North on the plat of Oak Shores.

I hereby certify that I have surveyed the above described property and the map hereon is correct to the best of my professional knowledge and belief and shows the size and location of the property, its exterior boundaries, the location and dimensions of all visible structures thereon, boundary fences, apparent easements and roadways and visible encroachments, if any.
