Property Exhibit

of
No. 46 Northwoodside
Lot 2 of Certified Survey Map No. 1174,

recorded in Vol. 5 of Certified Survey Maps of Walworth County on Page 236 and located in the Northwest 1/4 of Section 2, Town 1 North, Range 17 East, Town of Linn, Walworth County, Wisconsin.
Excepting therefrom lands conveyed by a Quit Claim Deed recorded November 13, 1998, in Vol. 659 on Page 89 as Document No. 398551.

Surveyed by: **William Hagenah**
315 Warwick Road
Kennilworth, Illinois 60043

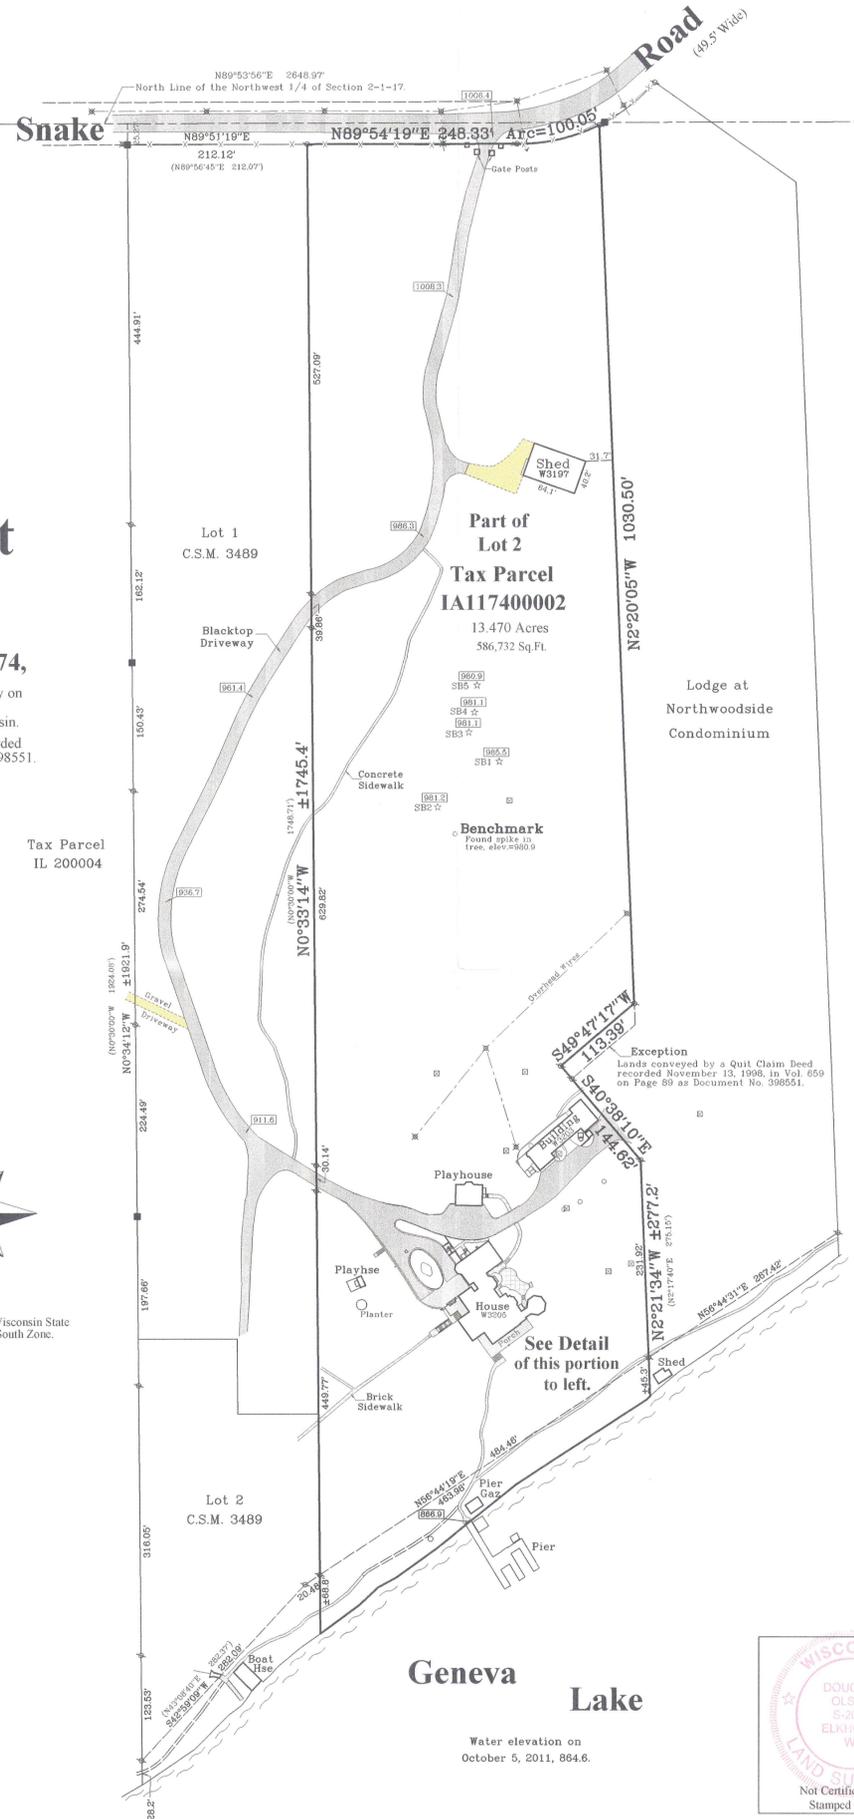
Bearings reference to the Wisconsin State Plane Coordinate System, South Zone.

Geneva Lake

Water elevation on
October 5, 2011, 864.6.
