# Plat of Survey

## Lots 1 & 2 in Block 8 of Genevista,

a subdivision located in the Southwest 1/4 of the Southwest 1/4 of Section 10,  
Town 1 North, Range 17 East, Town of Linn, Walworth County, Wisconsin.

Sheet 1 of 1 Sheets  
Drawing Name: thur17e-2012058-2012058plat.dwg  
Job Reference Number  
**2012.058**

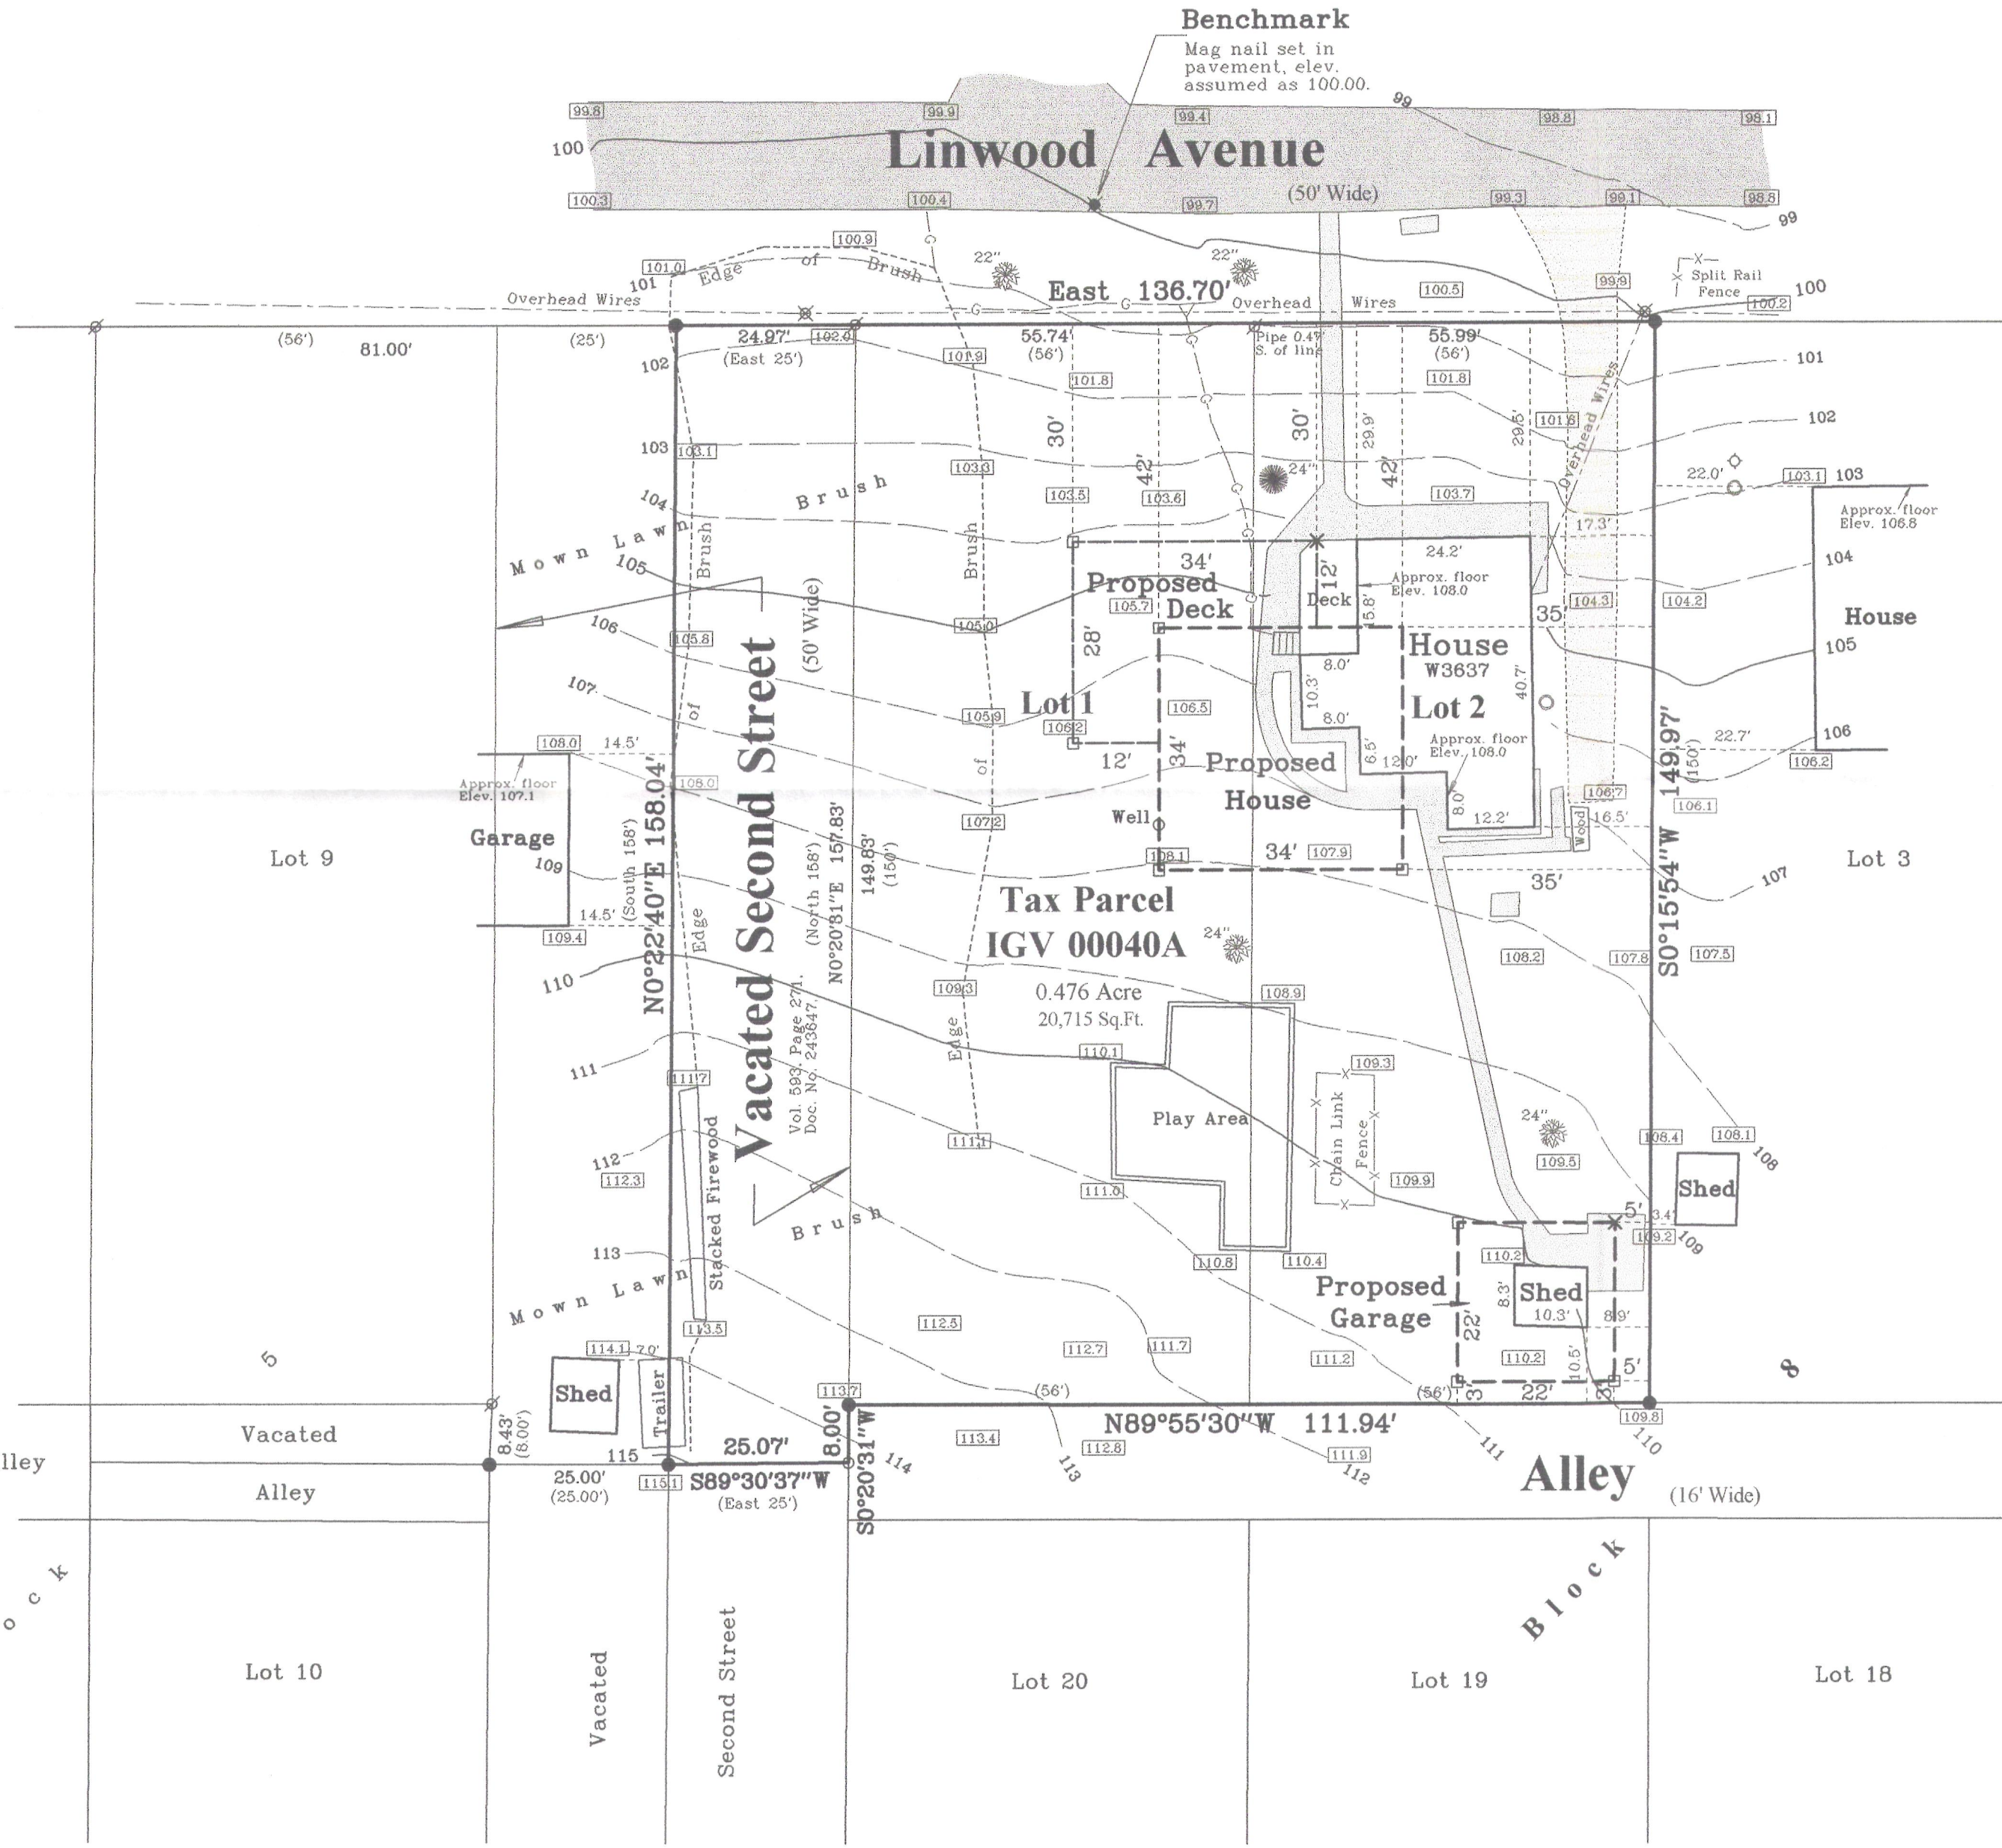
ALSO, A parcel of land described in an Abridgment of Judgment recorded in Vol. 593  
on Page 271 as Document No. 243647, as shown below:

Beginning at the Northwest corner of Lot 1, Block 8, Genevista Subdivision; thence East  
25 feet to the centerline of the vacated roadway; thence South 158 feet along the center-  
line of said roadway; thence East 25 feet; thence North 158 feet along the West line of  
said lot to the point of beginning.

Bearings reference to previous  
surveys of record.
