DUNHAM SURVEYING, S.C. SURVEYING & SUBDIVIDING DELAYAN, WISCONSIN 53115

I, George T. Dunham, Surveyor, certify that I have surveyed the property described as follows:

Lots 11 and 12 and the West 1 of Lot 10, all in Block 6 of Lake View Park, a subdivision located in Section 16, T 1 N,

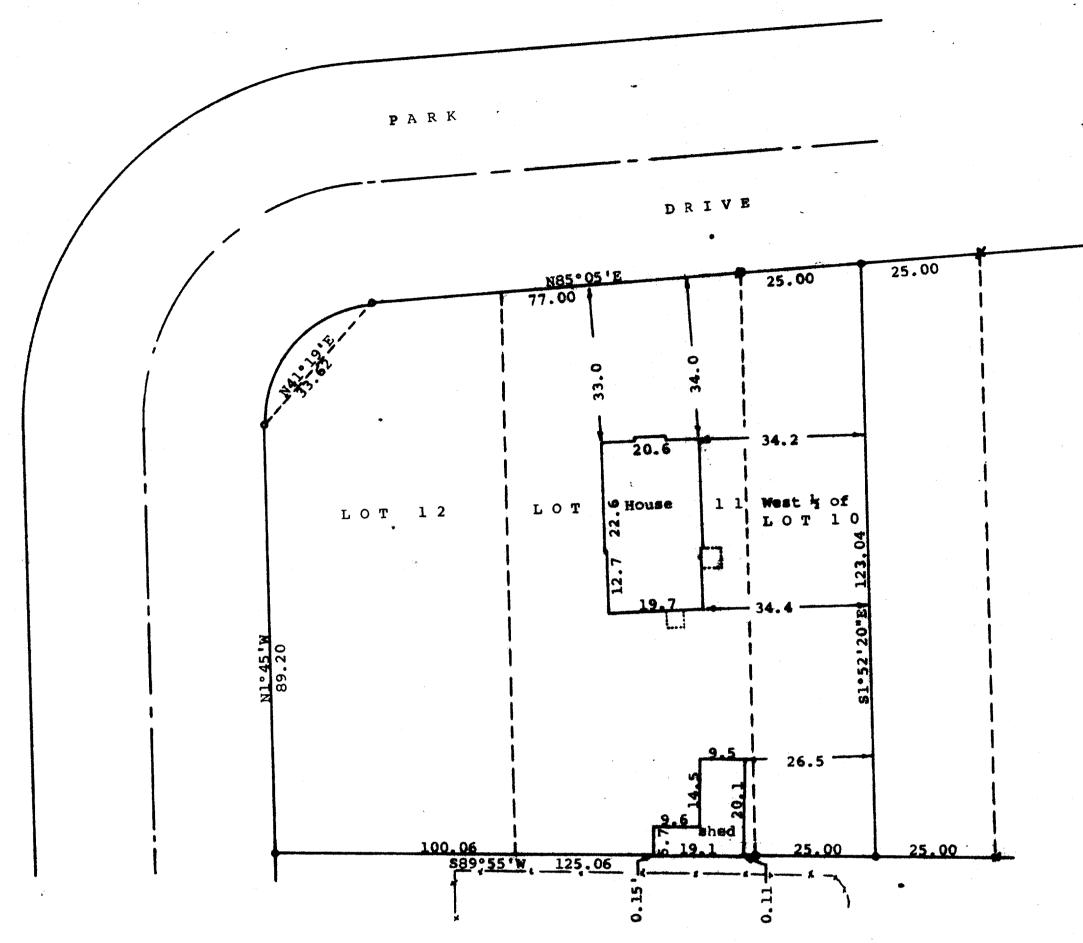
Scale -1" = 20B= Pose Pin Found • = Posey Pin Found and 3/4" X 24" Iron Pipe Set • = 3/4" % 24" Iron Pipe x= Rust mark found of Posey Pin. Spike left

-4- = Fence Line Bearings referenced to the south line of Park Drive with the assumed bearing of N85°05'E Survey ordered by: The Rauland Agency 118 Kenosha

R 17 E, Walworth County, Wisconsin,

and that the map shown above is a true representation thereof and shows the size and location of the property, its exterior boundaries, the location of all visible structures and dimensions of all principal buildings thereon, boundary fences, apparent easements, roadways and visible encroachments, if any, and that I have surveyed the property hereon described according to the official records to the best of my knowledge and belief. August 6, 1985
