# Plat of Survey

## Lot 8 in Block 6 of Delmar,

a subdivision located in the Southwest 1/4 of Section 27, Town 2 North,  
Range 16 East, Town of Delavan, Walworth County, Wisconsin.

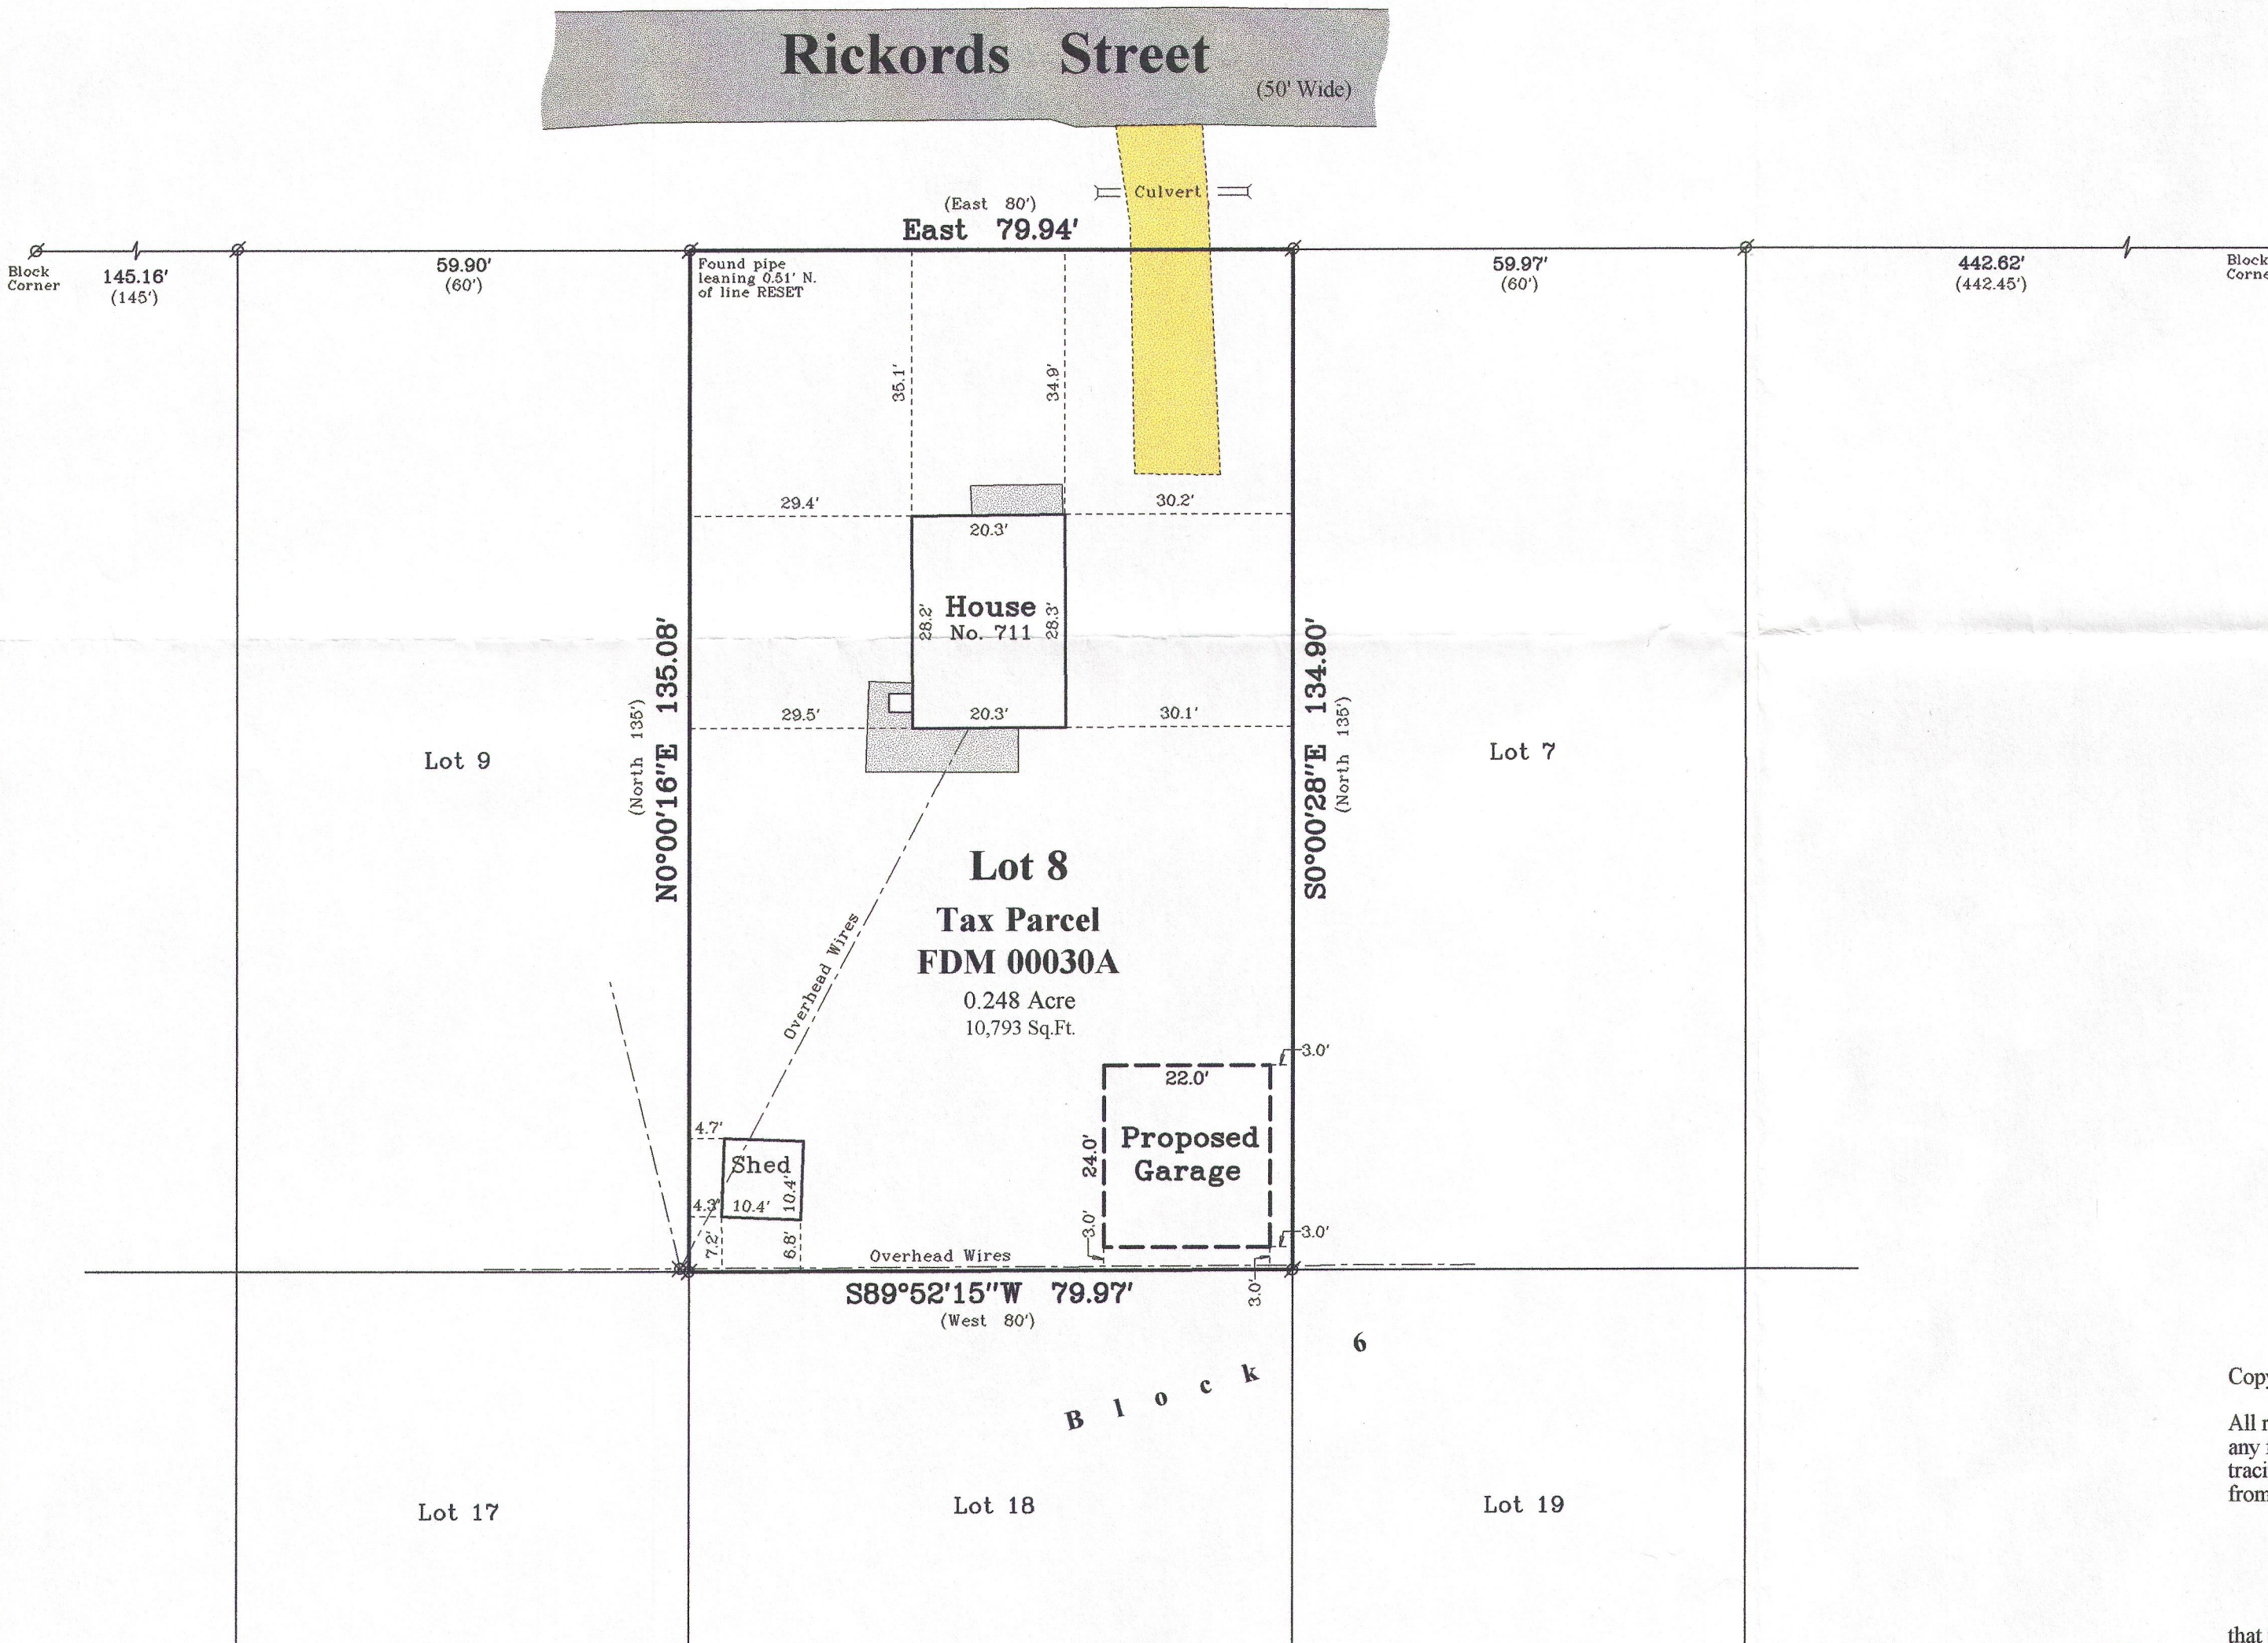
Bearings reference to the South line of Rickords  
Street recorded as East on the plat of Delmar.
