Plat of Survey

Lot 1 of Certified Survey Map No. 3148,

recorded in Vol. 17 of Certified Survey Maps of Walworth County on Page 157 and located in the Southwest 1/4 of Section 6, Town 2 North, Range 16 East, Town of Delavan, Walworth County, Wisconsin.

Surveyed for: **Robert Groover**
N4693 Dam Road
Delavan, Wisconsin. 53115

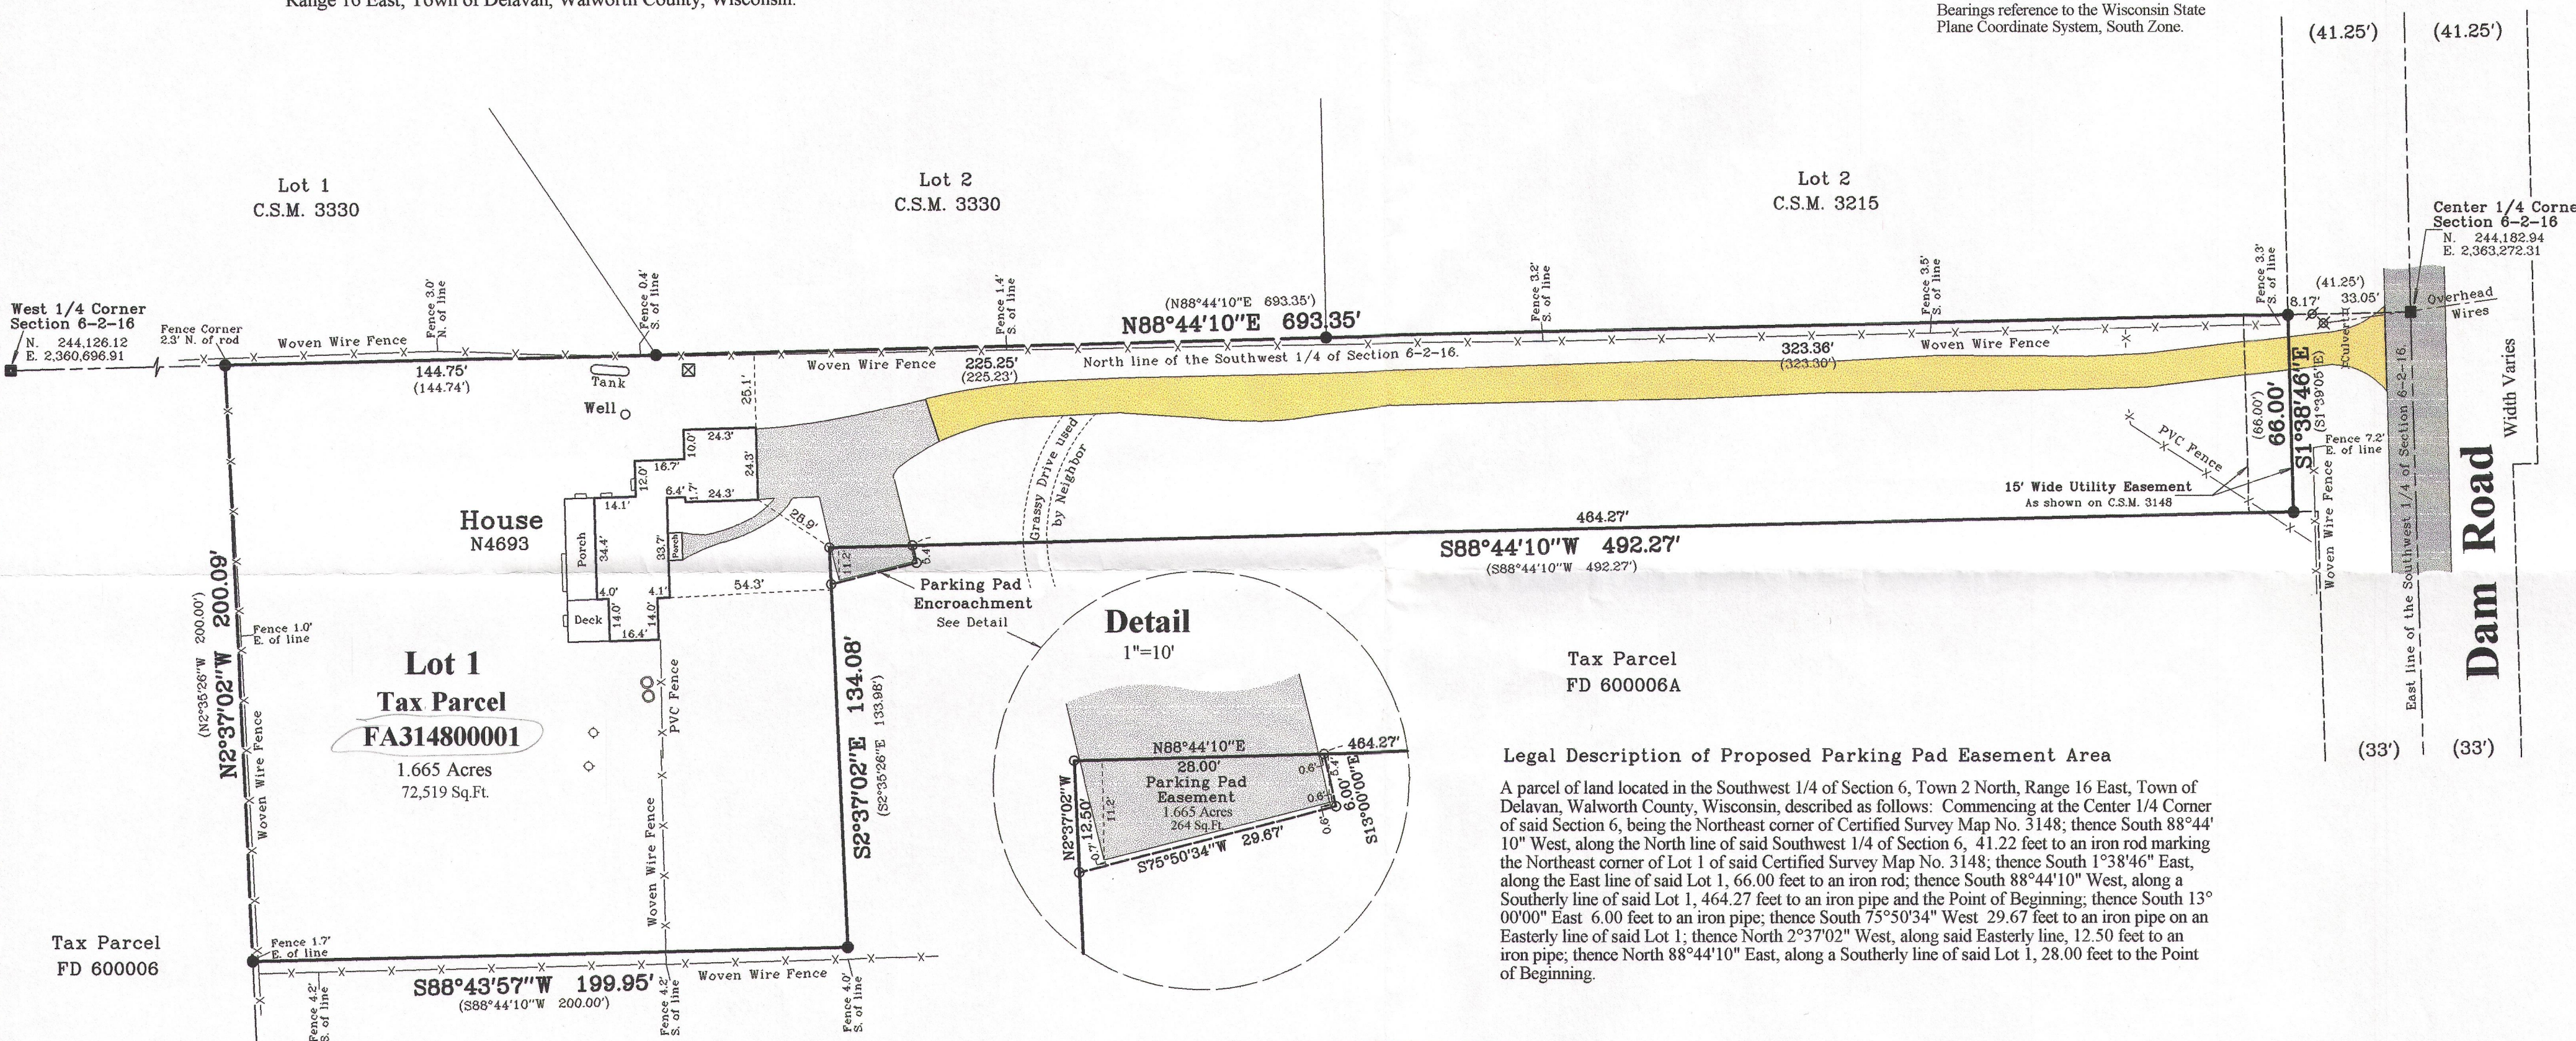
Bearings reference to the Wisconsin State Plane Coordinate System, South Zone.

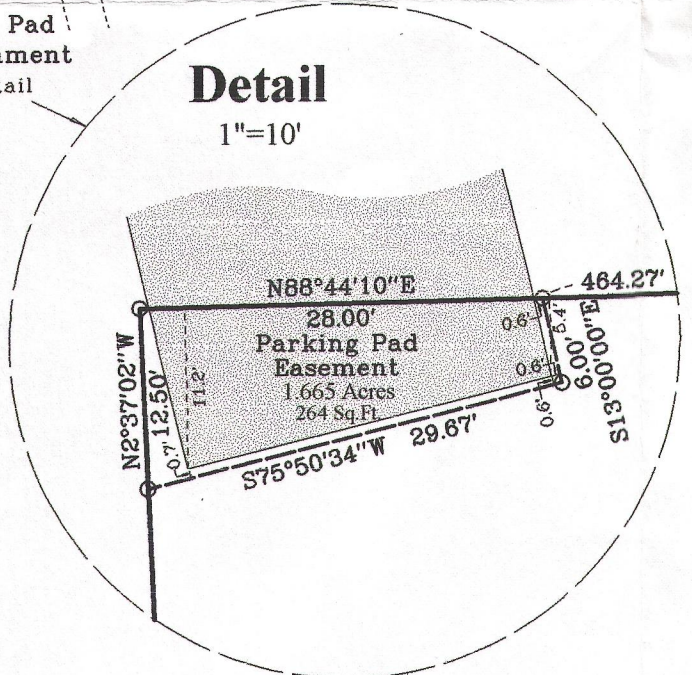
Detail

Legal Description of Proposed Parking Pad Easement Area

A parcel of land located in the Southwest 1/4 of Section 6, Town 2 North, Range 16 East, Town of Delavan, Walworth County, Wisconsin, described as follows: Commencing at the Center 1/4 Corner of said Section 6, being the Northeast corner of Certified Survey Map No. 3148; thence South 88°44'10\" West, along the North line of said Southwest 1/4 of Section 6, 41.22 feet to an iron rod marking the Northeast corner of Lot 1 of said Certified Survey Map No. 3148; thence South 1°38'46\" East, along the East line of said Lot 1, 66.00 feet to an iron rod; thence South 88°44'10\" West, along a Southerly line of said Lot 1, 464.27 feet to an iron pipe and the Point of Beginning; thence South 13°00'00\" East 6.00 feet to an iron pipe; thence South 75°50'34\" West 29.67 feet to an iron pipe on an Easterly line of said Lot 1; thence North 2°37'02\" West, along said Easterly line, 12.50 feet to an iron pipe; thence North 88°44'10\" East, along a Southerly line of said Lot 1, 28.00 feet to the Point of Beginning.
