# Plat of Survey

**Lots 8 through 15, except the Westerly 17 feet of Lot 15, and Lots 19 through 25, all in Block 9 of Delavan Lake-View Crest,**

a subdivision located in the Northeast 1/4 of the Northwest 1/4 of Section 31,  
Town 2 North, Range 16 East, Town of Delavan, Walworth County, Wisconsin.

Surveyed for: **National Repair Solution, LLC**

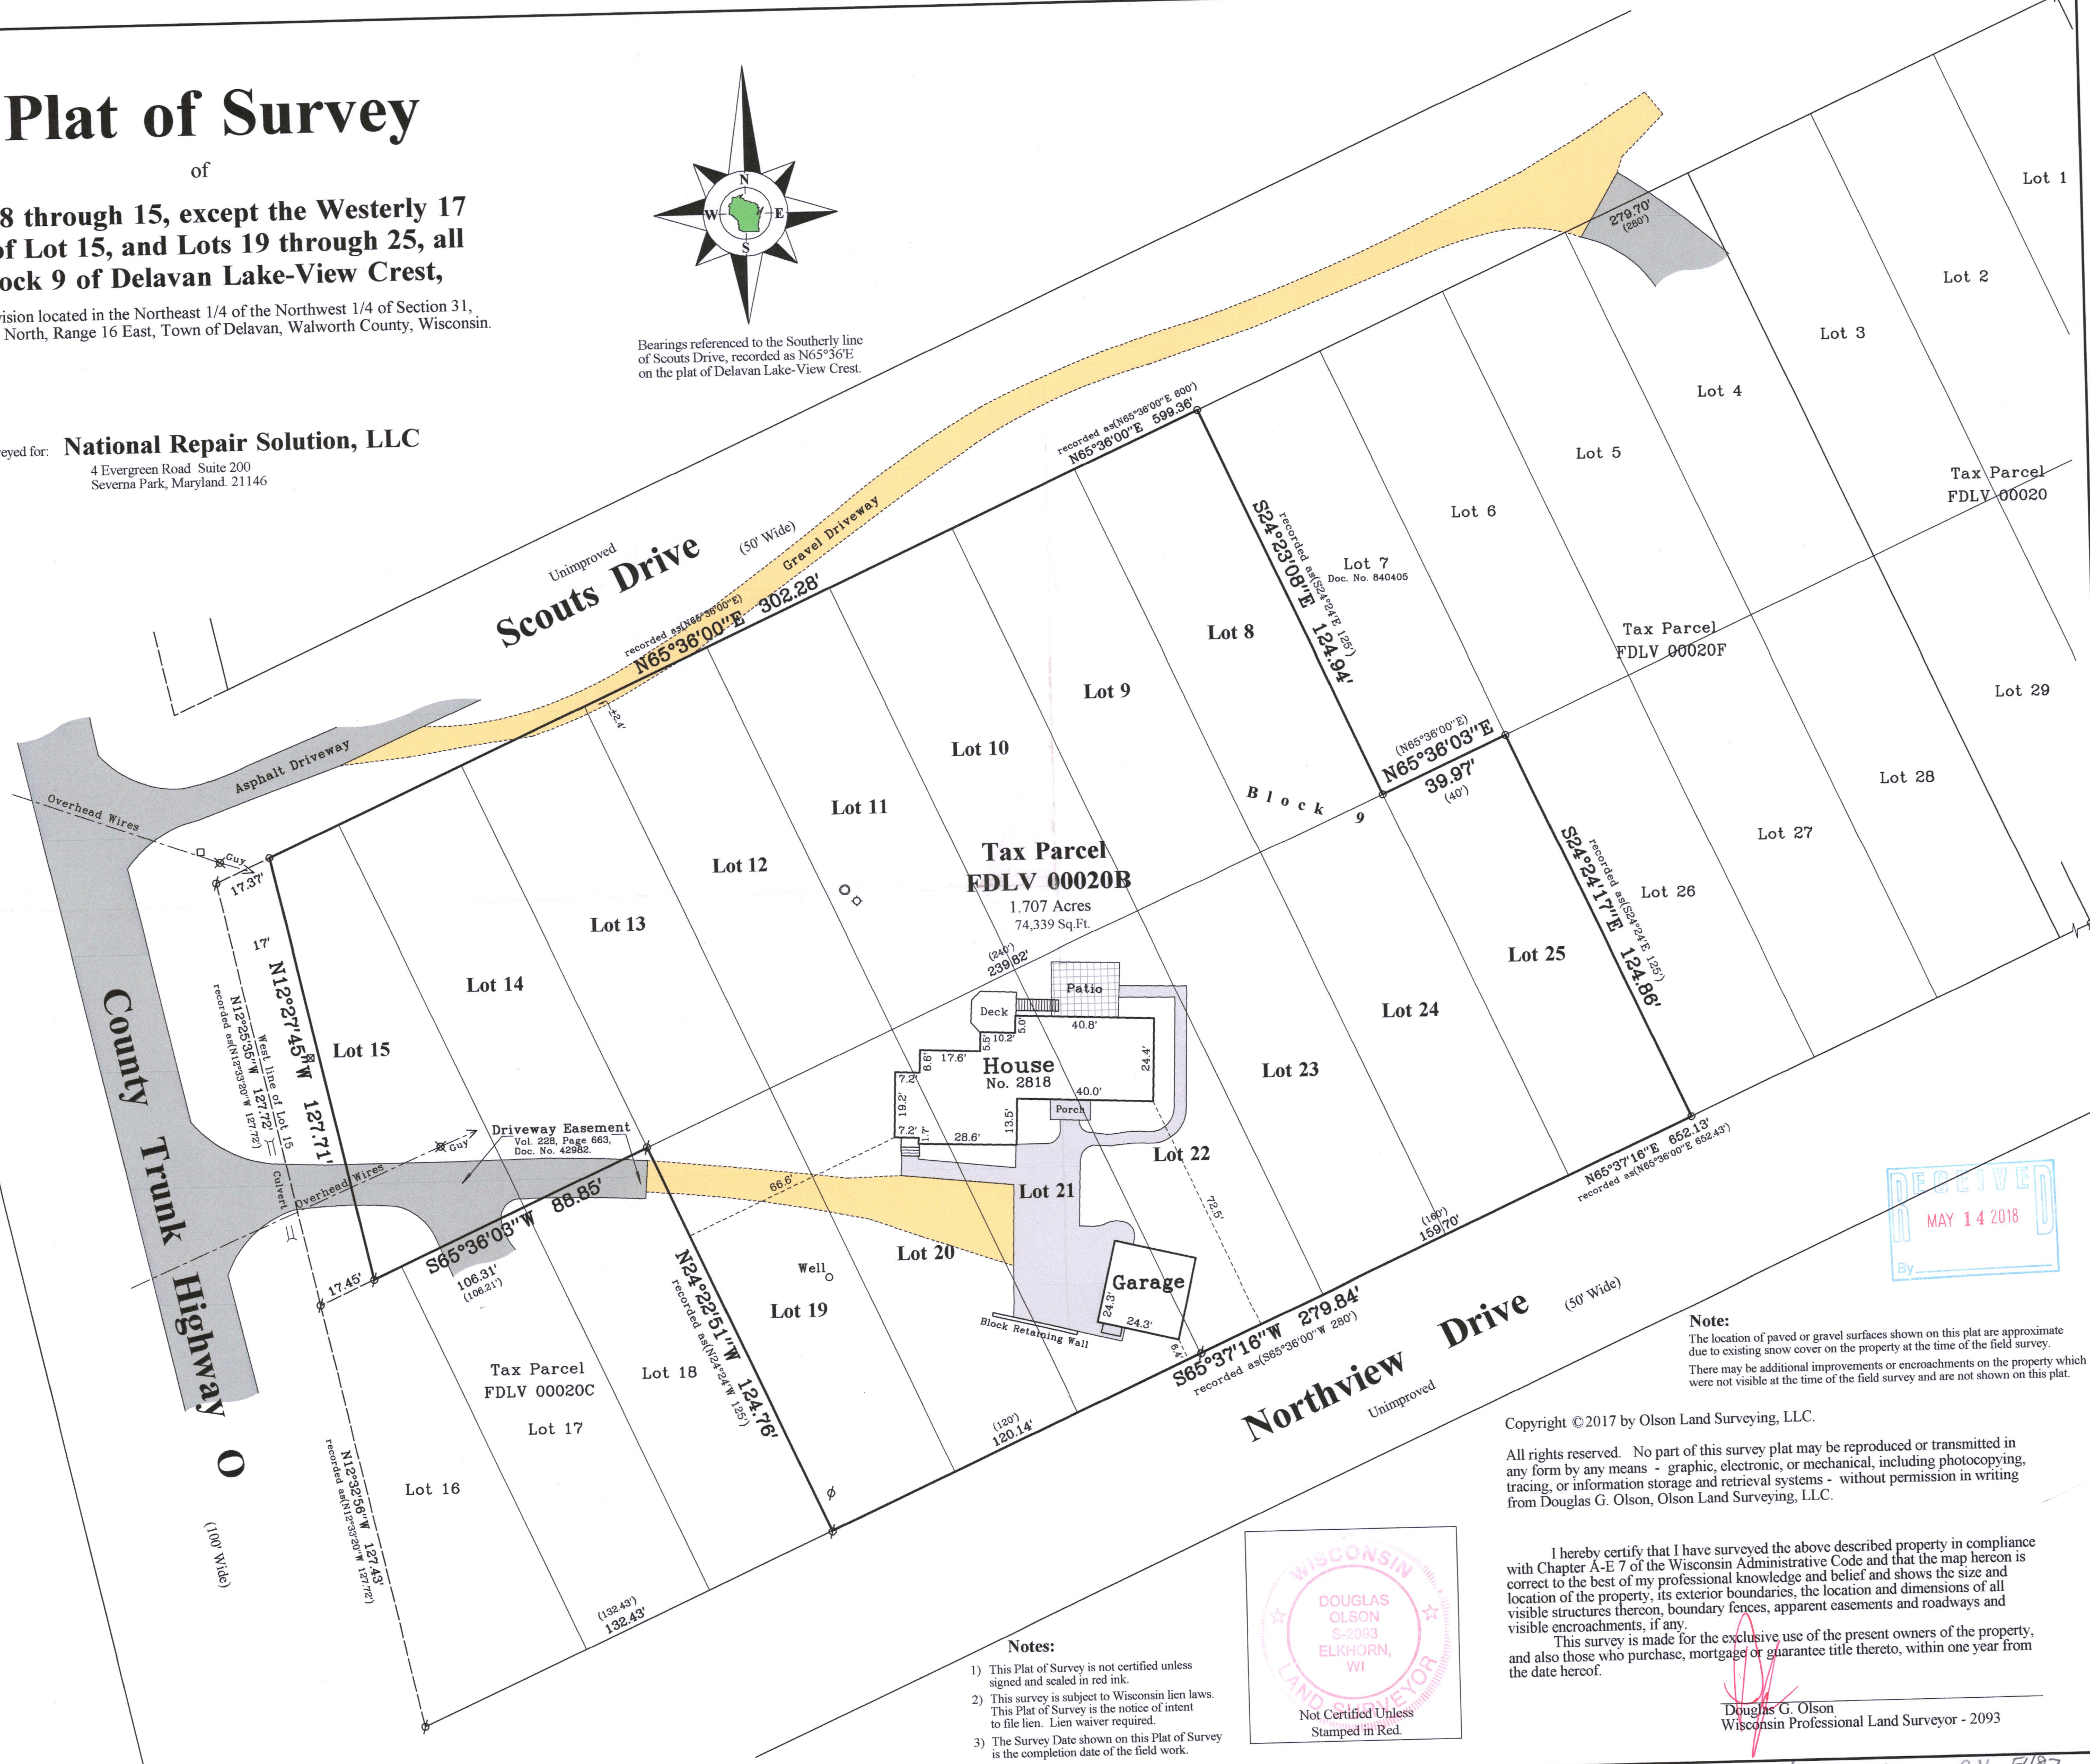
Bearings referenced to the Southerly line of Scouts Drive, recorded as N65°36'E on the plat of Delavan Lake-View Crest.
