# Plat of Survey

## Lot 16 in Block 2 of Delmar,

a subdivision located in the Southwest 1/4 of the Southwest 1/4 of Section 27,  
Town 2 North, Range 16 East, Town of Delavan, Walworth County, Wisconsin.

**Beth Walker**

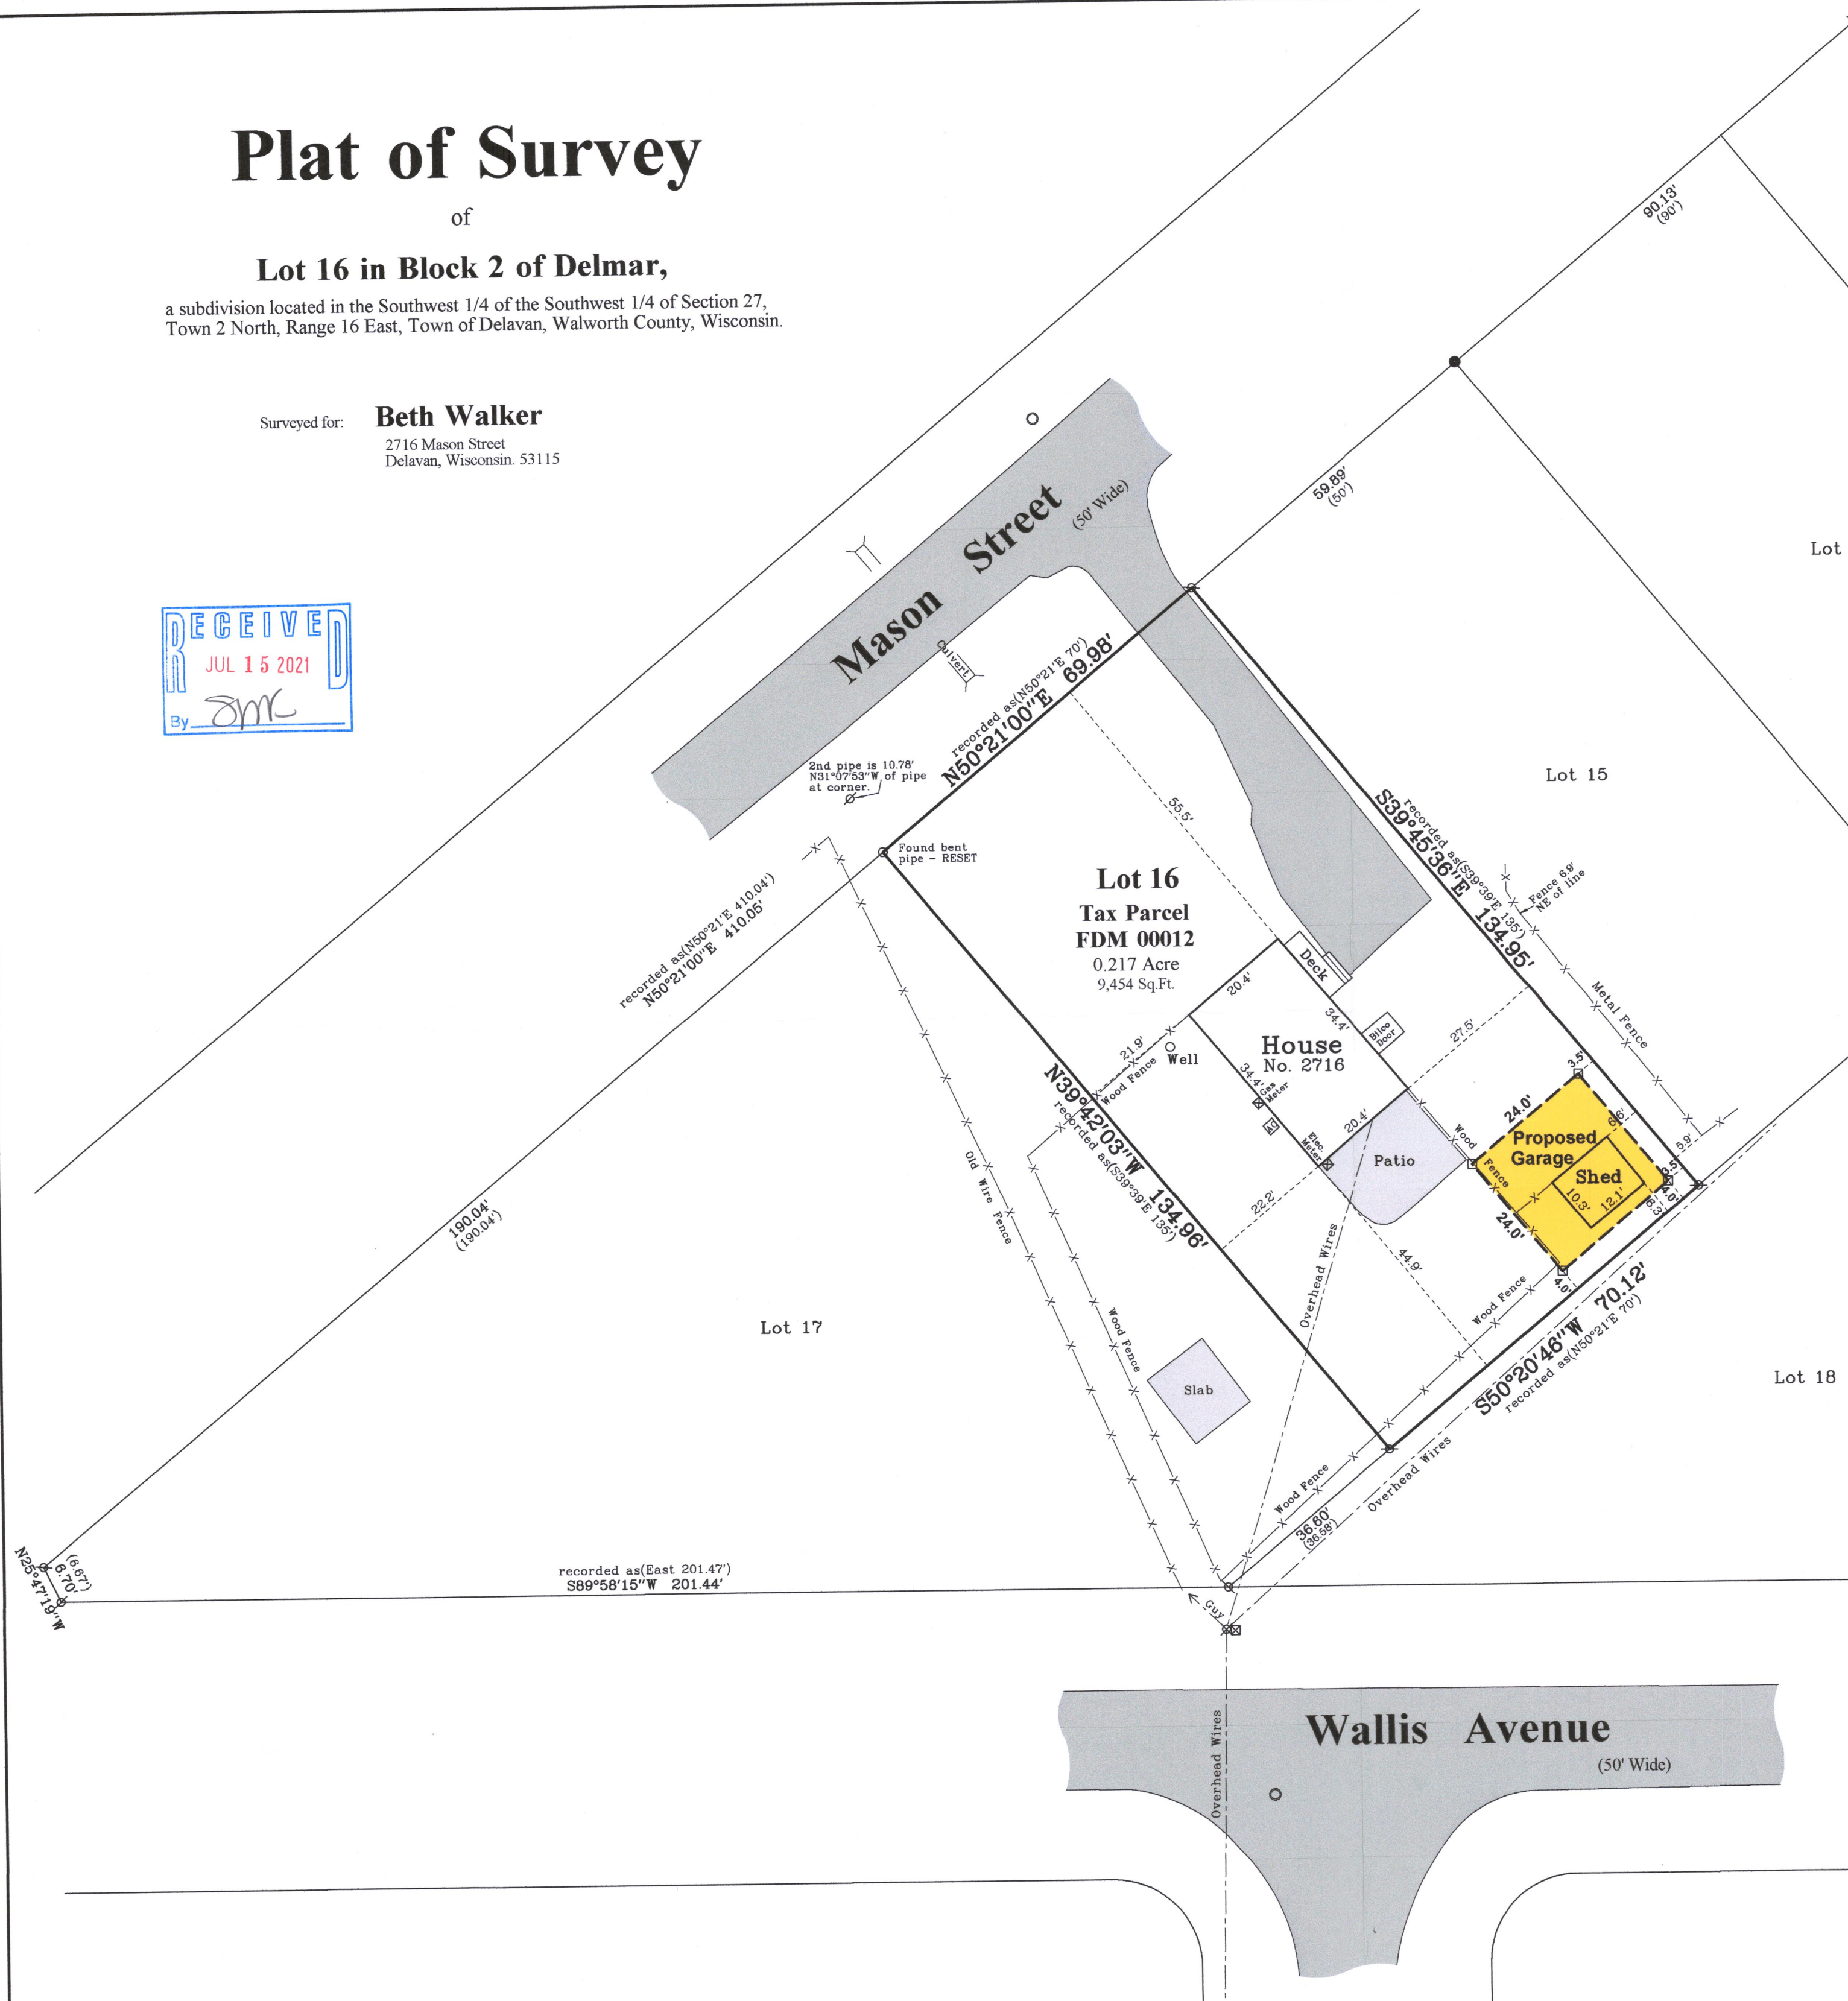
Bearings referenced to the Southeasterly line of Mason Street, recorded as N50°21'E on the plat of Delmar.

Survey Date: April 28, 2021.  
Revisions: No. 1 - Proposed Garage  
No. 2 - Adjustment to Proposed Garage
