DUNHAM SURVEYING, S.C. SURVEYING & SUBDIVIDING DELAVAN, WISCONSIN 53115

Lot 31 in Lake Delavan Highlands, a subdivision located in the South & of the Southeast & of Section 31, T 2 N, R 16 E, Walworth County, Wisconsin,

November 12, 1993 Updated August 23, 1994 to show location of proposed garage Updated September 16, 1994 for Flood Plain Line - 929.0

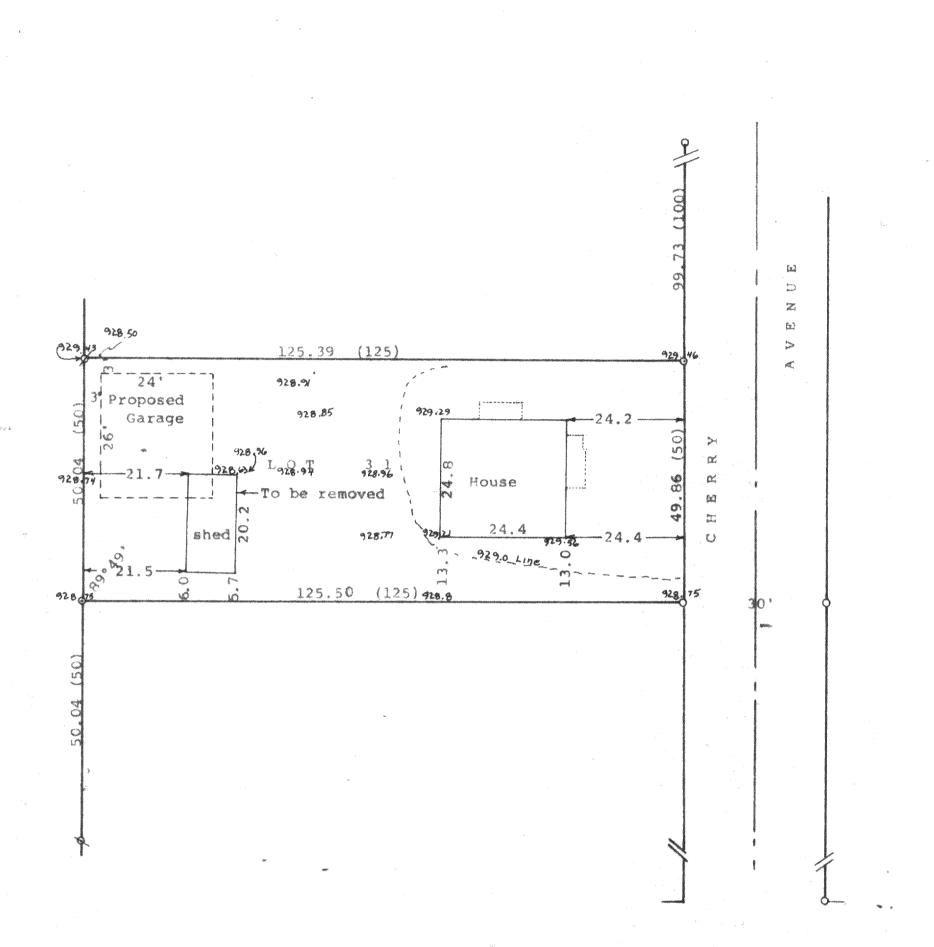
Scale + 1" = 20' $\emptyset = 3/4$ " Iron Pipe Found 0 = 3/4" X 24" Iron Pipe Set X = 14" Iron Pipe Found (0.00)= recorded distance Survey ordered by: Robert Hertel 10510 Altgeld Court Melrose Park, IL 60164 Survey updating ordered by: Deschner Building Contractors Inc.

and that the plat shown above is a correct representation thereof and shows the size and location of the property, its exterior boundaries, the location of all visible structures and dimensions of all principal buildings thereon, boundary fences, apparent easements, roadways and visible encroachments, if any, and that I have surveyed the property hereon described, according to the official records, to the best of my knowledge and belief.

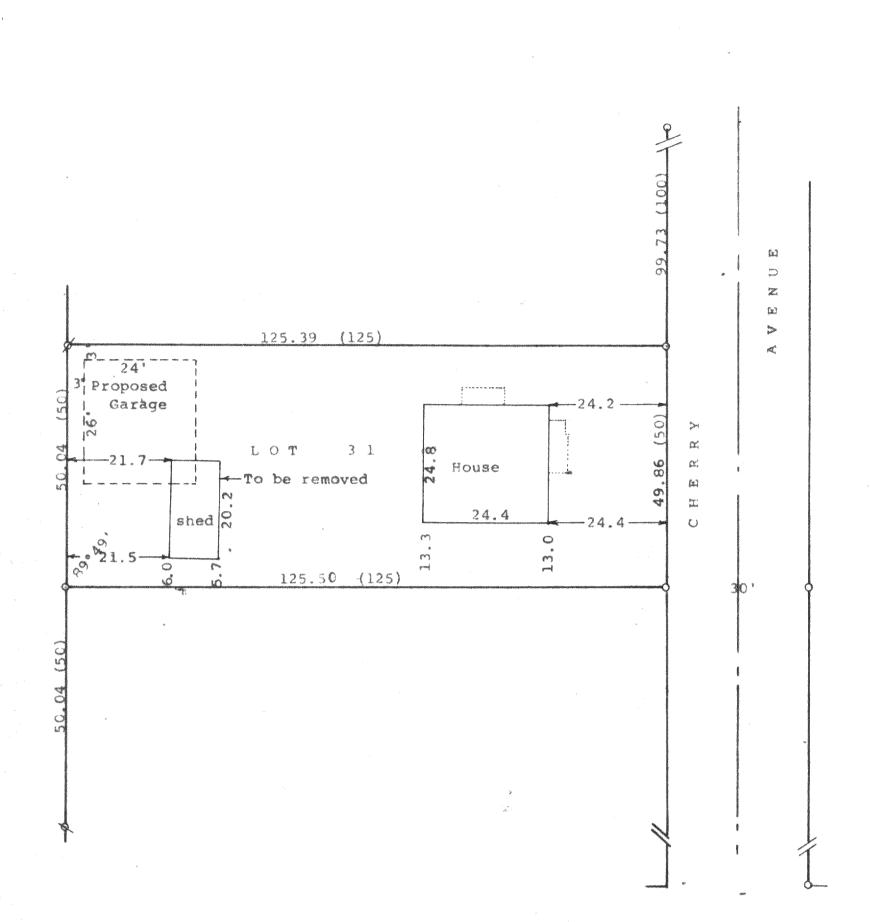
Scale - 1'' = 20' $\beta = 3/4$ " Iron Pipe Found 0 = 3/4" X 24" Iron Pipe Set X = 14" Iron Pipe Found (0.00)= recorded distance Survey ordered by: Robert Hertel 10510 Altgeld Court Melrose Park, IL 60164 Survey updating ordered by: Deschner Building Contractors Inc. 3338 North Shore Drive Delavan, WI 53115

Lot 31 in Lake Delavan Highlands, a subdivision located in the South & of the Southeast & of Section 31, T 2 N, R 16 E, Walworth County, Wisconsin,

and that the plat shown above is a correct representation thereof and shows the size and location of the property, its exterior boundaries, the location of all visible structures and dimensions of all principal buildings thereon, boundary fences, apparent easements, roadways and visible encroachments, if any, and that I have surveyed the property hereon described, according to the official records, to the best of my knowledge and belief. November 12, 1993

Updated August 23, 1994 to show location of proposed garage
