Plat of Survey

Lands described in a Warranty Deed recorded in Vol. 631 on Page 3498 as Document No. 290177 as shown below:
 A part of Lot 8 of Meacham's Park, part of Lot 1 of Harrington Subdivision and part of the unplatted land lying between Meacham's Park and Harrington Subdivision, all located in the NE Fractional 1/4 of Fractional Section 27, T2N, R16E, Walworth County, Wisconsin, described as follows: Commencing at the southeast corner of Meacham's Park; thence S 42° 13' W along the northwesterly line of the Public Road 45.24 feet to the northeast corner of Harrington Subdivision; thence S 49° 48' 30" W along said road 72.02 feet to the place of beginning; thence continue S 49° 48' 30" W along said road 80.34 feet; thence N 57° 36' 30" W 183.57 feet to an iron pipe on the north line of Harrington Subdivision; thence continue N 57° 36' 30" W 39.00 feet to an iron stake; thence continue N 57° 36' 30" W 23.8 feet more or less to the shore of Delavan Lake; thence northeasterly along said shore 80.1 feet; thence S 57° 00' 54" E 2 feet to an iron stake; thence continue S 57° 00' 54" E 105.88 feet to the south line of Meacham's Park; thence continue S 57° 00' 54" E 62.56 feet to th

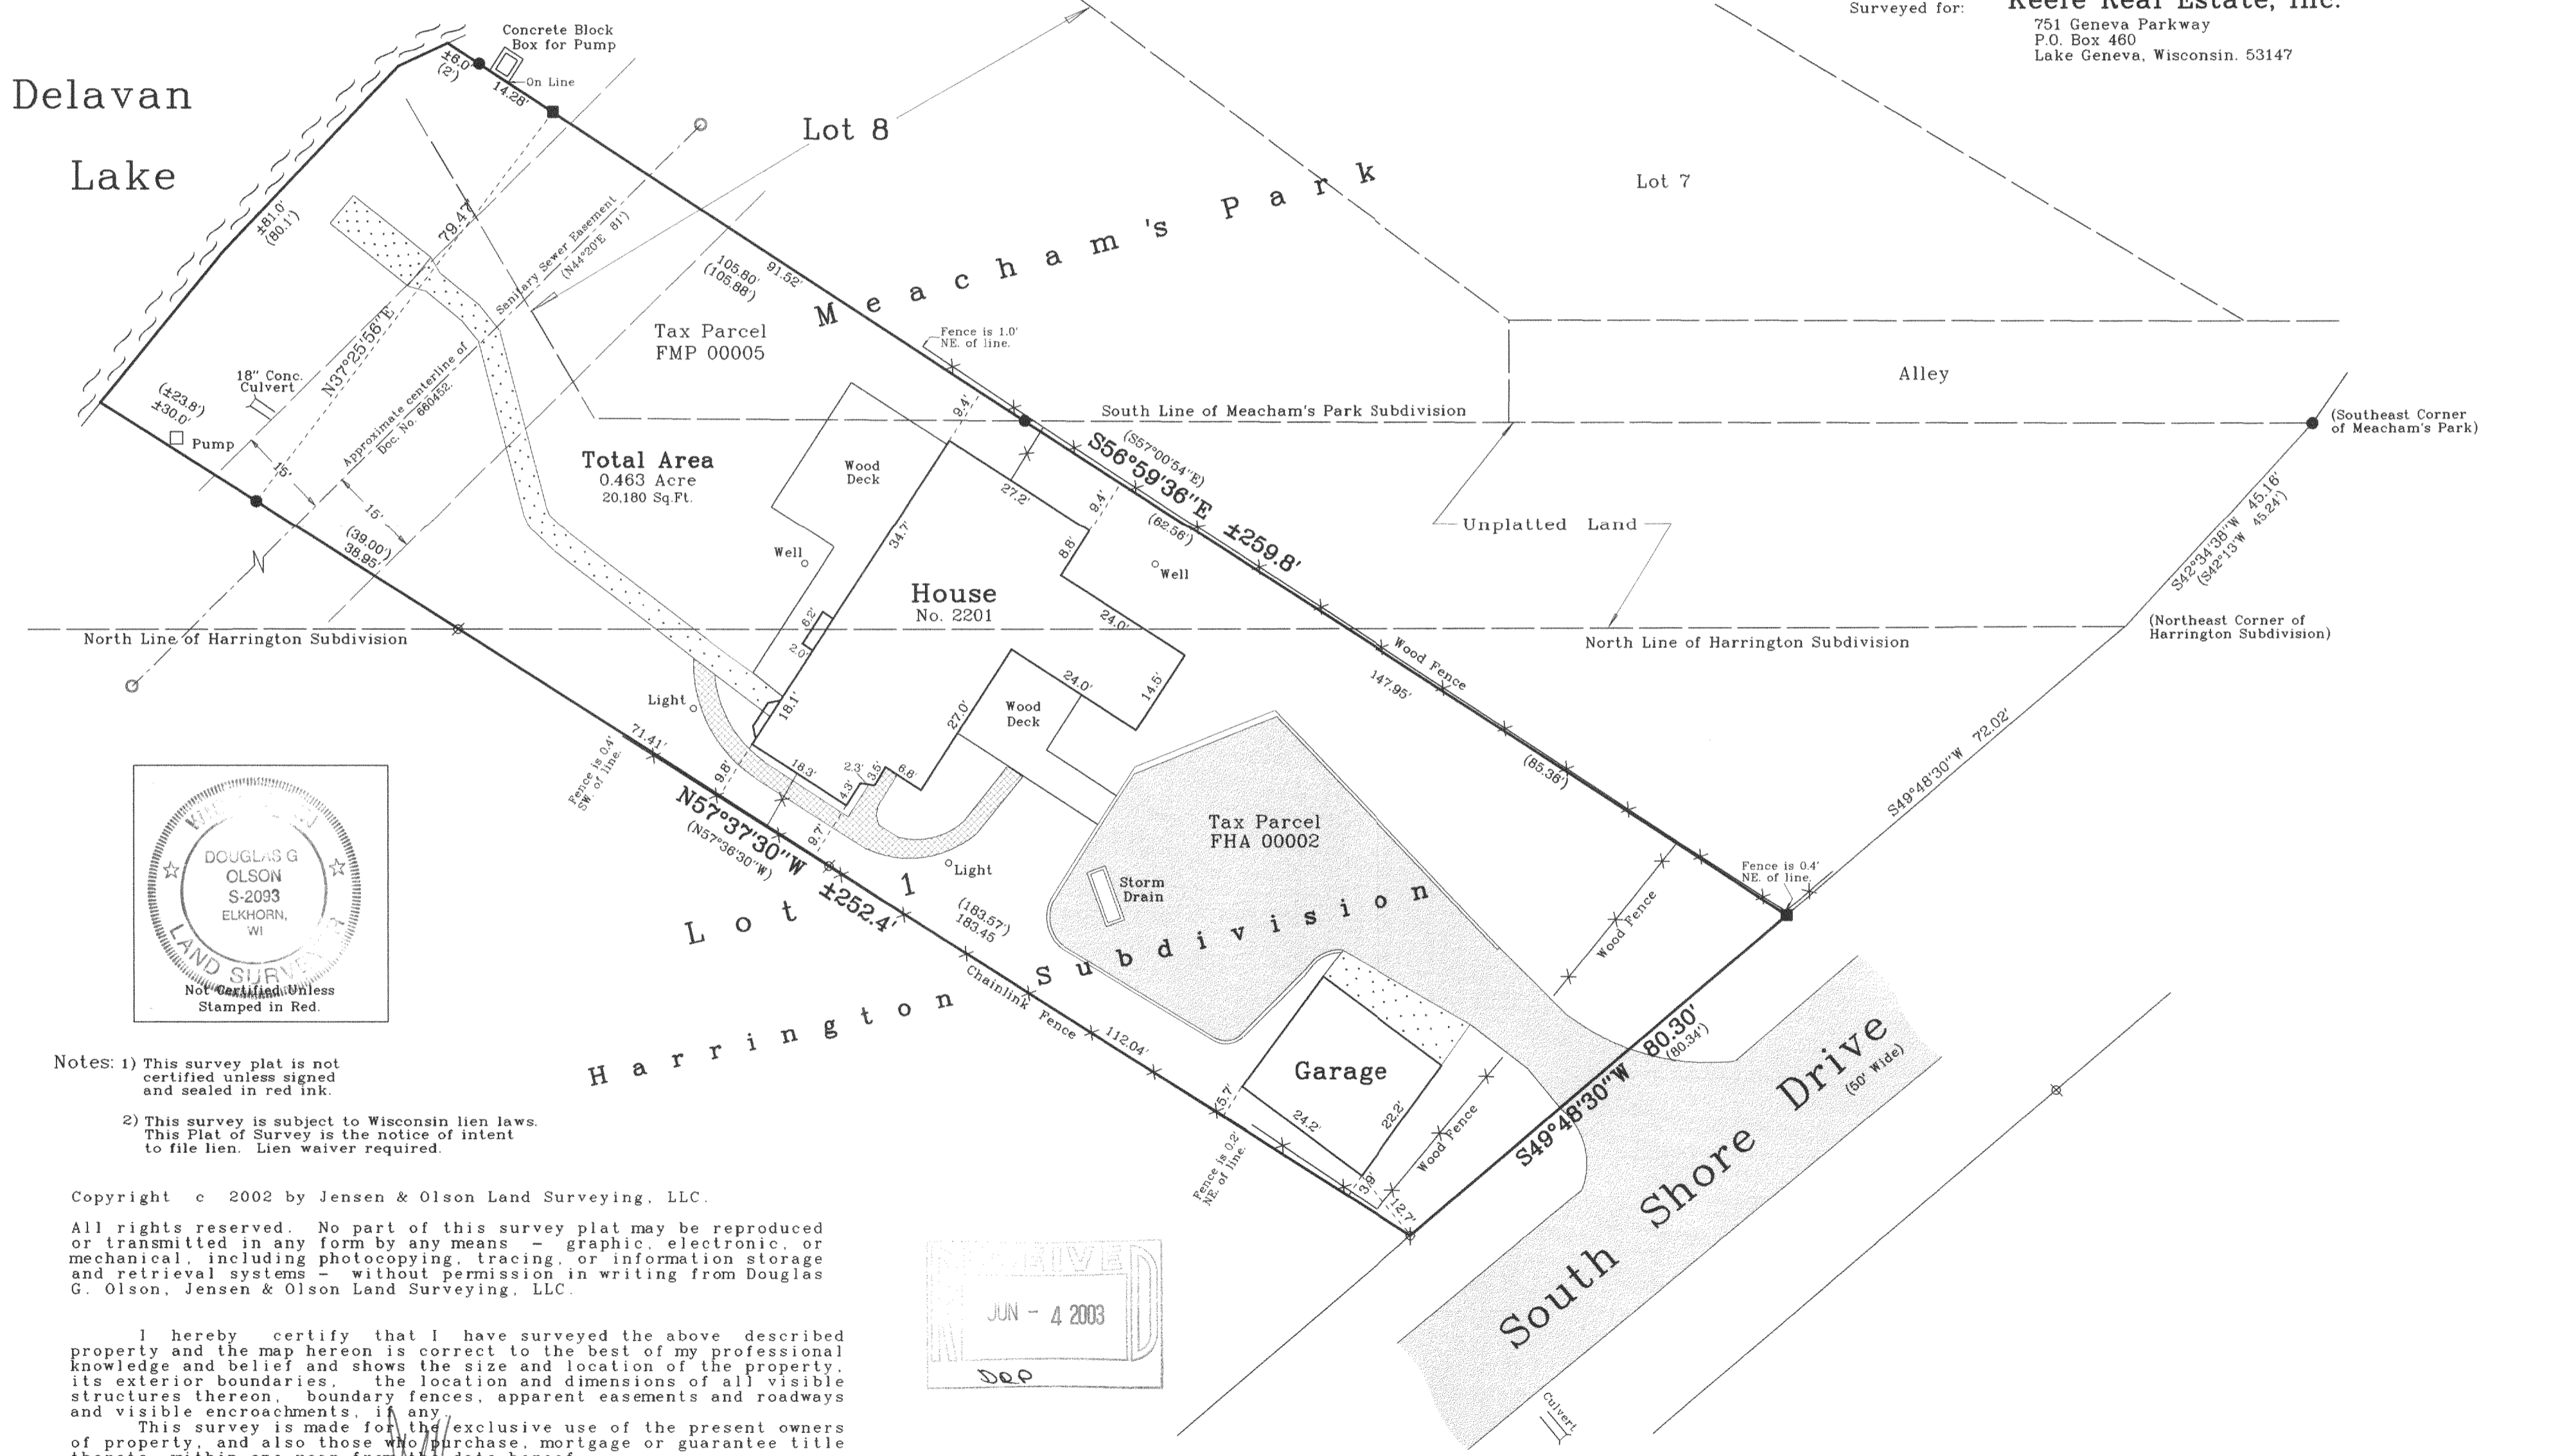
Bearings reference to previous surveys of record.

I hereby certify that I have surveyed the above described property and the map hereon is correct to the best of my professional knowledge and belief and shows the size and location of the property, its exterior boundaries, the location and dimensions of all visible structures thereon, boundary fences, apparent easements and roadways and visible encroachments, if any.
 This survey is made for the exclusive use of the present owners of property, and also those who purchase, mortgage or guarantee title thereto, within one year from the date hereof.
