Plat of Survey

Lot 8 in Block 6 of Delmar,

a subdivision located in the Southwest 1/4 of Section 27, Town 2 North, Range 16 East, Town of Delavan, Walworth County, Wisconsin.

Surveyed for: **Chris Moore**
4115 Ash Avenue
Delavan, Wisconsin. 53115

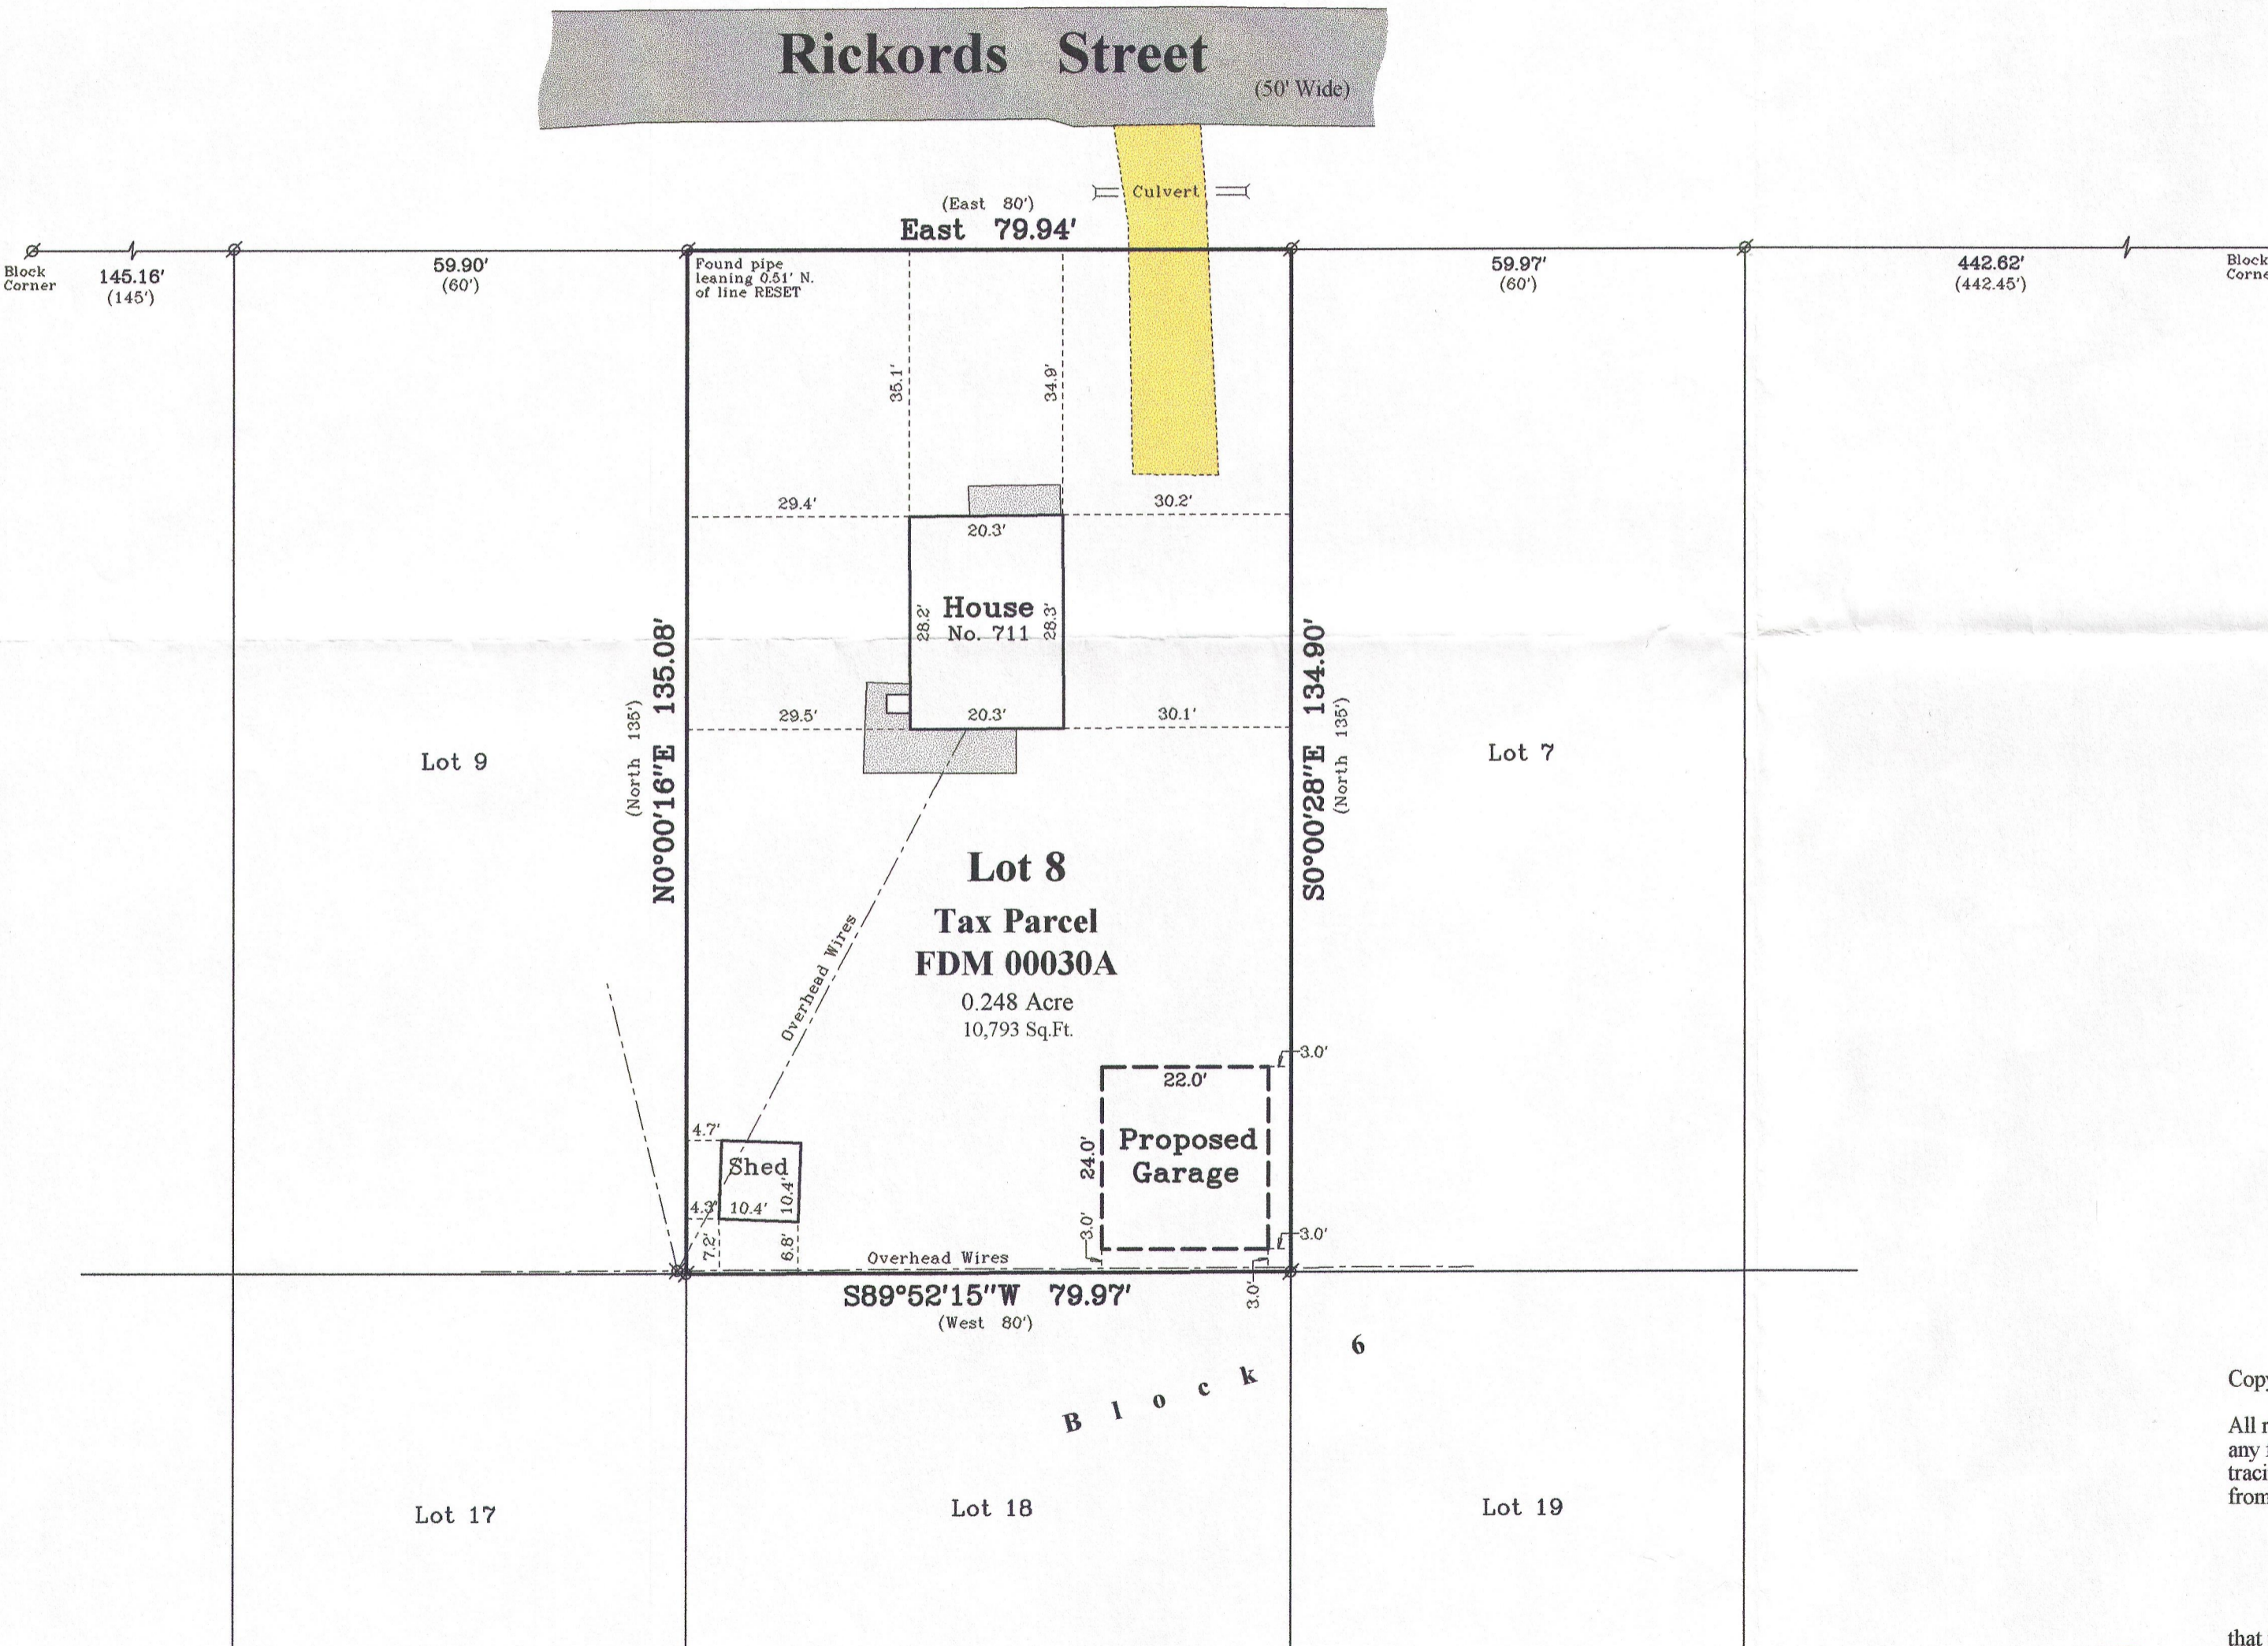
Bearings reference to the South line of Rickords Street recorded as East on the plat of Delmar.
