Plat of Survey

The West 1/2 of Lot 1 of Sidon,

a subdivision located in Government Lot 3 in the Northwest 1/4 and the Southwest 1/4 of Section 28, Town 2 North, Range 16 East, Town of Delavan, Walworth County, Wisconsin.

Surveyed for: **Keefe Real Estate, Inc.**

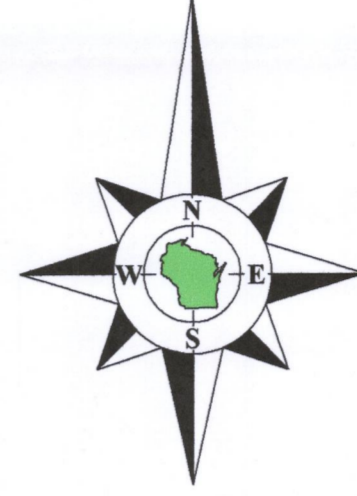
Bearings referenced to the South line of the Northwest 1/4 of Section 28, recorded as S89°12'47"E in the Wisconsin State Plane Coordinate System, South Zone, (NAD-27).

Coordinates are referenced to the Wisconsin State Plane Coordinate System, South Zone, (NAD-27).
