Plat of Survey

of  
Lots 5820 thru 5827, Block 103 of Lake Como Beach,  
located in Section 28, Town 2 North, Range 17 East,  
Town of Geneva, Walworth County, Wisconsin.

Surveyed for: **Edward Schenk**  
N3287 Hickory Road  
Lake Geneva, Wisconsin. 53147

Mapping Date: 10-30-95  
Revisions:  
Sheet 1 of 1 Sheets  
Job Reference No.  
**1995.095**

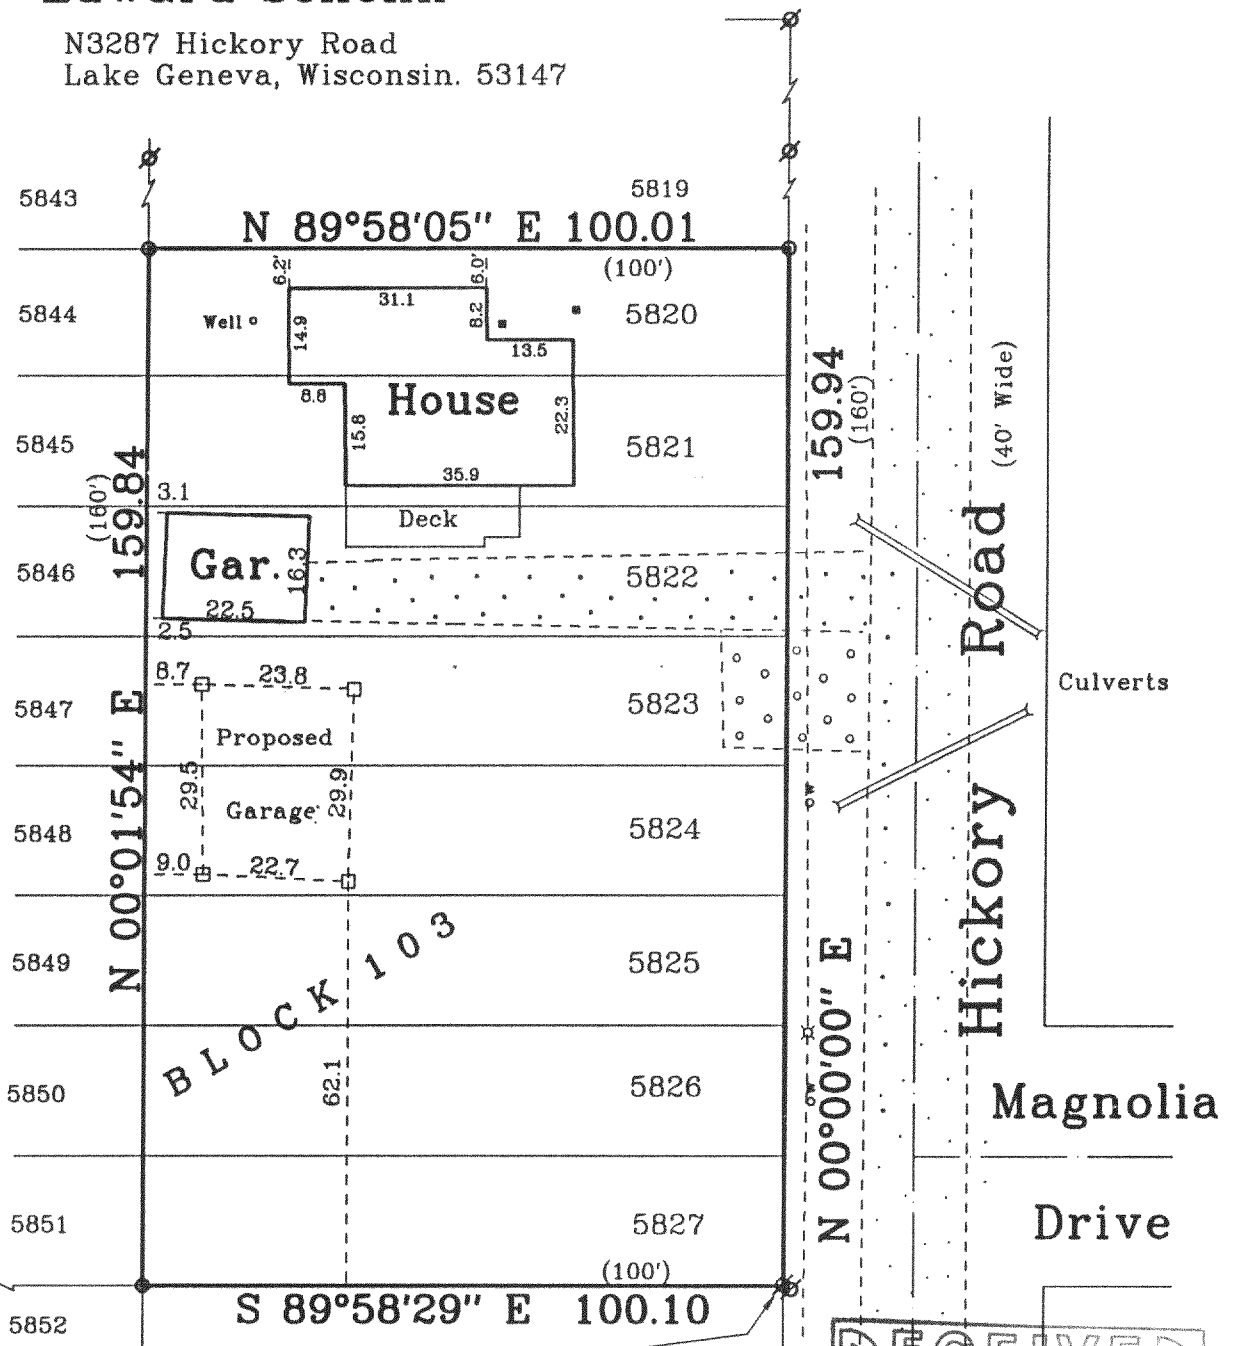
Lots 5820 thru 5827, Block 103 of Lake Como Beach,  
located in Section 28, Town 2 North, Range 17 East,  
Town of Geneva, Walworth County, Wisconsin.

Scale in feet: 1" = 30'
