Plat of Survey

Lot 1 of Certified Survey Map No. 560,

recorded in Vol. 3 of Certified Survey Maps of Walworth County on Page 3 and located in the Northwest 1/4 of Section 15, Town 3 North, Range 15 East, Town of Richmond, Walworth County, Wisconsin.

Surveyed for: **David Lundberg**
W8487 County Road A
Delavan, Wisconsin. 53115

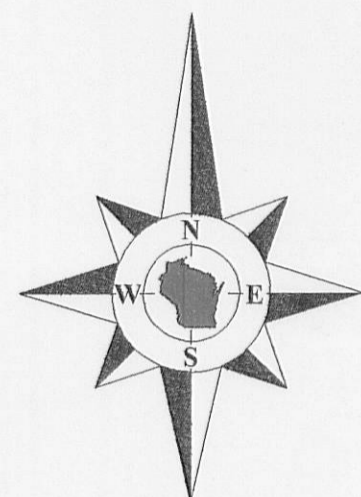
Bearings reference to Certified Survey Map No. 560.

Northwest Corner
Section 15-3-15.
(N. 287.183.00)
(E. 2.343.978.85)

East line of the Northeast 1/4 of Section 15-3-15.
(S87°13'12"E 2844.79'
West line of the Northwest 1/4 of Section 15-3-15.
