Plat of Survey

Lot 1 of Certified Survey Map No. 4379,

recorded in Vol. 28 of Certified Survey Maps of Walworth County on Page 203 and located in the Northwest 1/4 of Section 36, Town 4 North, Range 16 East, Town of LaGrange, Walworth County, Wisconsin.

Surveyed for: **Sandra Hamilton**
21727 Sound Way #101
Estero, Florida. 33928

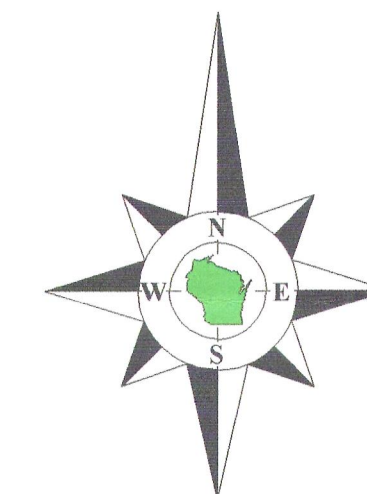
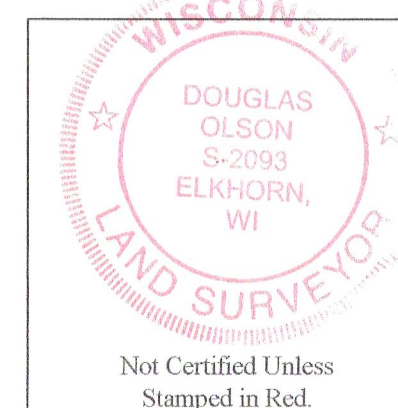
Sheet 1 of 1 Sheets
Drawing Name: HA4379-1 (6-2011) 1063-2011063 Plat (S)
Job Reference Number
2011.063
2011.063

Bearings reference to the Wisconsin State Plane Coordinate System, South Zone.

Elevations on this survey are referenced to a recorded elevation of 886.959 on Benchmark FX-P-9, a chiselled + on the Southwest wingwall of the Honey Creek dam. This elevation is referenced to the National Geodetic Vertical Datum of 1929 (NGVD29).

The flood elevation information shown on this survey is referenced to Flood Insurance Rate Map (FIRM) No. 55127C0065D and the Flood Insurance Study (FIS) report dated October 2, 2009 prepared by the Federal Emergency Management Agency (FEMA). These publications were prepared using the North American Vertical Datum of 1988 (NAVD88). Page 18 of the Flood Insurance Study gives the following conversion factor for Walworth County, NAVD88 + 0.2 feet = NGVD29.

A 100 year flood elevation of 886.2 NGVD29 was used on this survey based upon an elevation of 886 NAVD88 on the above mentioned FIRM and FIS.
