PLAT OF SURVEY OF

LOT 3, LAKE BEULAH COUNTRY CLUB
SUBDIVISION, LOCATED IN SECTION 18,
TAN, RIBE, WALWORTH COUNTY,
WISCONSIN.

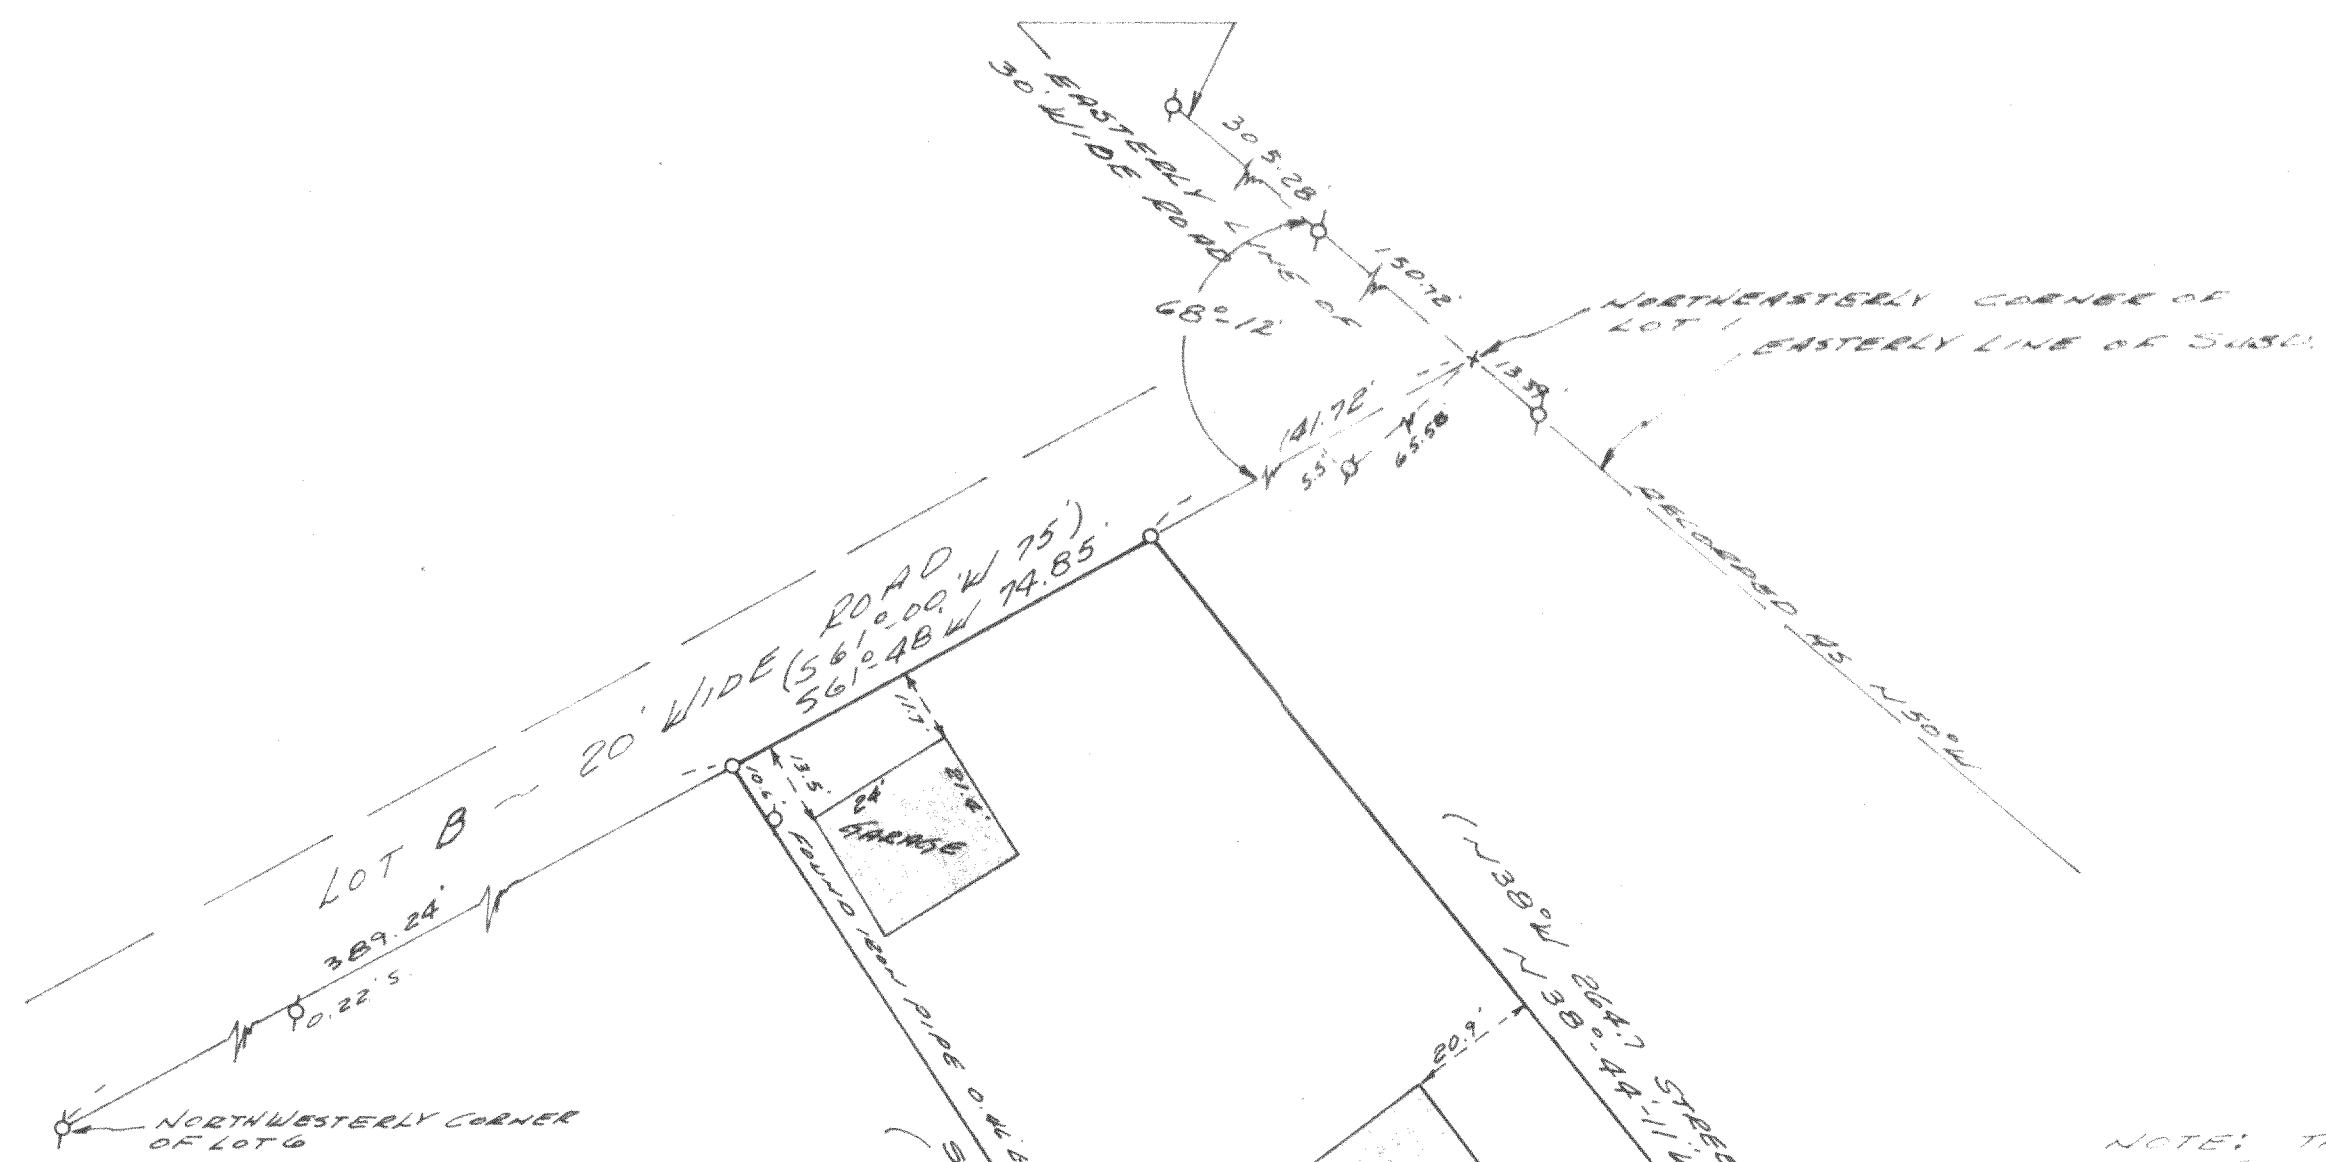
NOTE: THERE IS NO BEARING GIVEN ON THE MEANDER LINE ON THE RECORDED PLAT.

SOUTHWESTERLY
CORNER OF LOT 6
ON MEANDER LINE

BEARINGS ESTABLISHED
FROM EASTERLY LINE OR
SUBD. RECORDED AS NSCL

NOTE: SET IRON PIPE
FALLS ON FENCE LINE

FOUND IRON PIPE
APPEARS TO HAVE BEEN
SET IN THE RETAINING
WALL.

POINT FALLS ON
CONC. RETAINING WALL
NO IRON PIPE SET.
